final report

Project code: P.PIP.0260
Prepared by: Gavin Inglis
Machinery Automation and
Robotics
Date published: June 2012
ISBN:

Bladestop – Phase 4 Final Report

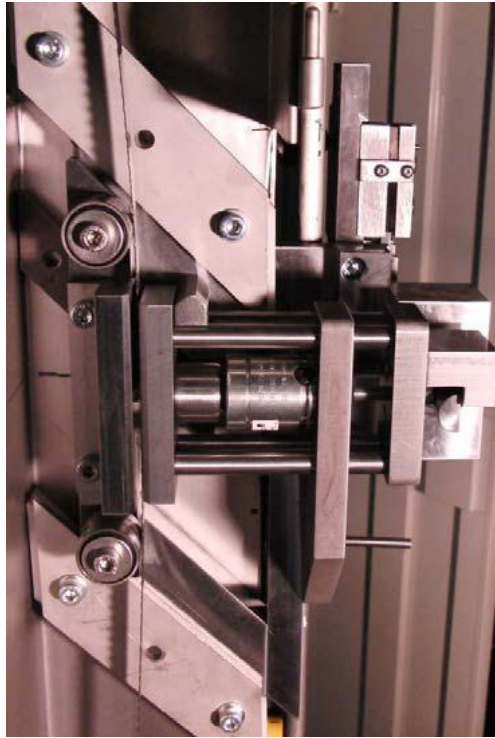
Fig.4 First Prototype mechanism

The concept proved to work well during initial trials restricting blade travel to 40 – 60 mm, which is well within the specified 150mm. However when conducting the 1000 trip test to ensure reliability at MAR a number of issues arose:

- 1) The linear slides showed signs of wear and lead to difficulties in latching the mechanism
- 2) The mechanism consisted of a lot of individual components bolted together, these came loose with operation
- 3) Part of the mechanism has stainless steel rubbing on stainless steel which tended to bind up.

This led to a redesign and development of the second prototype which included the following upgrades:

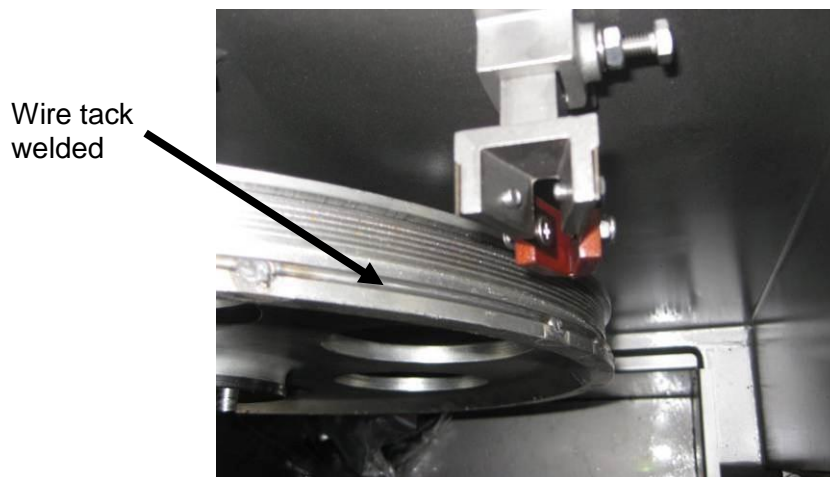
The bottom flywheel had previously had a strip of wire tack welded to it to inhibit the saw blade from jumping forward when the BladeStop mechanism was actuated. This is now fully welded to prevent any entrapment. Wheel scrapers were also added to prevent meat build up on the wheels.

Fig.13 Previous tack welding of wire

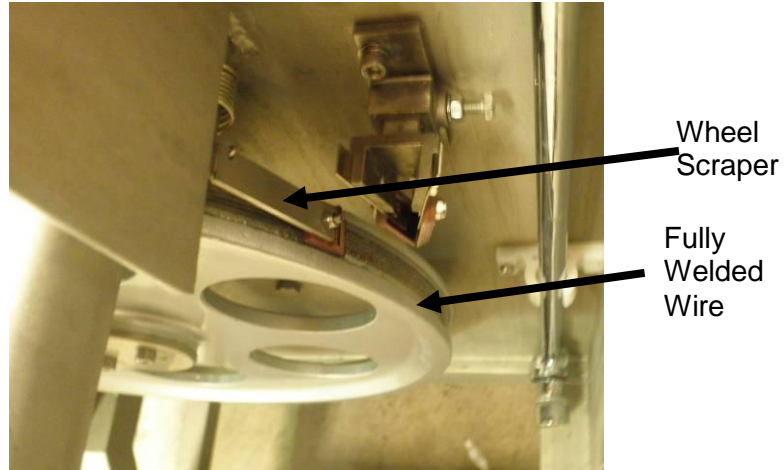
Fig 14: Welded wire and wheel scrapers

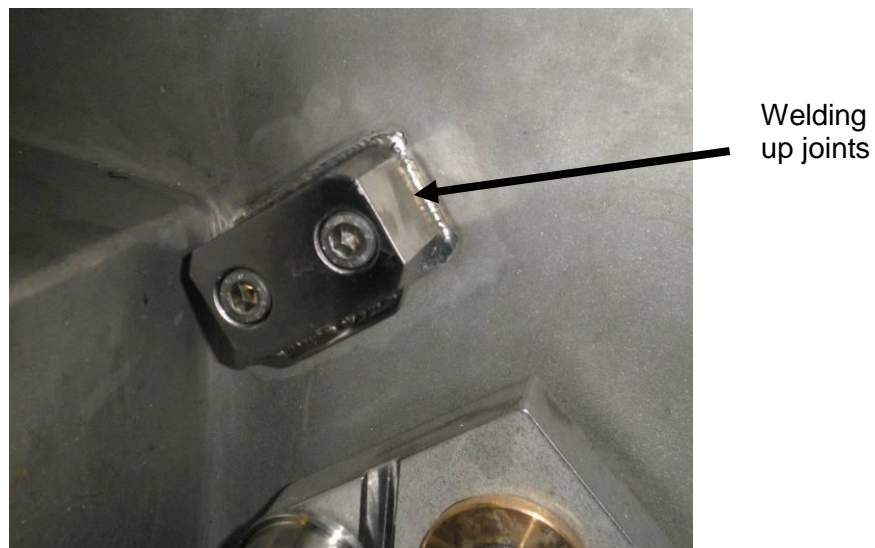
The mechanical stops that had previously been fastened on with bolts only left a gap for entrapment around it's edge. These gaps have now been welded (see Fig15) to prevent the chance of any meat build up.

Fig 15: Welded up joints on plate support

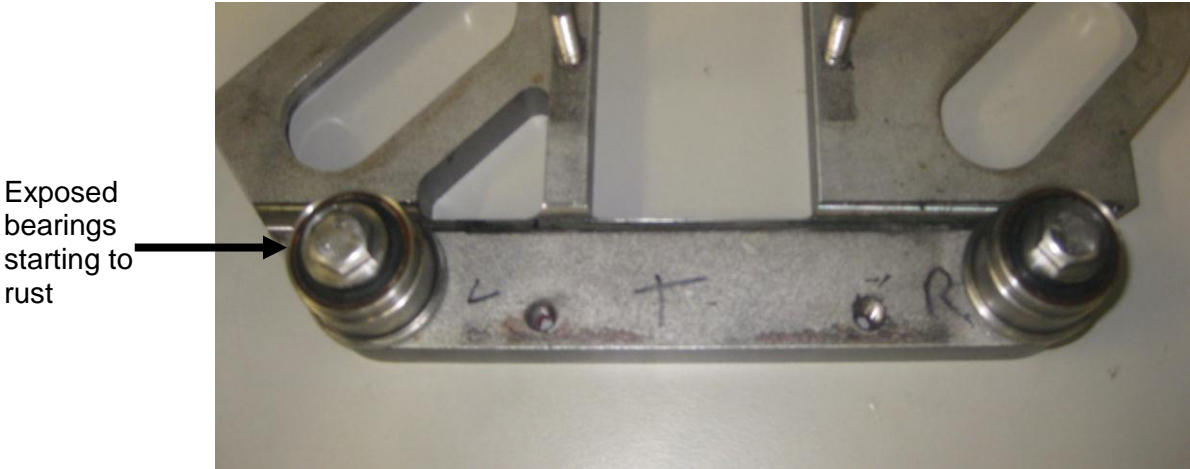
The bearings in the previous design were failing due to a number of reasons:

- 1) Over heating from high running speeds
- 2) Corrosion due to the wash down
- 3) Minimum load not being achieved

Fig.16 Previous Bearing Sleeve Design

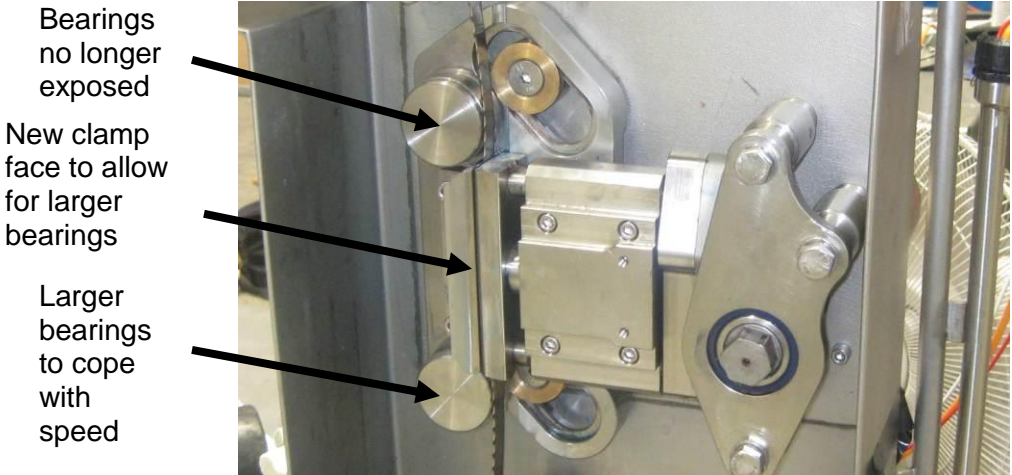
Fig.17 New Bearing Design

- The bearings have been upgraded in size to meet the high speed requirements of the blade.
- One bearing is now being used instead of 3 to meet the minimum load requirements.
- The bearing sleeve has been changed to a completely sealed design to prevent water and chemical ingress.
- The bearings are now a food grade stainless steel bearing which is lubricated with a food grade of grease and sealed

It is felt that these design changes will dramatically increase the performance and lifetime of the bearings.

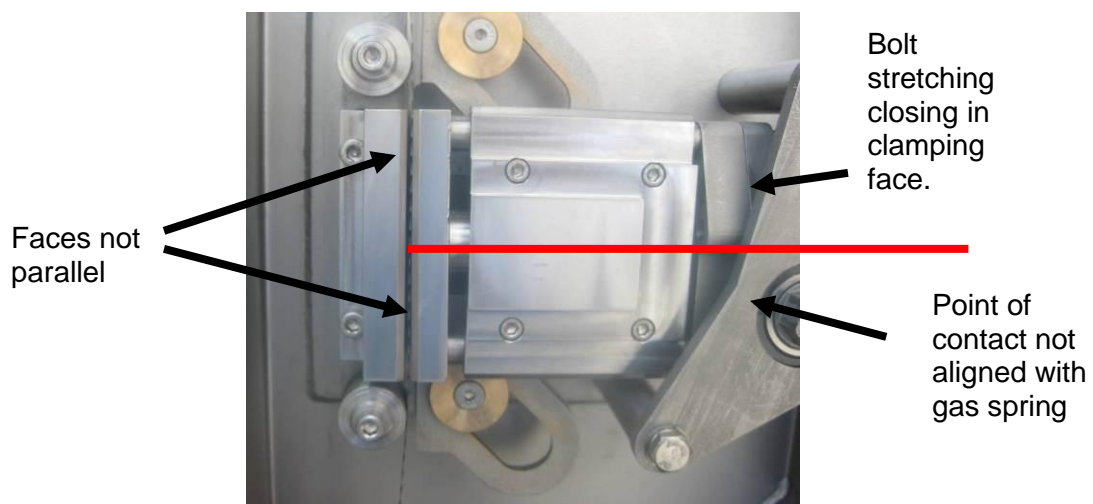
On the previous design the blade was found to be cutting into the clamping faces while running after the mechanism had been cocked (clamping faces held open) for a period of time. This was due to the following issues:

- 1) Bolts on the clamping face stretching from being overloaded
- 2) Unbalanced loads caused by an offset between the gas spring position and the latching mechanism.

Fig.18 Old Mechanism

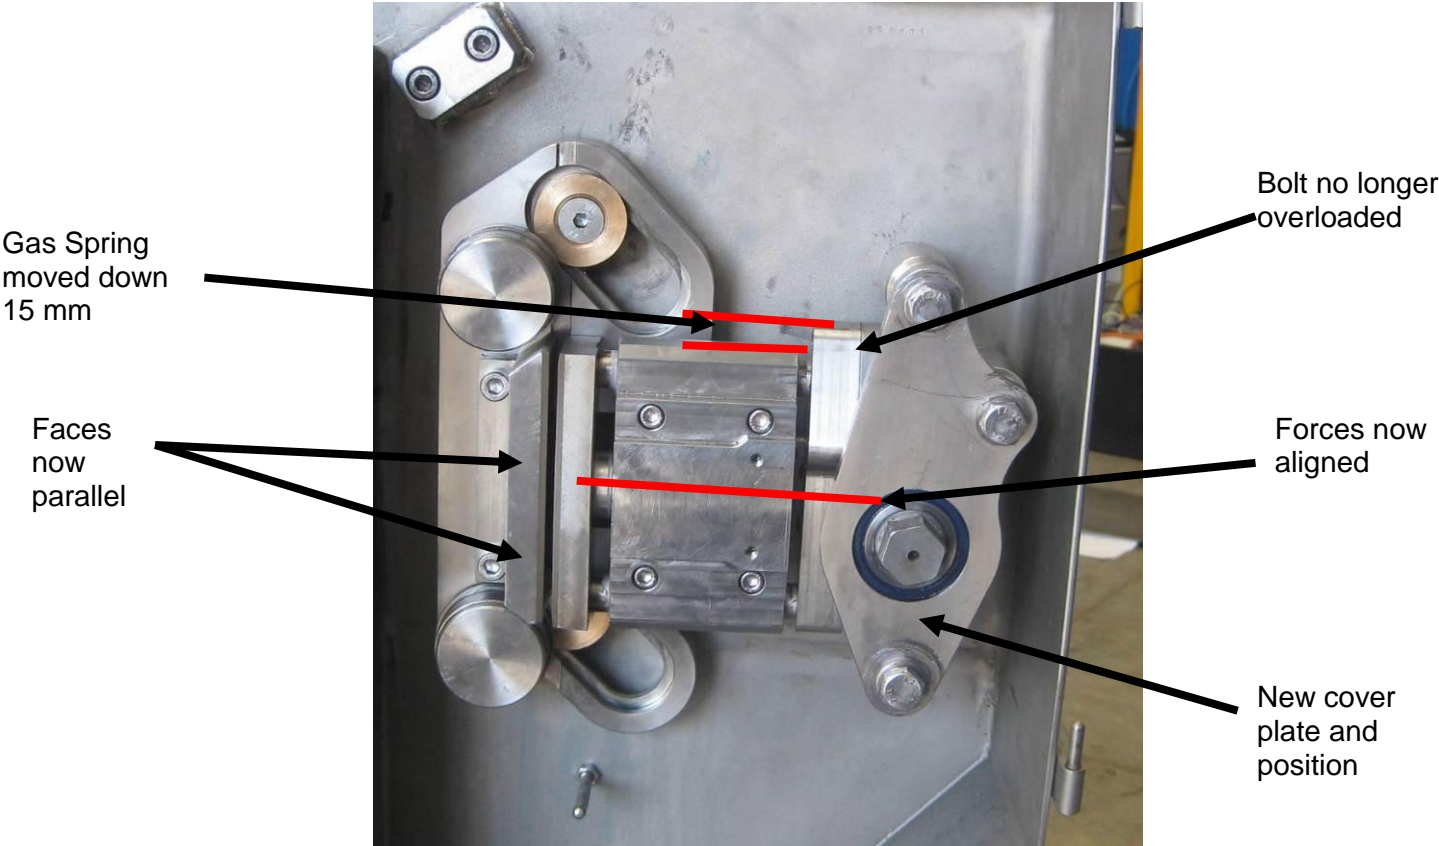
Fig.19 Changes to align the cocking forces

- Lowering of the front part of the mechanism by 15 mm to align the gas spring with the point of contact on the latching mechanism.

With the mechanism aligned properly the bolts are no longer overloaded. In changing the position of the front part of the mechanism, the cover plate and three mounting shafts were changed to allow for the movement as depicted in Fig.18 and 19.

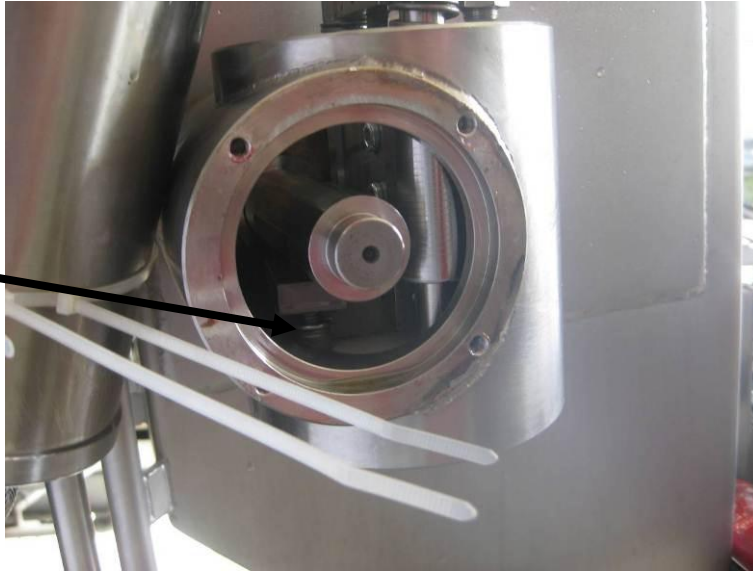
The bolts at the bottom of the oil filled compartment connecting to the main shaft have failed. This was due to the following reason:

- 1) Forces from the gas spring over loading the bolts

Overloaded
bolts caused
failure

Fig.21 Overloaded Bolts

This issue was been resolved by using grade 12.9 black steel bolts which meet the maximum load requirements of this mechanism.

This change will see the lifespan of these bolts significantly increase.

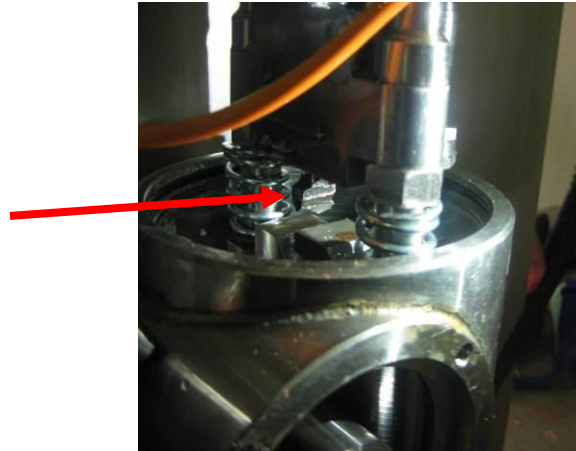
The second stage finger latch (figure 22) had failed while on site. During the design review the following issues have been identified as the cause:

- 1) Stress applied by the gas spring is nearing the yield stress of the material
- 2) Faces on the latch are not completely flat from the manufacturing process used causing a point load to one side

Previously snapped 2nd stage finger latch

Fig.22: Broken stage two finger latch

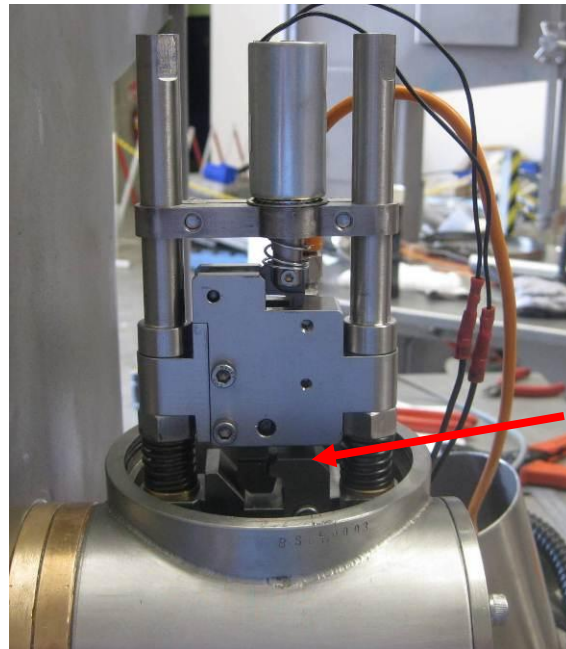
Thicker finger to reduce stress and prevent damage.

Fig.23 New stage two finger latch

- Increased material thickness at critical points to reduce loading of the material and subsequent failures
- The manufacturing procedure has changed to a more capable process to improve the integrity of the part.

It is felt that these changes will significantly increase the lifespan of the 2nd stage finger latch.

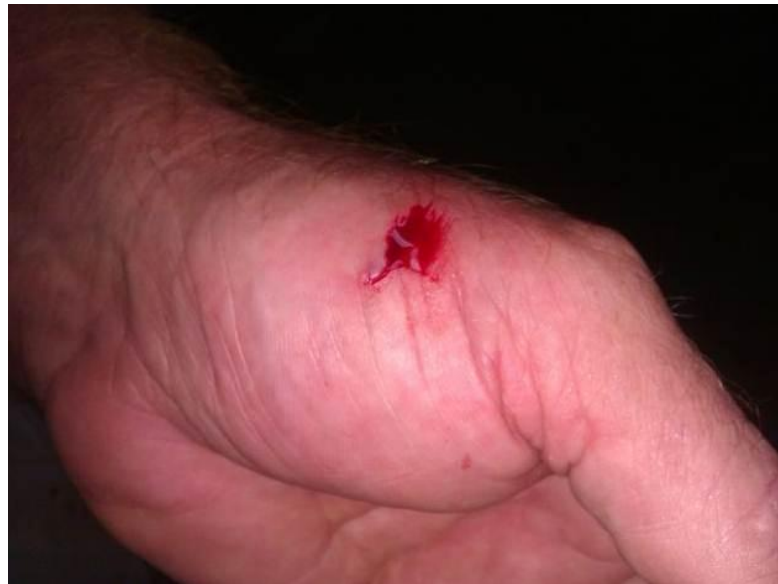
MAR returned to site the week of the 9th of January 2012 and the issues experienced prior to Christmas were resolved. The saw was put into production following this and has been running in production since this time. In late January the saw was moved to a heavier duty cutting position and it was found that the blade was twisting due to the increased force required to cut the harder bones. The saw was removed from this position and returned to the lighter duty operation of cutting lamb chops where it has remained since this date. The Bladestop received its first reported activation preventing a serious injury during the week of 19/3/12. The image below shows the graze received following Bladestop activation.

Fig.24 Graze received following first reported Bladestop Activation preventing a serious injury

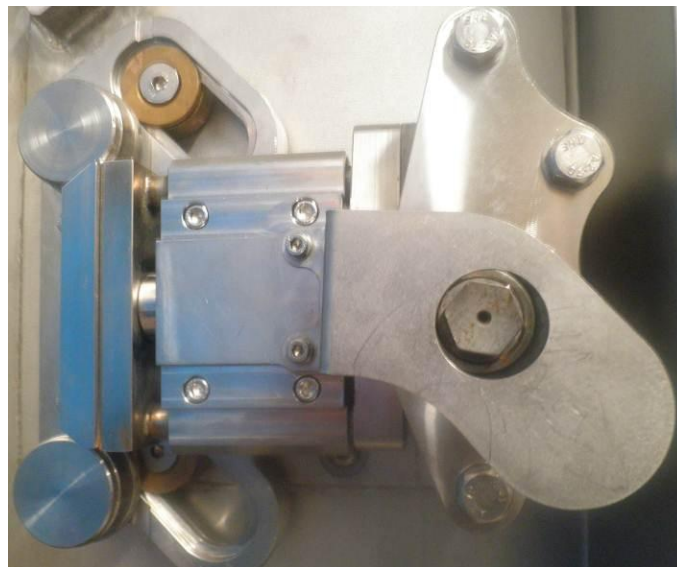
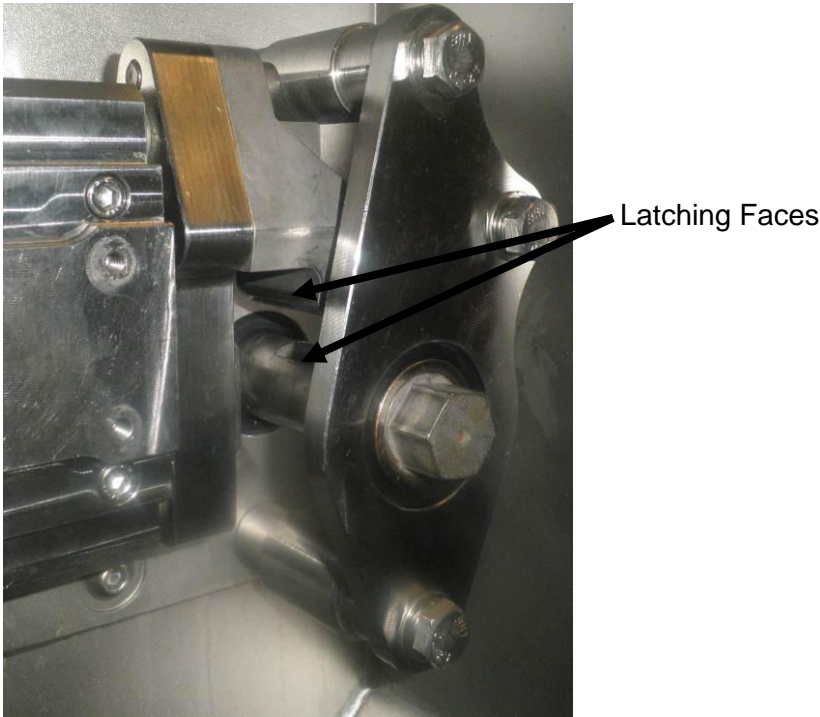
Following the installation of the new PCB both prior to Christmas and during January there were a number of issues with relatching the mechanism and the saw was taken out of production on a number of occasions due to this. As with the GMP saw ACC had moved the saw to a heavier duty cutting position and were finding issues with the blade twisting as the harder bones were pushed through the blade. To overcome this the tension on the blade was significantly increased. This had the effect of making the Bladestop mechanism difficult to latch because the tighter blade was not allowing the mechanism to fall naturally, under gravity, to the required latching position. A guide shown in Fig. 25 below had been installed in an attempt to ensure that the mechanism was in the correct position before latching was possible. Attempting to latch the mechanism with it out of position causes the two latching faces/lips (shown in Fig.26 below) to slip over each other and damage the edges of these faces. Repeated attempts at latching will cause further damage and induce stresses in the mechanism that will cause damage to other components in the mechanism. This has occurred twice at ACC. In early February MAR replaced damaged parts onsite and the saw went back into production in the heavy duty location and with the higher tension on the blade. Within two weeks the same issue had occurred and MAR made the decision to remove the saw from site and bring it back to MAR Sydney to investigate the issue further.

Fig.25 Image showing guide for latching

Fig.25 Image showing latching faces
