final report

Project code: P.PIP.0749

Date published: 8 February 2019

JBS Automated Rib Cutting – Detector Upgrade

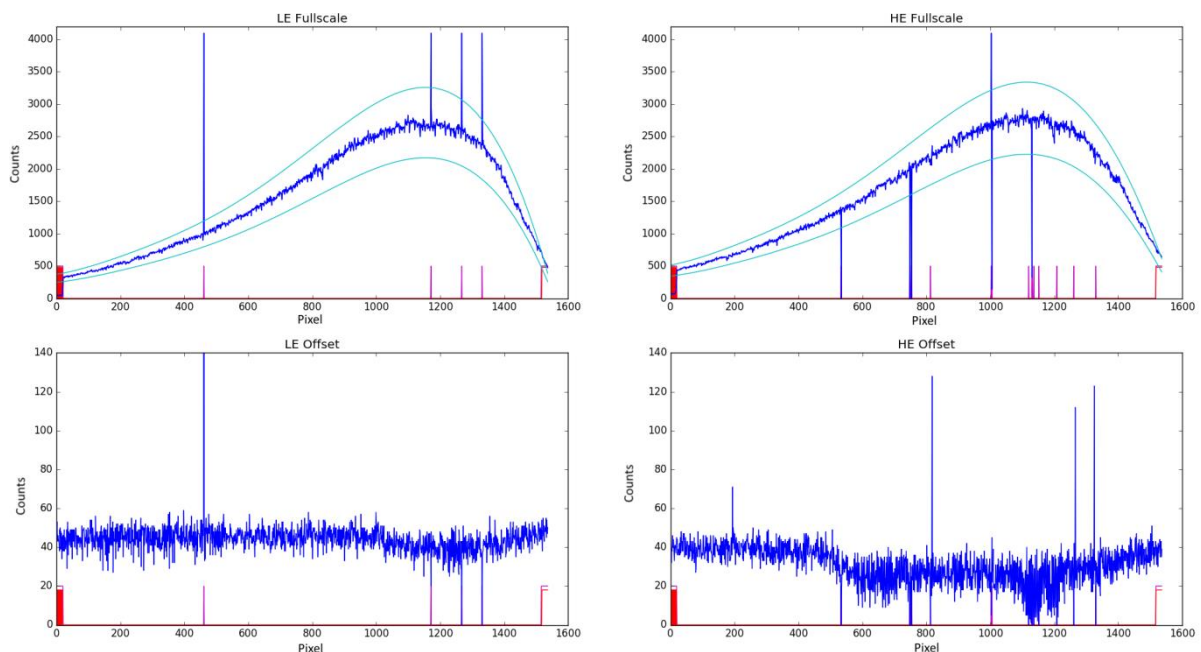
Each detector consists of two calibration signals, the 'fullscale' signal which is the response when the x-rays illuminate the detector with no object, and the 'offset' signal which is the response when no x-rays illuminate the detector. A properly operating system has the response shown in Fig. 1, where the number of bad pixels is small and isolated and can easily be dealt with software corrections. When the system is in distress the response is typically depressed, where there are too many bad pixels. These bad pixels are tagged primarily due to a lower than normal or non-existent offset signals, a characteristic of detector x-ray damage.

Fig. 1 X-ray detector response during December 2014

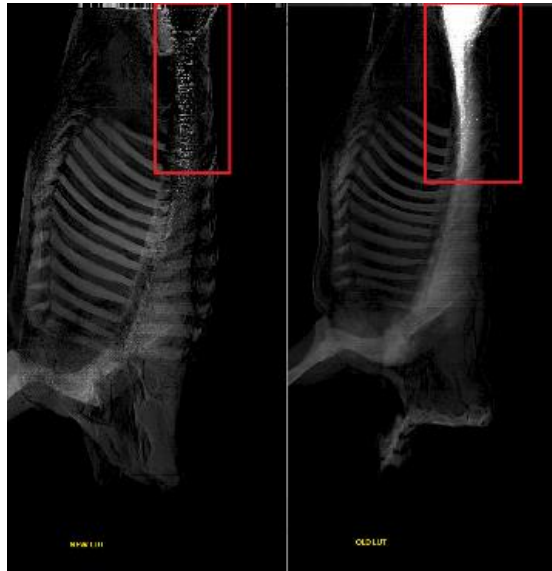
Once all the modifications were completed, the bone-contrast enhancing calibration was performed again. In Fig. 2, the left image shows a carcass processed with the newest calibration data whereas the right image shows a carcass processed with an older calibration data. The left image is better than the right image on two counts:

1. There are less artefacts, as shown in the red box.
2. The first rib is more visible, even though this carcass is bigger.

Fig. 2 Bone enhanced carcass images before and after modifications.
