final report

Project code:P.PIP.0327 & P.PSH.0701Prepared by:Sean Starling

Scott Technology

JBS Fully Automated X-Ray Lamb Middle System

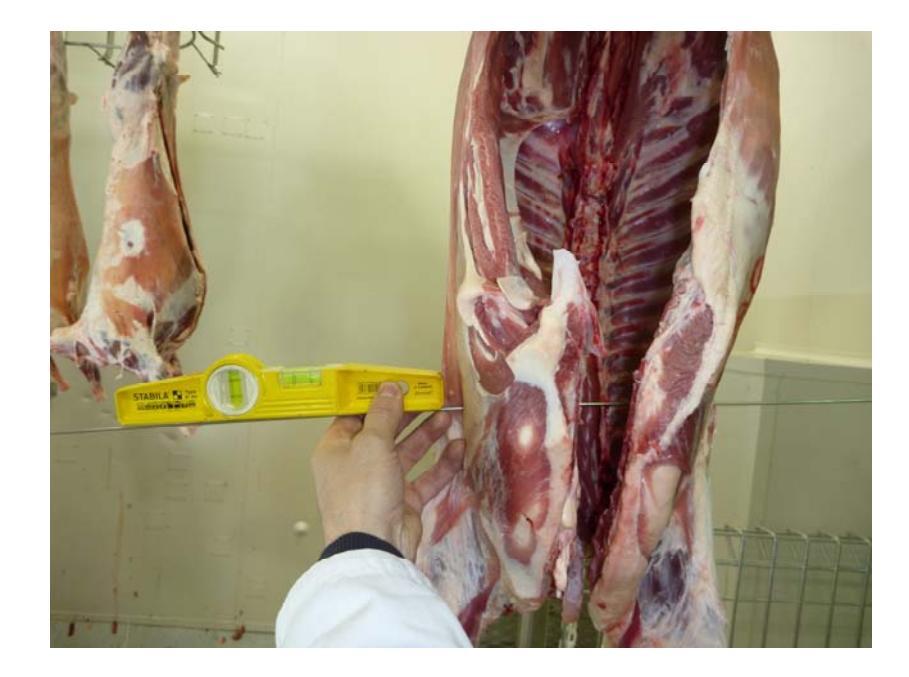
Of interest, even if the left and right side of the carcase were both simultaneously x-rayed, to keep machine purchase prices to the lowest possible, the Scott primal cutter and middle machine cannot process a carcase that has a lopsided rib cage. For this to be achievable additional components would need to be installed which would in turn increase the cost to Australian processing Clients. An example of a carcase not hanging correctly and hence the 4th rib location on the left and the right side not parallel to each other AND both perpendicular to the horizontal plane is depicted in the following image. Note the bubble on the spirit level is not positioned in the middle of the two

level lines. This image is one of the images taken by Scott staff during the various evaluation steps that have occurred.

Originally the JBS Bordertown facility utilised metal skids/gambrels and this caused animals to set into rigour in a lopsided manner and hence resulted in a cut forequarter having unequal ribs on the left and the right side of the carcase. A previous variation covered the costs of mechanical changes to the Scott system to enable the system to handle the wider plastic skids, however did not cover the costs associated with labour (and related travel costs) in working on the system leading up to this discovery and the post ongoing involvement of Scott staff, working with JBS staff, to minimise additional upstream causes such as an aggressive hide puller or how the chillers are stacked.

Hence, once the JBS system was converted to plastic skids, then is was also ascertained that it was not just the metal skids that were causing the problem (although they were some of the cause) and that additional work was required on both the Scott system and JBS processing operations within the slaughter floor and chilling operations to reduce the ribcage horizontal misalignment issue.

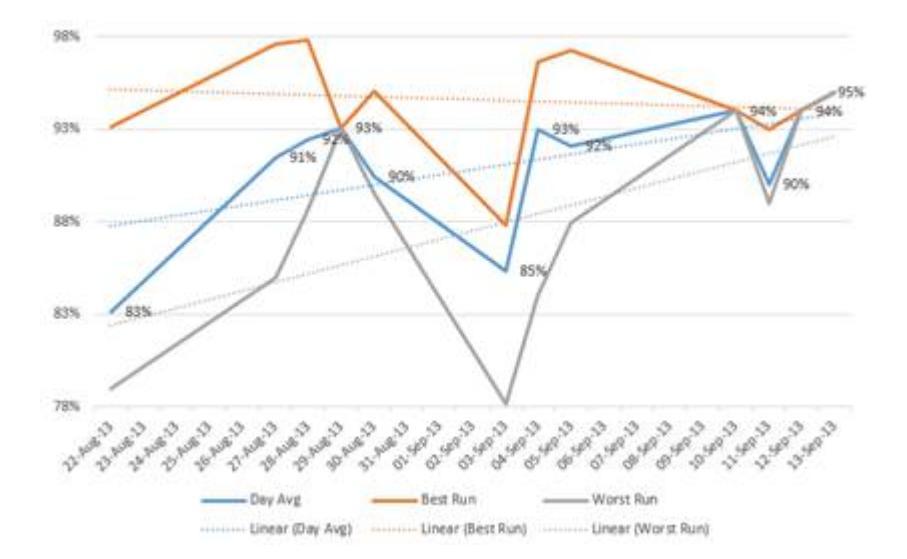
FQ 4 Rib - Right Side Only

The first improvement step change occurred after the 23rd August when the commitment was made to convert the Scott equipment to plastic hooks. Since then a combination of mechanical alignments of all mechanical aspects and x-ray algorithm software improvements have been made, the later almost on a daily basis, throughout September. The following depicts the stepwise improvement changes at Bordertown during this period.

4 Rib FQ	- Measu	red Side	4 Rib FO	Q - Whole	Carcase
		Runs	Day	Best	Worst	Day	Best	Worst
			Avg	Run	Run	Avg	Run	Run
	22-Aug-13	3	83%	93%	79%	73%	87%	62%
	27-Aug-13	7	91%	98%	85%	84%	95%	74%
	28-Aug-13	6	92%	98%	89%	89%	90%	84%
	29-Aug-13	1	93%	93%	93%	87%	87%	87%
	30-Aug-13	3	90%	95%	90%	83%	85%	77%
	03-Sep-13	3	85%	88%	78%	81%	85%	74%
	04-Sep-13	7	93%	97%	84%	92%	97%	83%
	05-Sep-13	5	92%	97%	88%	92%	97%	87%
	10-Sep-13	1	94%	94%	94%	87%	87%	87%
	11-Sep-13	2	90%	93%	89%	79%	88%	77%
	12-Sep-13	4	94%	94%	94%	85%	86%	84%
	13-Sep-13	2	95%	95%	95%	83%	88%	77%
1

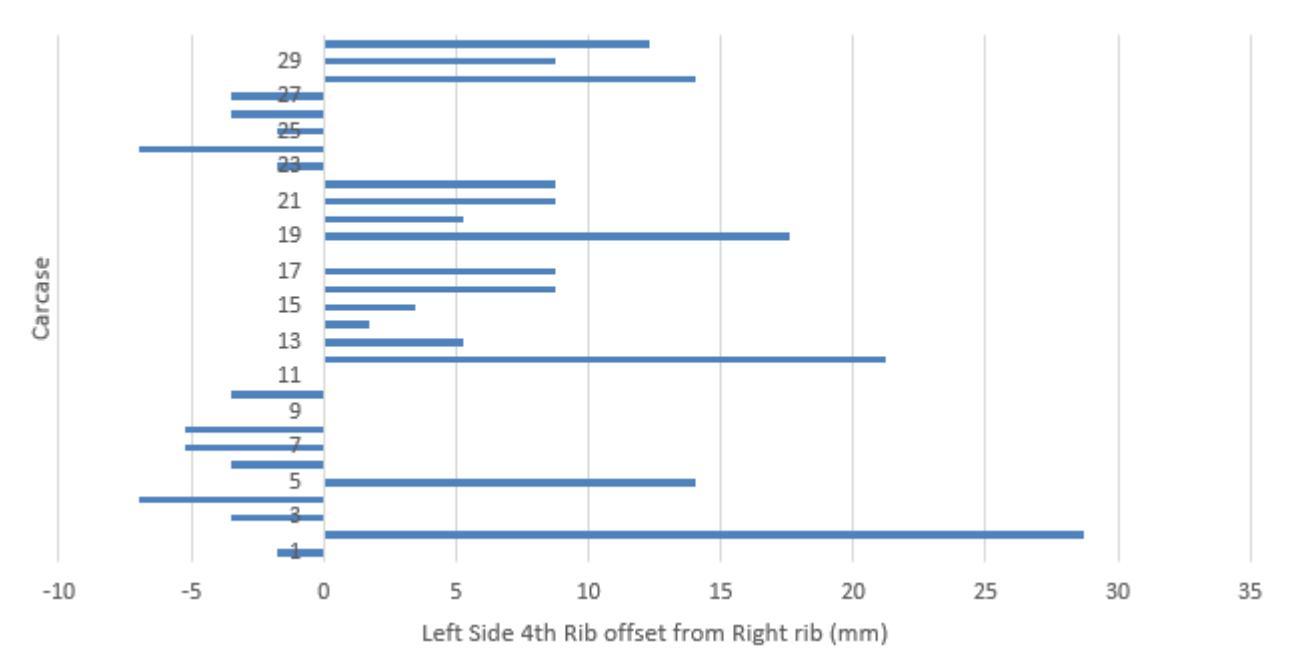
JBS Bordertown Carcase Rib Cage Alignment

On the 23rd September 2013, a team of JBS/Scott personnel undertook a preliminary analysis in the chiller of 30 random carcases to ascertain the frequency (and magnitude) of any alignment issues of the fourth rib on the left and the right of the carcase with respect to being horizontal.

The chart below sets the right rib at a zero datum point. The chart then depicts if the left rib was lower (+ve result) or higher (-ve result) from the right rib. Note with intercostal spacing approximately 10mm on average, and taking a centre point intercostal cutting point of 5 mm, any left rib that is >5mm in either direction will reduce the 'left side cutting accuracy' noticeably being a concern, a 10mm misalignment would arguably be a definite bad cut.

- 57% of measured carcases had a +/- 5mm misalignment
- 20% of measured carcases had a +/- 10mm misalignment

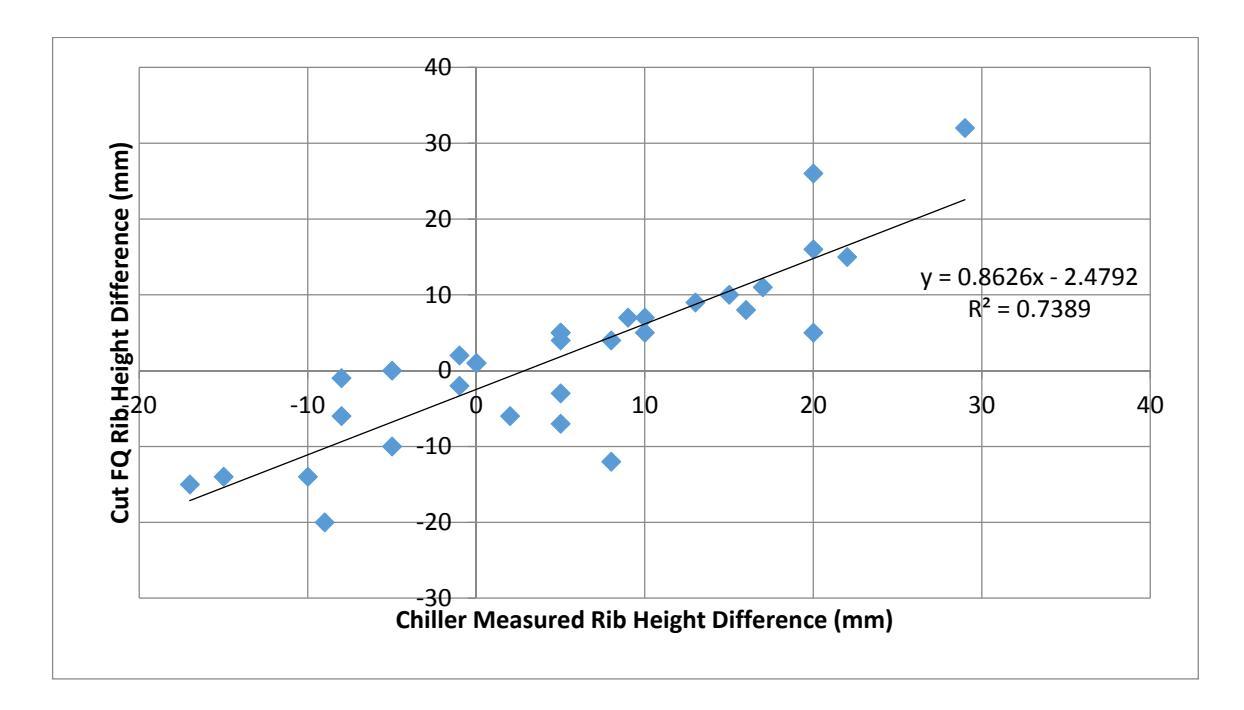
During early October, Scott undertook a larger sampling regime at Bordertown and ascertained the following results. This time the carcases where measured in the chiller and then the resultant forequarter (once cut by the primal system) compared with the measured chiller carcase results to confirm that that prediction of a bad cut from a chiller measurement truly resulted into a real life poor accuracy cut.

All of this work assisted Scott and JBS to then commence looking for other pre-chiller production causes and hence result in a lower than ideal cutting accuracy for JBS.

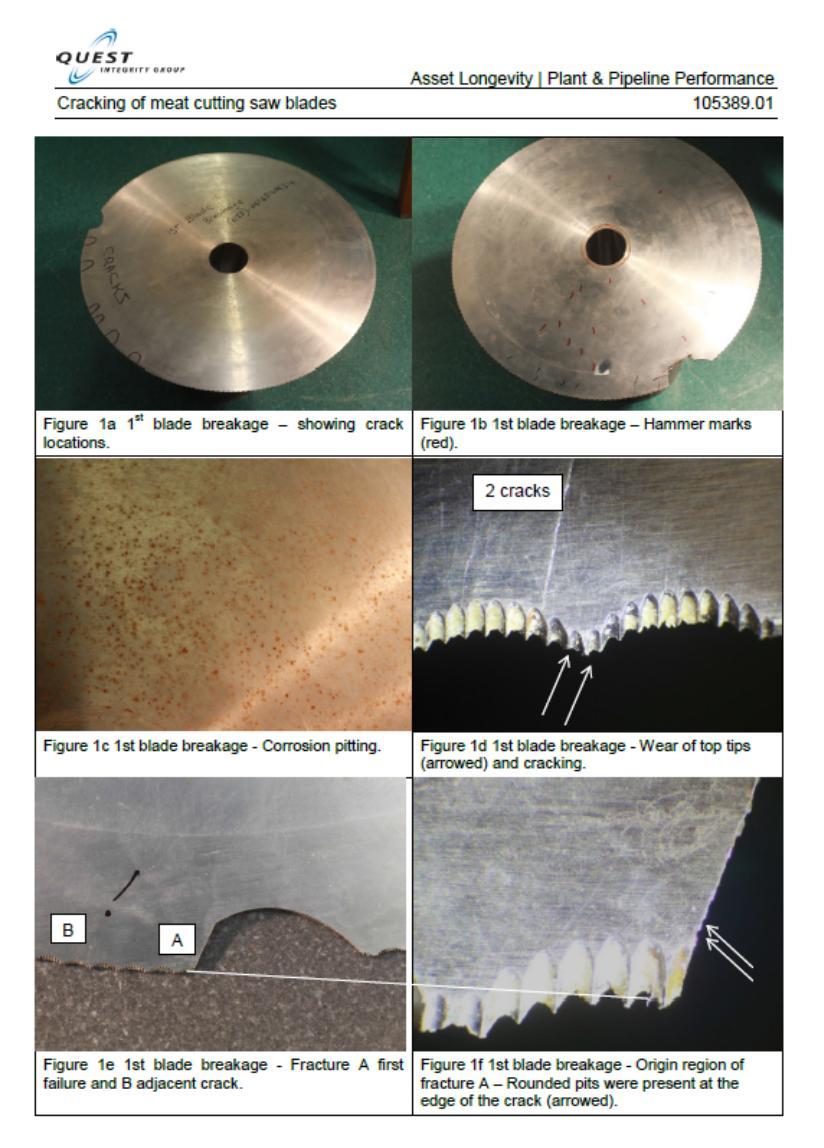
At least ten (10) blades, at a RRP of \$5,000(each) failed. The preliminary report from the Quest Integrity Group, report with filename: 105389 01 Report Issued February 2014.pdf (Supplied as a confidential document to MLA) ascertained that the cause of the breakages were a result of pitting

from the JBS cleaning chemicals, which in turn lead to stress fractures and eventually blade breakage.

In addition to various accuracy issues, the JBS installation experienced considerable blade breakage issues. Scott worked with the supplier, and in parallel with a materials group (the Quest Integrity group – confidential report available), to develop a new metal recipe and heat treatment process for Bordertown. Again although the initial breakage issue is confined to the primal machine, the middle machine utilises the same blades and the problem manifest itself within the middle unit operation as well, as expected. The cause of the breakages are a result of pitting from the JBS cleaning chemicals, which in turn lead to stress fractures and eventually blade breakage.
