final report

Project code: P.PSH.0259
Prepared by: Jason van Beurden
Industrial Research Limited
Date submitted: July 2009
Date published: August 2011

Gas depelting at Peel Valley Exporters, Tamworth

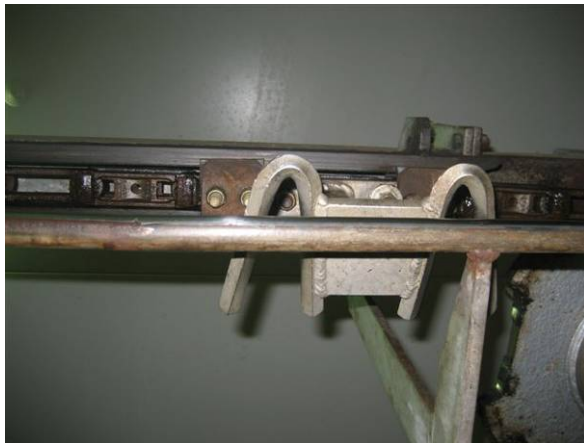
Figure 1. Tight hook.

Peel Valley uses two styles of hook, with different means of mounting to the chain and different displacement away from the permanently mounted rub bar (see figs.1&2). Also, the hooks are relatively short, meaning that the hooves are not far from the chain (see fig. 3). As a result, the inductive hook sensor could not be used, and mounting the latching mechanism as designed was impossible. Also, variation in surface loading meant that the legs twisted to varying degrees, presenting at different orientations.

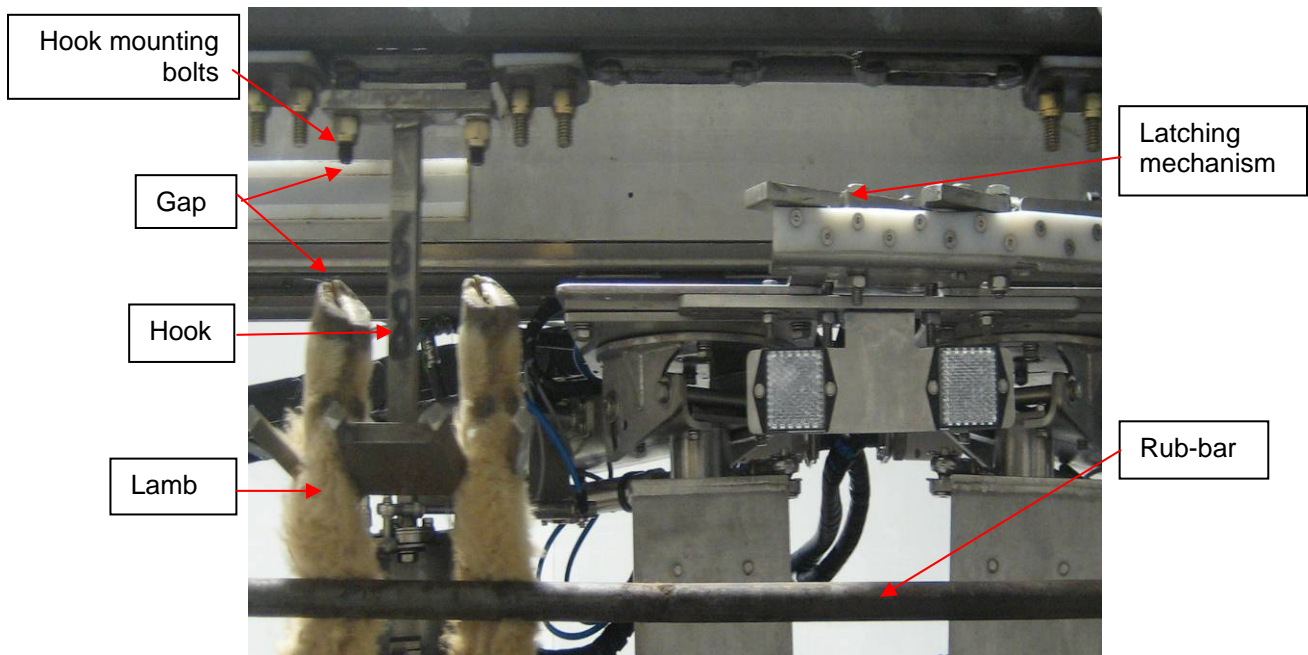
Figure 3. Latching position and gap.

NB: Hooves shown aren't as big and gnarled as some observed.

To enable the machine to be used, the PLC program code was modified to remove the requirement for the hook sensor. Also, the latching pawl (component which engages with the chain) was lengthened so the latch could work in the narrow gap between hook mounting bolts and hooves.

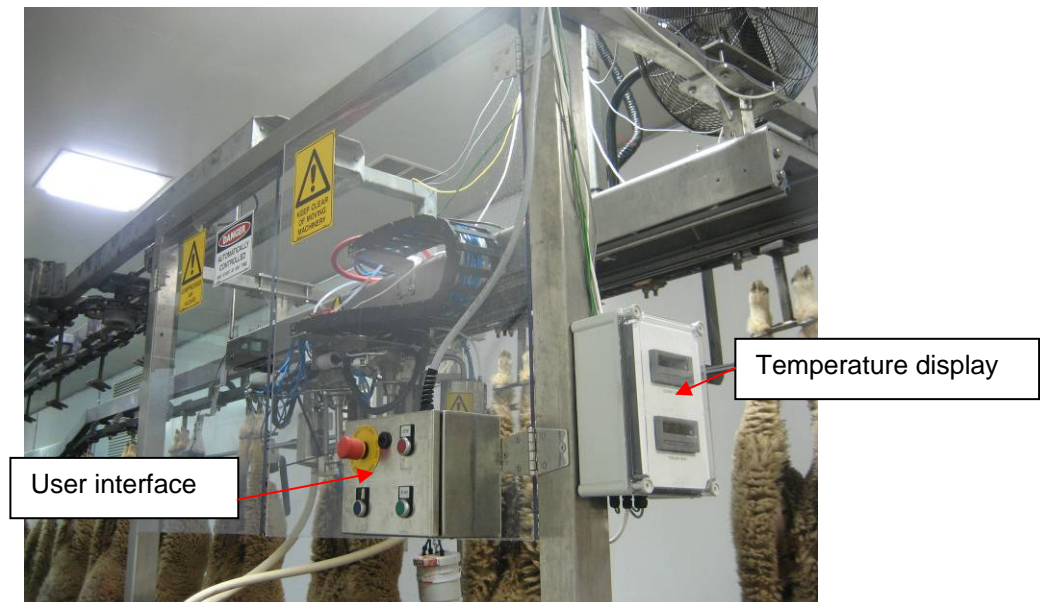
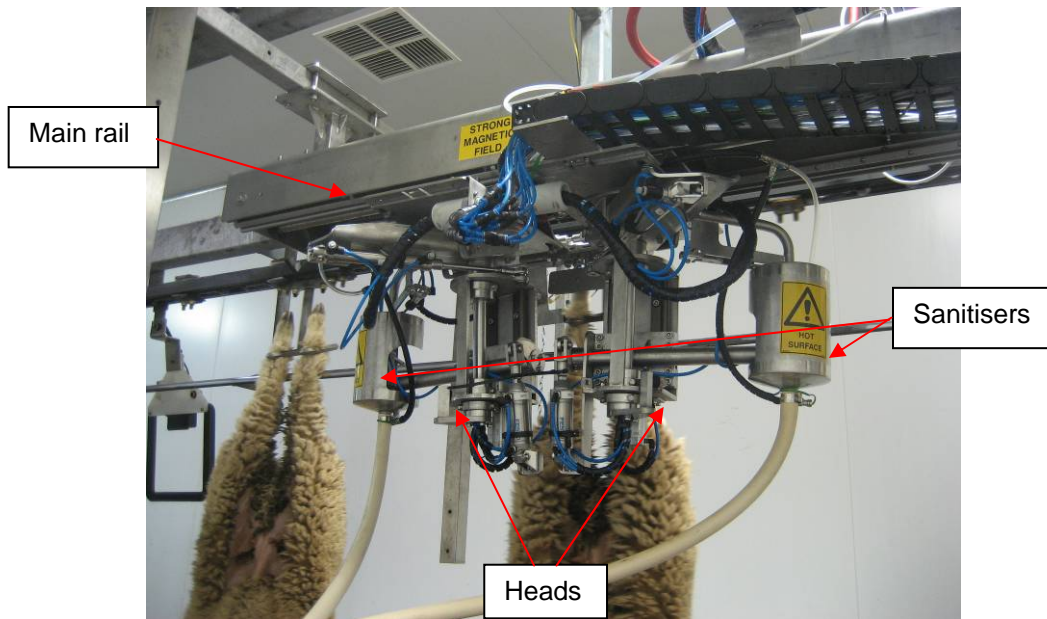
The set up between the two sites was significantly different, with the rear legs presented at Tamworth and the machine mounted inside the chain, above the belly (see figs 4&5). Positioning inside the chain was necessary due to the rub-bar arrangement at Peel Valley.

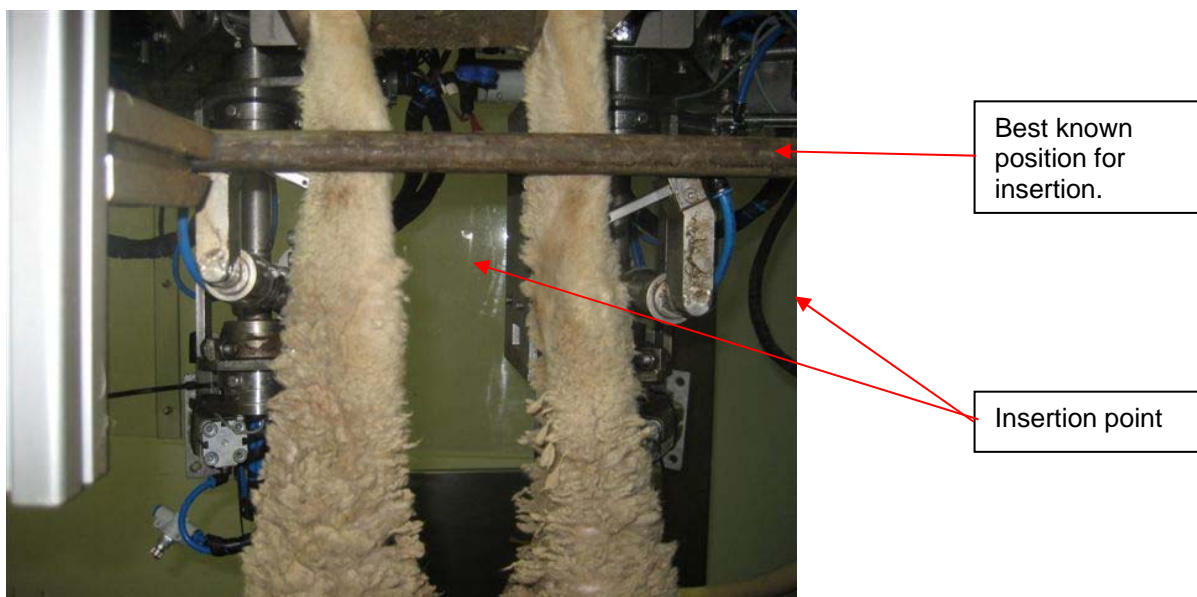
Figure 6. Blade insertion location.

These modifications improved the hit rate (see tables 1 & 2 for results). However, it seems that the low position means that the blade now tends to inflate tissues rather than separating the pelt from the carcass, also causing “blown shoulders”. No positive feedback was received from the line.

In an effort to counter these problems, first a stabiliser bracket was fitted, then the location of the point of attack was lowered by removing the “down-cut” motion of 40mm, leaving the blades in the lowered position (see fig. 6).

A possible solution would be a local modification of the rub-bar, with the rub-bar lowered approximately 50-70mm for the length of the machine. This would need to be rigidly braced near the home position of the machine and points along its length to provide a repeatable reference. Once this was done, the heads could operate at the upper position which may improve the separation of pelt from carcass. If the machine needed to operate above this position, modifications to the latching mount would also be required.
