# final report

Project code: A.ENV.0089  
Prepared by: Richard Mayoh  
Rycam Industrial Pty Ltd  
Date published: April 2011

## **Learnings from the Burrangong Meat Processor covered anaerobic lagoon**

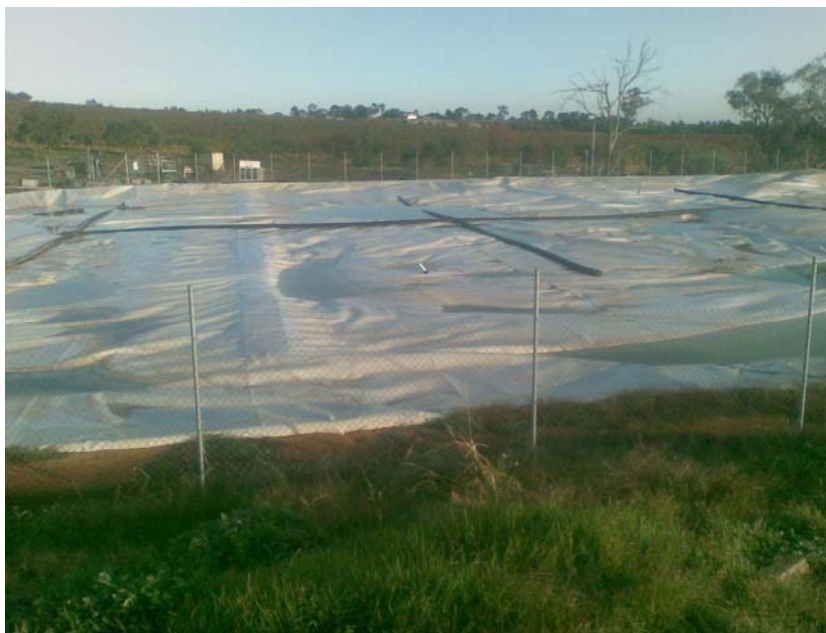
The cover was fitted with 150 mm dia PVC pipes filled with salt water to weight the cover and direct stormwater to a sump in the cover (Figure 1).

**Figure 1** BMP CAL with weight pipes

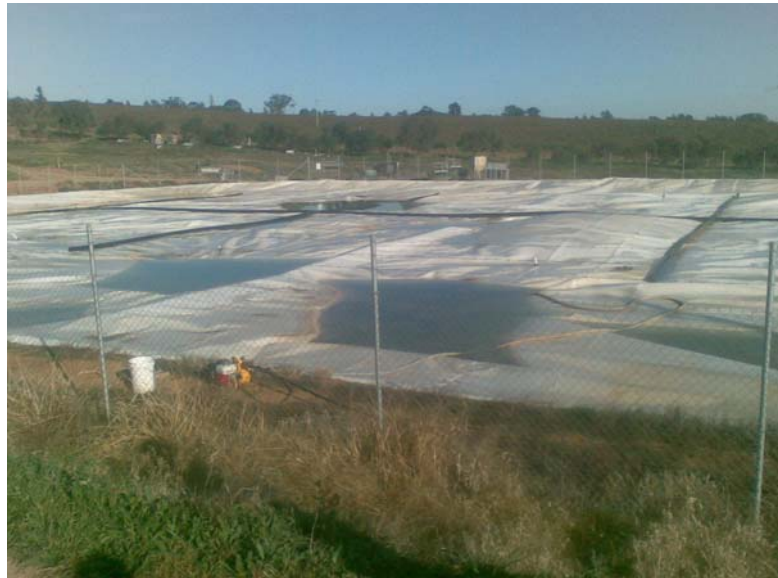
From the sump a pipe, under the cover and exiting through the pond wall, directed captured stormwater to an external sump for disposal (Figure 2). However, the weighted pipes tended to obstruct the flow of stormwater on the cover to the sumps.

**Figure 2** BMP CAL stormwater removal via portable pump.

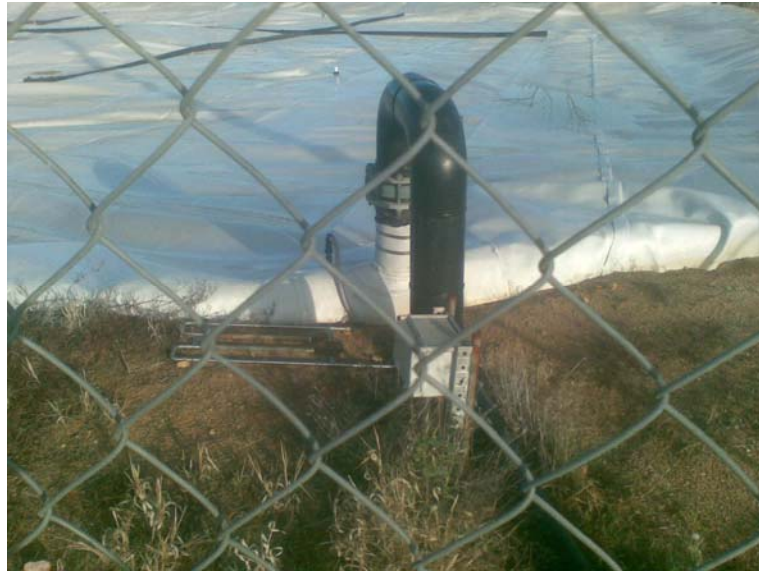
A 200 mm dia HDPE pipe was installed around the perimeter of the pond, under the cover to capture the gas. The pipe was fitted with 20 mm dia holes 300 mm apart to allow gas ingress. This collector was held in place during the pond-covering process with wire tied to star pickets embedded in the soil on the pond side of the pipe.

**Figure 3** BMP gas off-take

- A 200 mm dia HDPE feed pipe from the manifold under the cover to the knockout pot (Figure 3);
- A knock out pot;
- A 150 mm dia stainless steel pipe to the flare(Figure 4);
- A blower set controlled by pressure transducers originally installed upstream in the biogas pipe near the blower;
- Double block & bleed valves;
- Emergency vent;
- Take-off to the genset;
- Enclosed flare;
- A biogas mass flow meter was installed subsequently, but not as part of the original project.

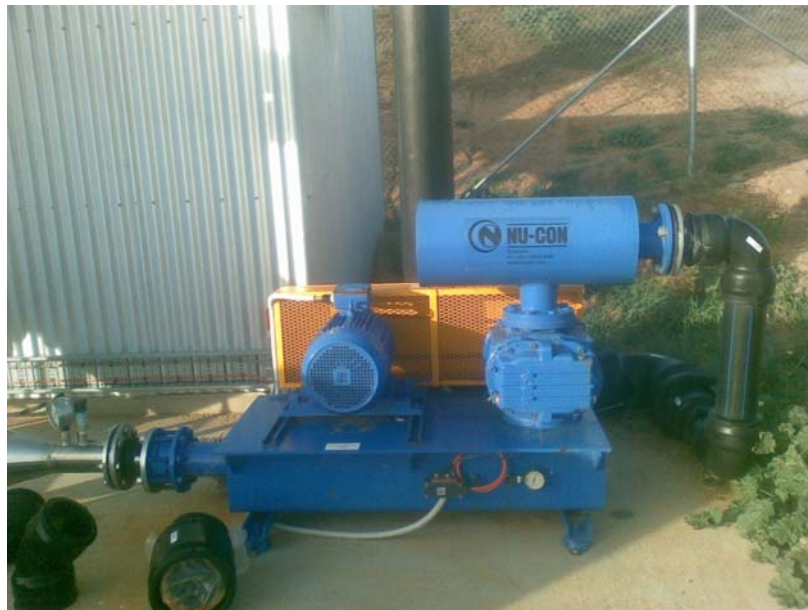
**Figure 4** Biogas blower pumping gas to the engines

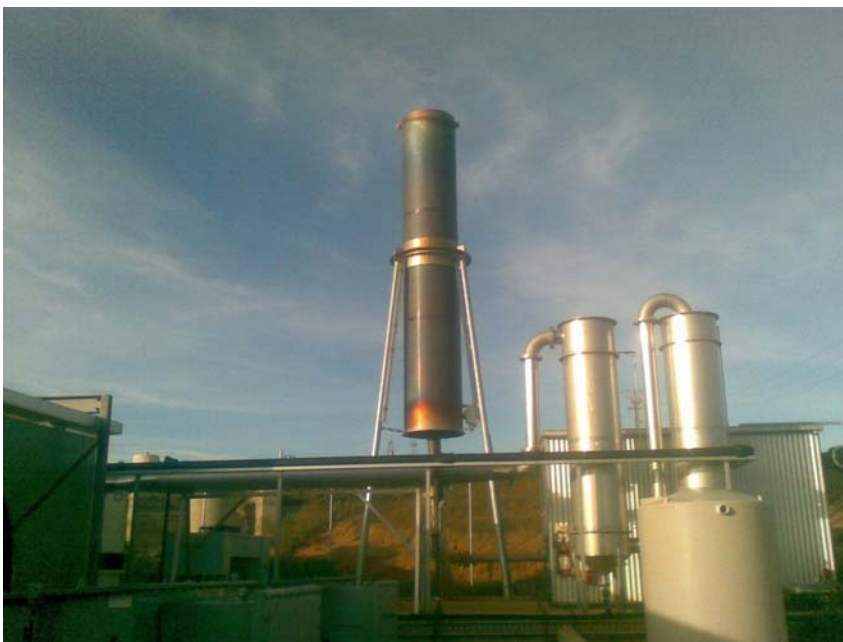
The flare was manufactured and installed by Australian Burner Manufacturers (ABM). Due to the urban setting of the facility, it was a fully enclosed type with a height of 5 metres and 0.8 metres diameter with a stainless steel shroud.

The flare had a continuous pilot light which was originally fuelled with biogas. This was changed to bottled LPG due to various difficulties. The pilot consumed two 100 lb cylinders of LPG per week.

Air was introduced into the flare burner by a simple venturi which meant that the air rate was fixed. Under normal ( $300 \text{ m}^3$  biogas/hr) operation, the flare was not visible.

**Figure 5** ABM enclosed flare with caustic desulphurisation scrubbers (right)

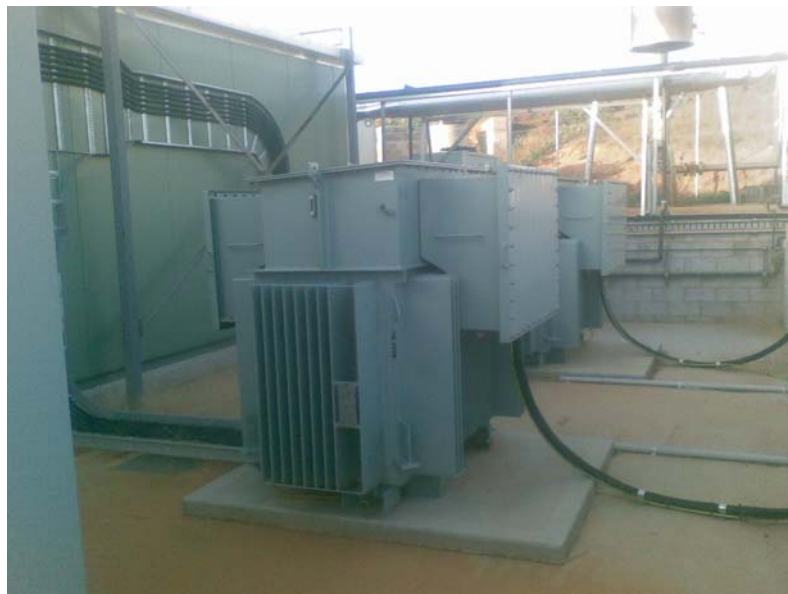
Two 800 kW Perkins gensets (gas engines) were installed, on a one duty/one standby arrangement. Because the electricity generated could not be sold back into the grid, the cogen unit was sized to meet the minimum plant base load (2am Sunday morning). The biogas needed conditioning prior to feeding to the gensets, especially due to quality issues that were experienced after installation. The single genset operation covered the facility base load.

**Figure 6** Genset Step-up Transformers

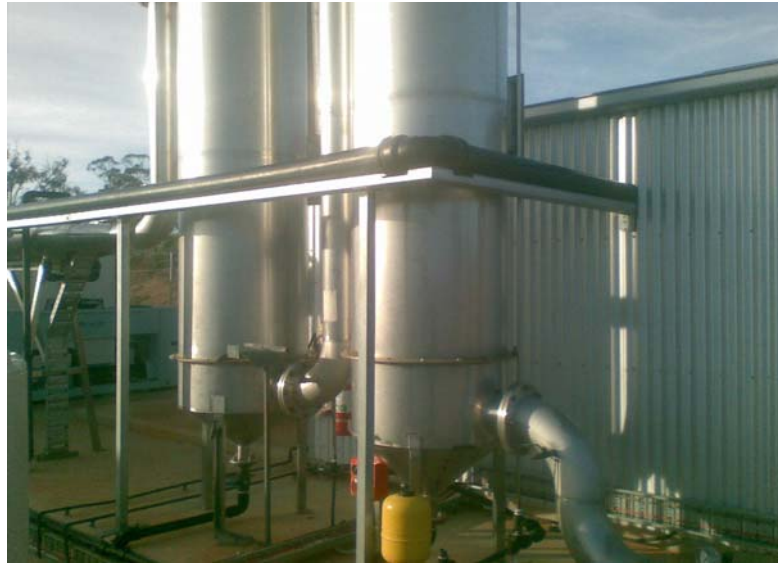
- A caustic scrubber to reduce H<sub>2</sub>S levels in the biogas (Figure 7).
- Dual shell & tube heat exchangers to chill the biogas using a glycol circuit to reduce moisture;

**Figure 7** Desulphurisation scrubbers

The scrubber units built on-site were effective in reducing the H<sub>2</sub>S in the biogas from 8% to approximately 0.2%v/v, which after conditioning was suitable for the gensets. The idea of an iron filings filter was also considered, but the gas flow was too large for this concept.

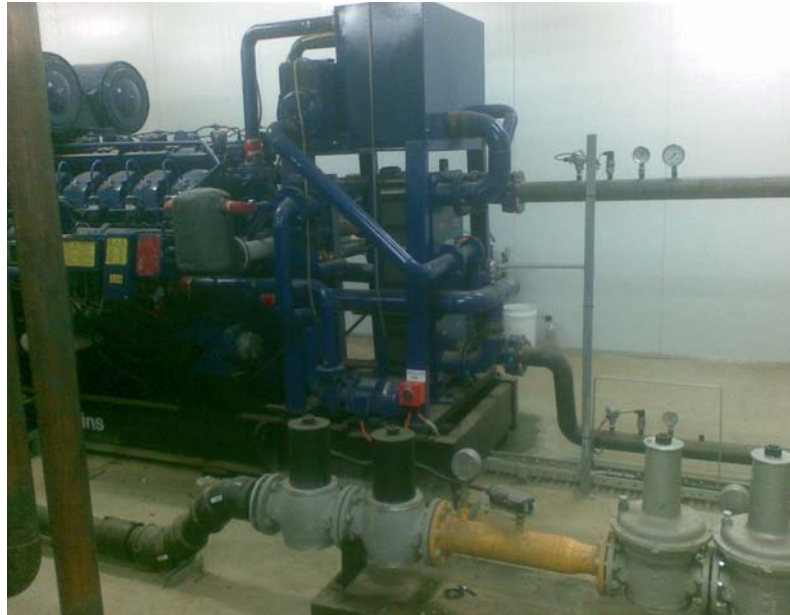
PLC-controlled hot water recovery was fitted by the plant engineer to capture this benefit (Figure 8). Hot water recovery of 200 kL/day was obtained by heating ambient water at 15°C to around 60- 80°C using the gas engine exhaust gas at approximately 460°C. The exhaust can be cooled safely to about 120-200°C . Cooling the exhaust to less than the dew point could result in water vapour getting back into the engine and causing problems.

**Figure 8** Plate heat exchanger (centre) generating hot water from gas engine water jacket cooling
