final report

PDS - Implementation of Producer Demonstration Sites to increase research adoption and practice change in the Kimberly and Pilbara

PDSWA001 - Investigating the practicality of regenerating degraded pastoral land on Larrawa station

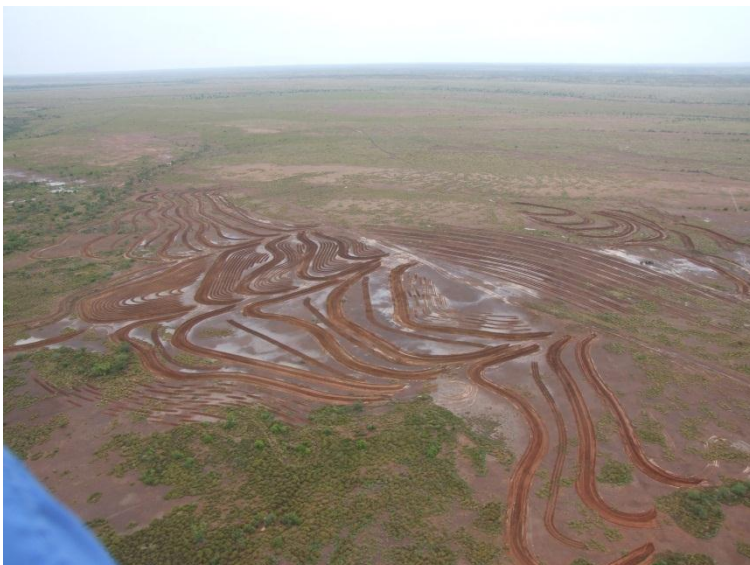
Photo A: Aerial view of the Larrawa station regeneration site, covered in open water ponds.

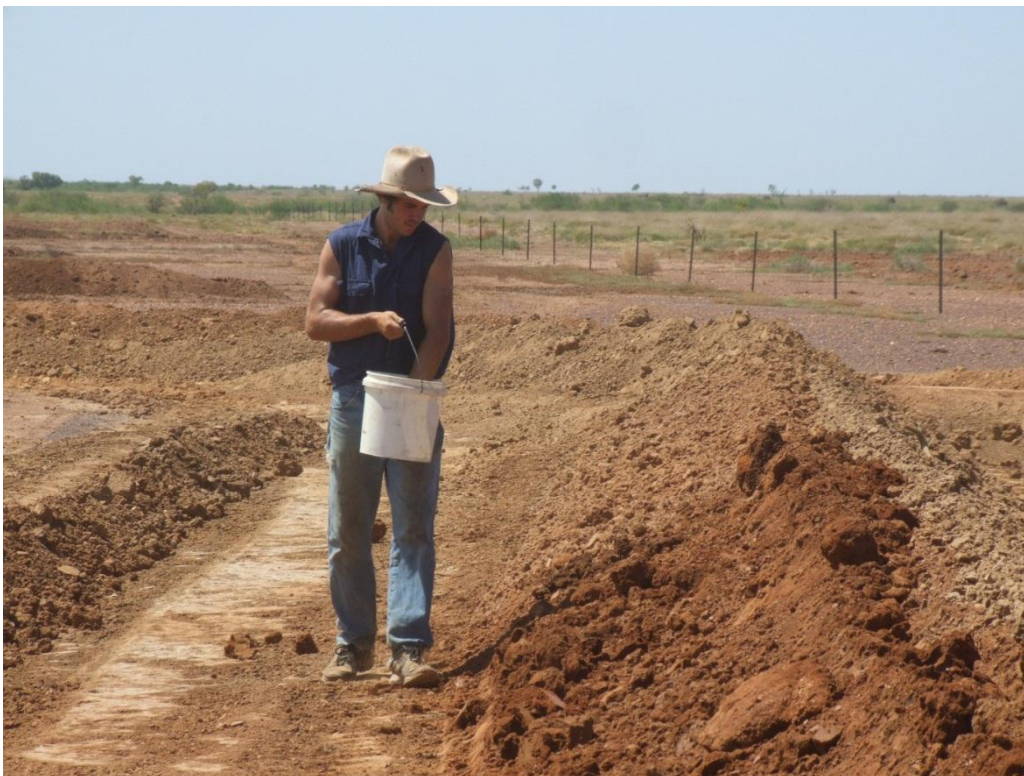
Photo B: Casting forage sorghum on inside of bank to ensure germinable seed is present

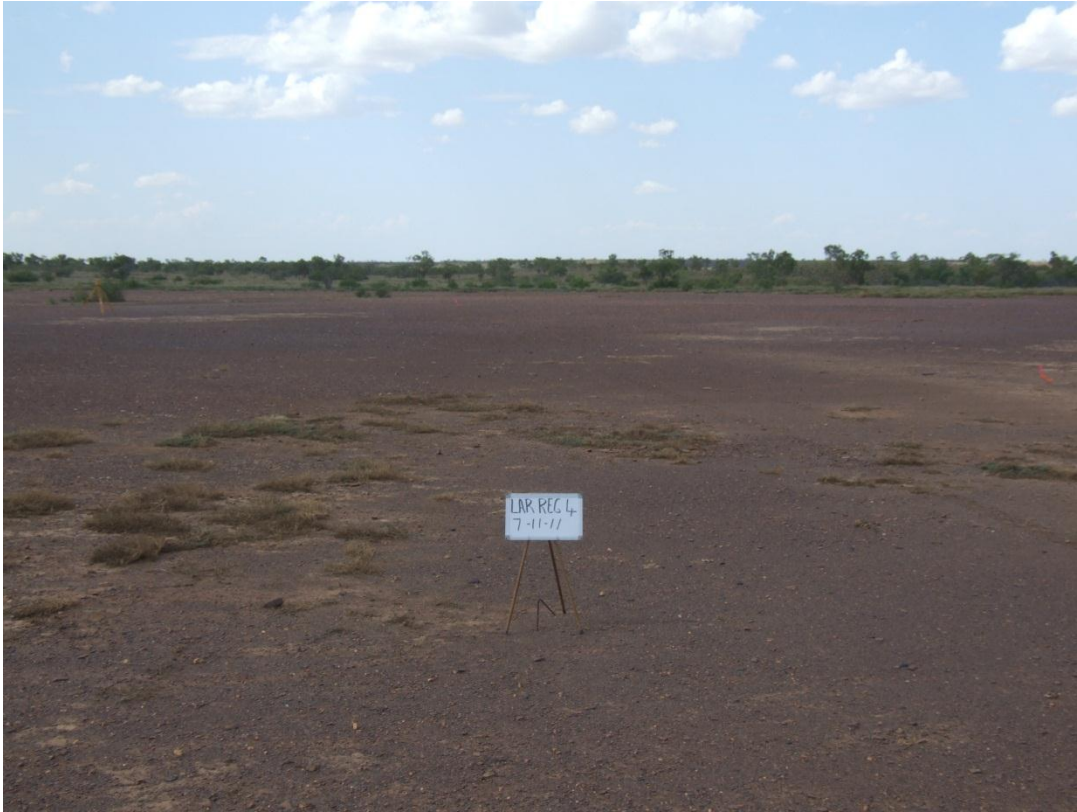
Photo C: Larrawa station regeneration monitoring site no.4 November 2011 (pre works)

Two RCM sites (LAR REG 4 and 5) were installed where open water ponds were constructed in November 2011. No annual or perennial plants were recorded at either site during installation. At the time of reassessment in April 2012 all quadrats (25) at both sites recorded some annual groundcover. Pigweed (*Portulaca* sp.) provided the majority of groundcover recorded; Kimberley couch (*Brachyachne convergens*) and sprint sorghum (*Sorghum sudanense* X *Sorghum sudanense*) were also recorded on site.

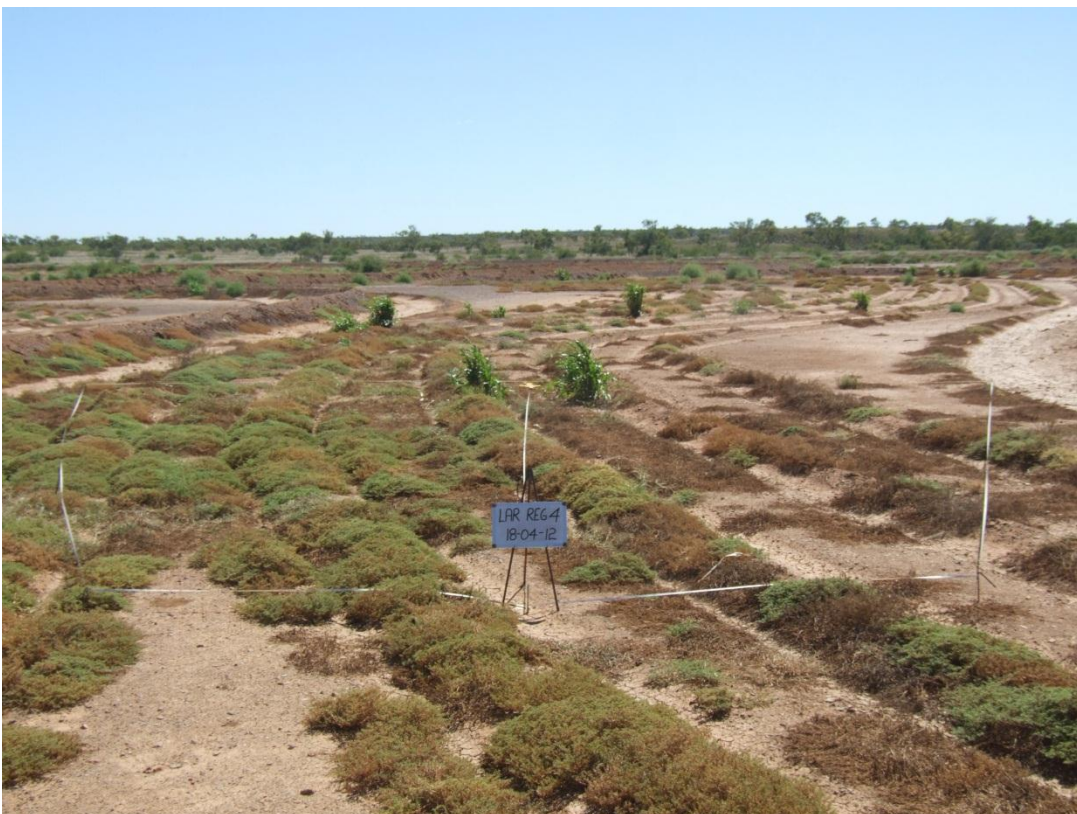
Photo D: Larrawa station regeneration monitoring site no.4 April 2012 (post works)

The construction of open water ponds was demonstrated with 16G and 12G machines in 2010 and 2011; all ponds constructed were surveyed. A significant increase in annual groundcover was recorded at both LAR REG 4 and LAR REG 5 after one wet season. The increase was more than that recorded at any other RCM site. Field observations where water had ponded were that the soil was spongy under foot and small cracks (2–4 mm) appeared after the subsurface clay layer had swelled and cracked. These observations were not noted at any of the other RCM sites. At the time of reassessment, no improvement in land condition was recorded, however an increase in groundcover was observed—attributable to increased soil moisture and a sign of improved ecological function.

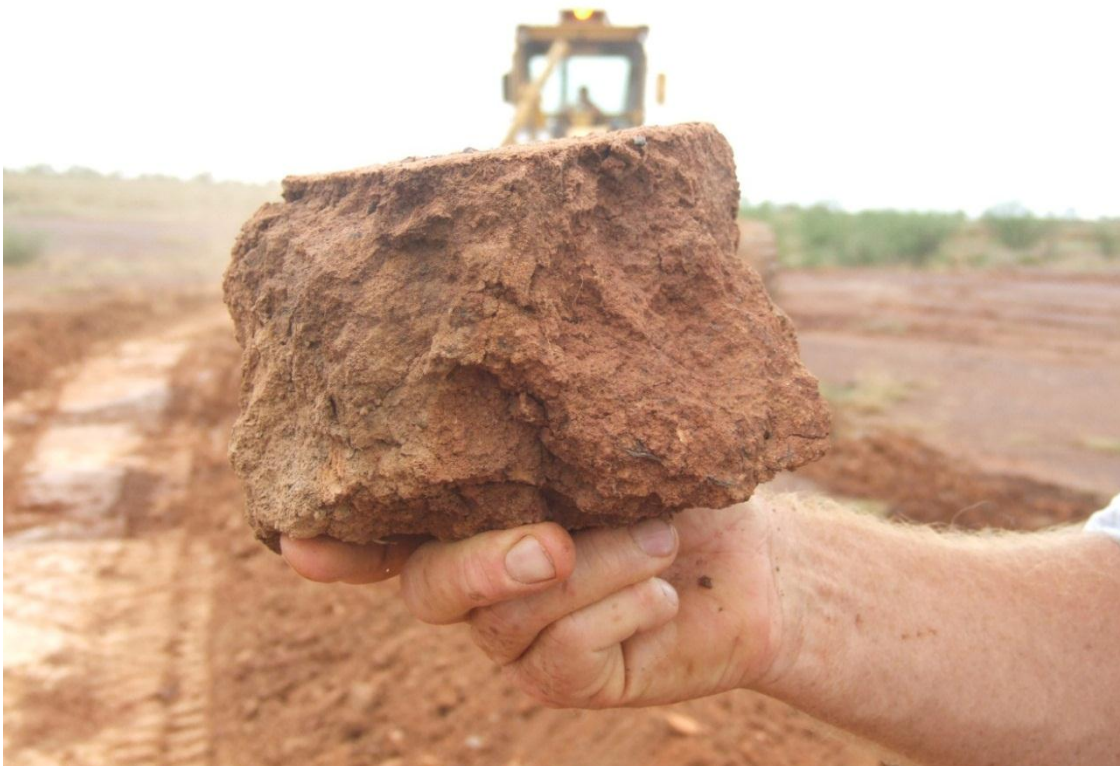
Photo E: Soil crust at Larrawa regeneration site

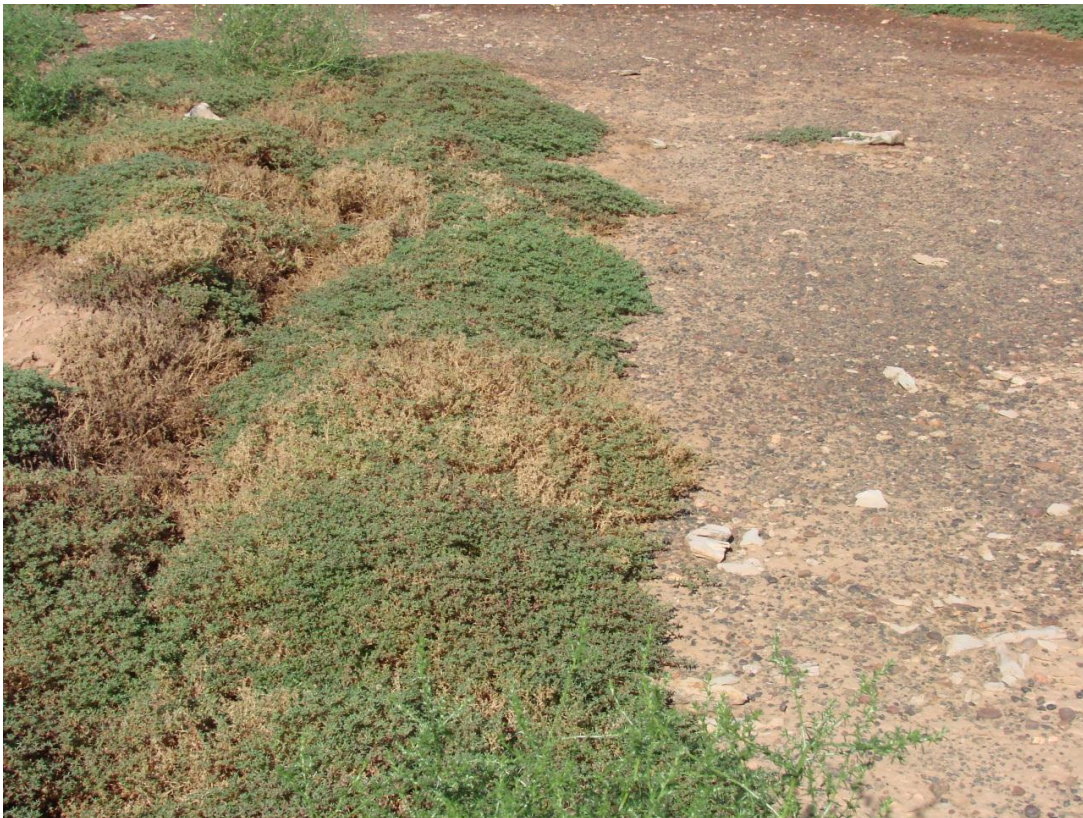
Photo F: Soil on the left covered in pigweed has been ripped and bare soil on the right was left undisturbed. Due to a lack of soil moisture there was no plant growth on the right

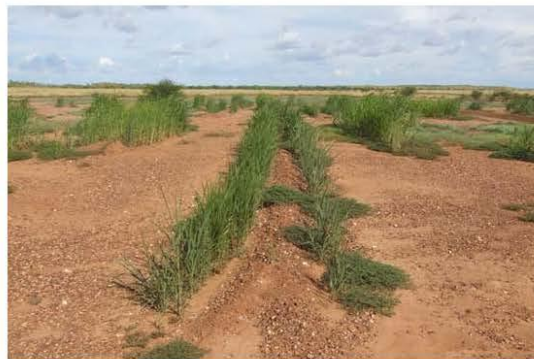
Photo B Annual forage sorghum growing in furrows created by agro-plough.

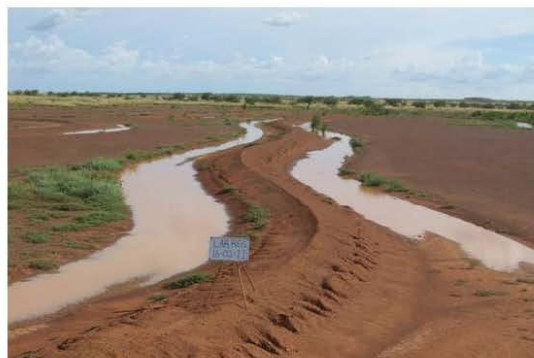
Photo C Open pond holding water on either side of bank.

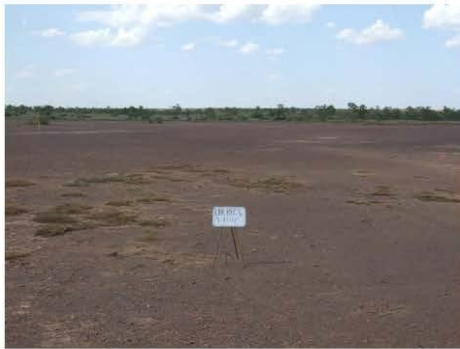
Larrawa regeneration monitoring site No.4 (pre-works)
– photo taken 7 November 2011.

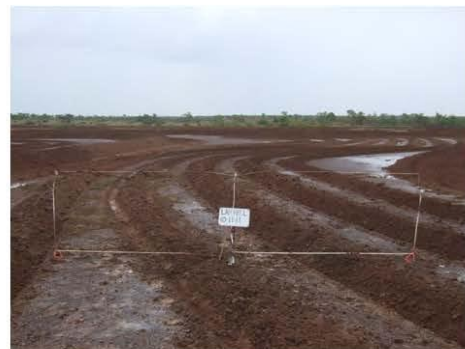
Larrawa regeneration monitoring site No.4 (post-works)
– photo taken 10 November 2011.

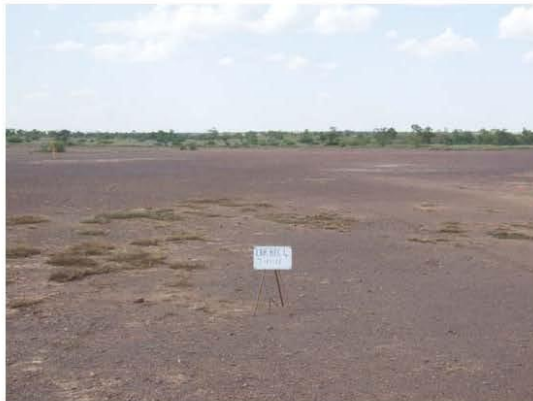
Larrawa regeneration site No. 4, recorded no annual or perennial plants during site installation

*At the time of reassessment in April 2012 all quadrats (25) at Larrawa regeneration site No. 4 recorded some annual groundcover. Pigweed (*Portulaca* sp.) provided the majority of groundcover recorded; Kimberley couch (*Brachyachne convergens*) and sprint sorghum (*Sorghum sudanense* X *Sorghum sudanense*) were also recorded on site. At the time of reassessment, no improvement in land condition was recorded, however an increase in groundcover was observed — attributable to increased soil moisture and a sign of improved ecological function.*

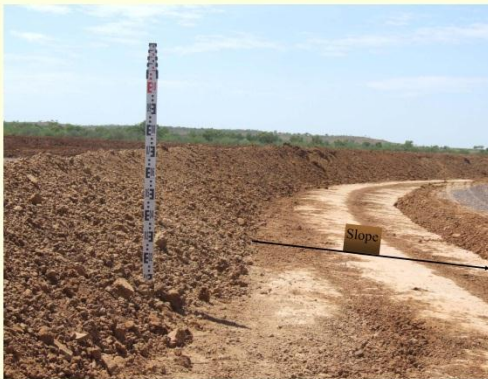
Photo 3. The bank has been constructed to a height of 70 cm. The borrow area slopes away from the bank which is essential. This prevents the grader blade from undercutting the bank.

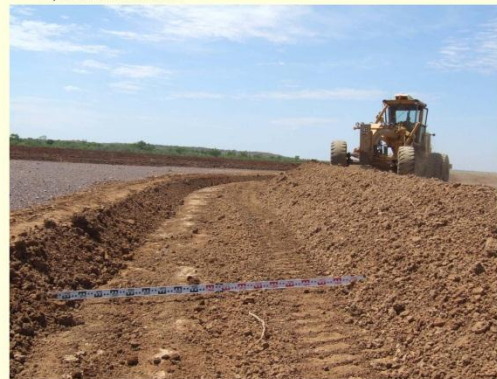
Photo 4. The borrow area is approximately 2 m wide. During construction one wheel of the grader will run along the base of the bank, the other wheel will run on undisturbed soil above the borrow area (see wheel tracks).

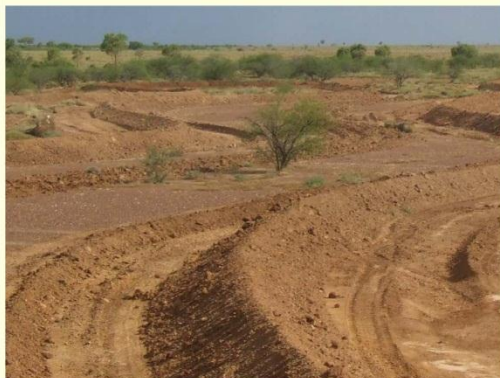
Photo 5. The bank base is 2 m wide and the top is domed. Having a wide base is an important aspect of the design criteria, providing a strong foundation that will reduce the incidence of soil slumping (banks subsiding).

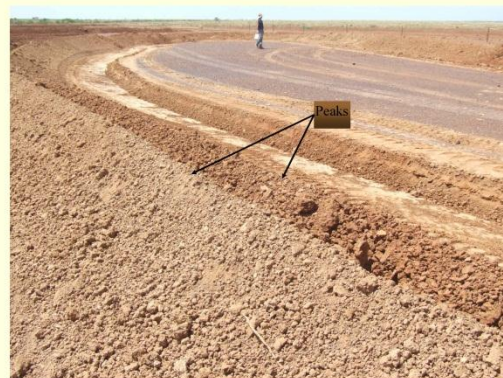
Photo 6. This bank is not domed at the top. This is undesirable, as water will pool between peaks, blow out at the weakest point, and cause the bank wall to wash away.

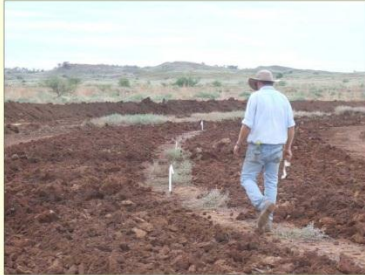
Photo 4. Collecting markers between rip lines before building bank. The non-ripped area between rip lines will form the bank base.

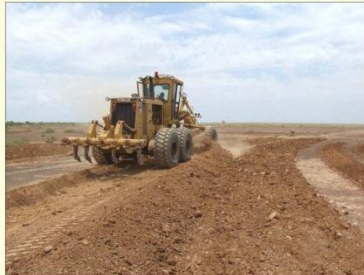
Photo 5. Taking first blade of soil to form bank, starting on outside of pond.

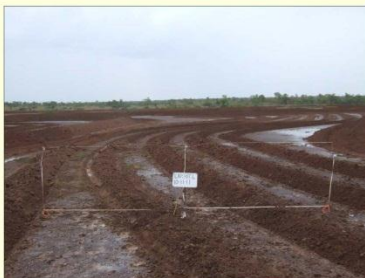
Photo 9. Larrawa station regeneration monitoring site No.4 (post works).
