# Final report

Project code: P.PSH.0905

## Advanced Carton Inspection DEXA X-Ray Machine with Extended Analytics

### Final Report - Public Version

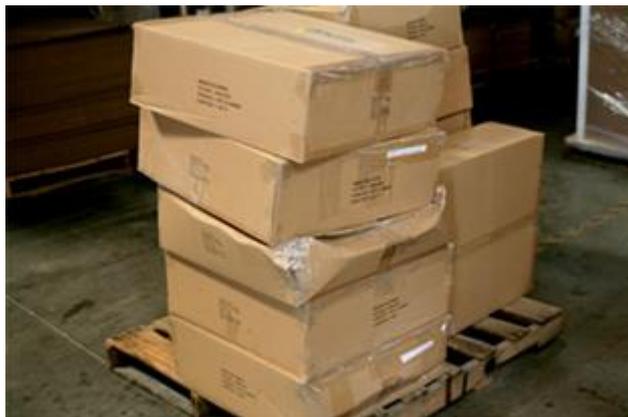
*Figure 1: The cartons of meat which collapsed due to low carton fill and not well distributed inside the box.*

Scott has had a number of enquiries from industry regarding a recognised requirement to monitor the fill rate of cartons. This is due to a number of reasons. Firstly, cartons that are under-filled or packed incorrectly are at risk of being crushed when stacked. This can cause product damage resulting in losses. When this occurs within a shipping container, it can also pose a safety risk as the integrity of the stack has been compromised. Furthermore, identifying the consistent under filling of cartons presents an opportunity for improved efficiency and financial gains. These not only lie in costs associated with materials but also, more significantly, those related to logistics.

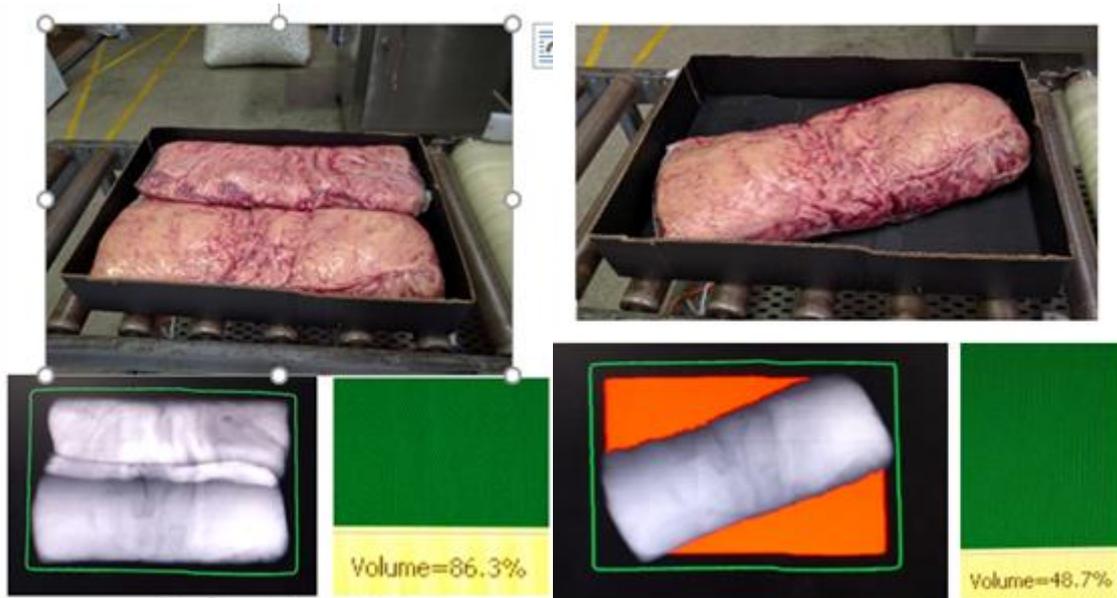
Figure 2: Meat boxes tested for carton fill.

Currently there is no way to monitor how a carton has been packed once the lid has been placed. As part of a stage 1 project Scott developed and built a proof of concept system using DEXA technology. This system was able to successfully calculate the fill-rate within a carton and flag those which fall below a certain threshold. It also checks for the existence of voids inside the carton which may present a significantly increased risk of crushing. The system was demonstrated with a number cartons filled with various arrangements of bone-in and boneless primals.

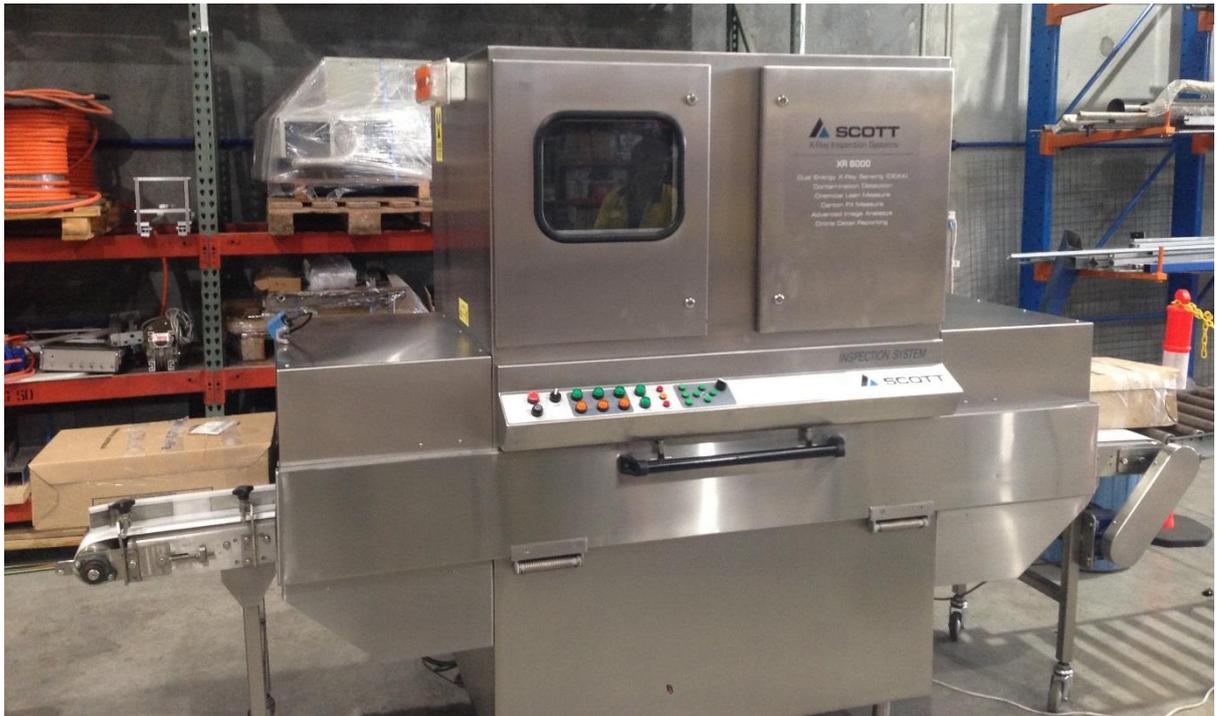
Figure 3: XR8000 inspection prototype platform with an upgraded detector inside.

The conveyor belt system was designed for standard width meat cartons and runs at a speed of 0.3 metres per second.

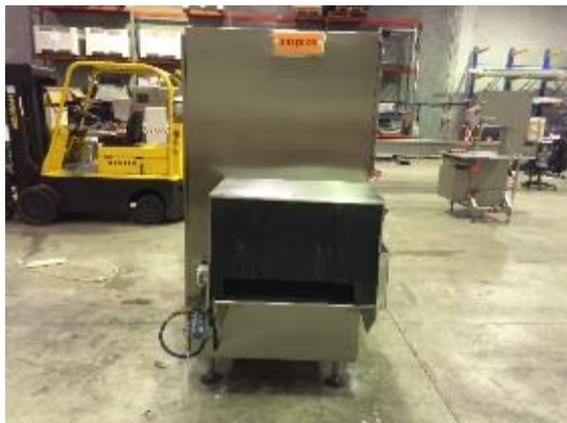
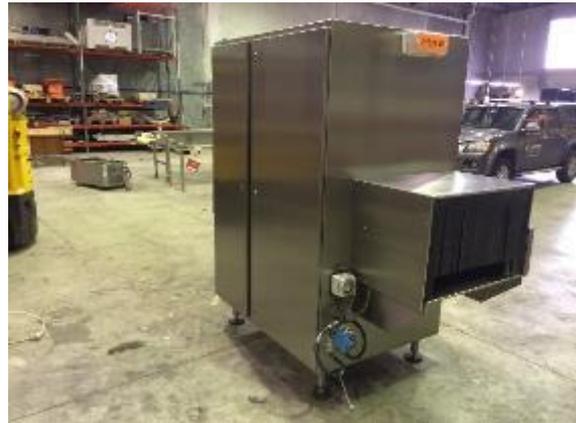
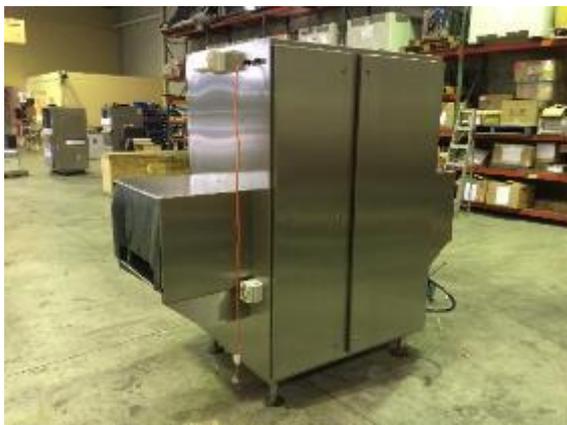
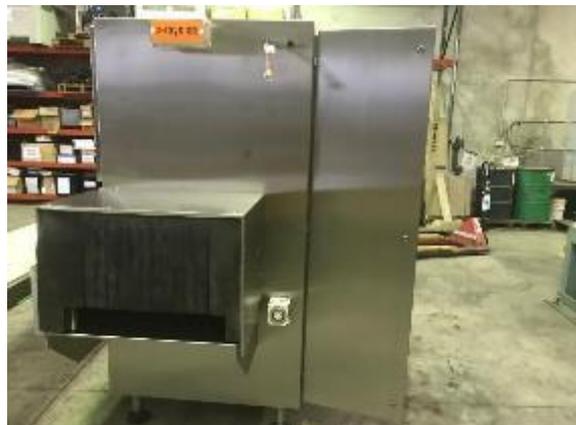
Figure 4: XR8000 inspection prototype platform with an upgraded detector inside.

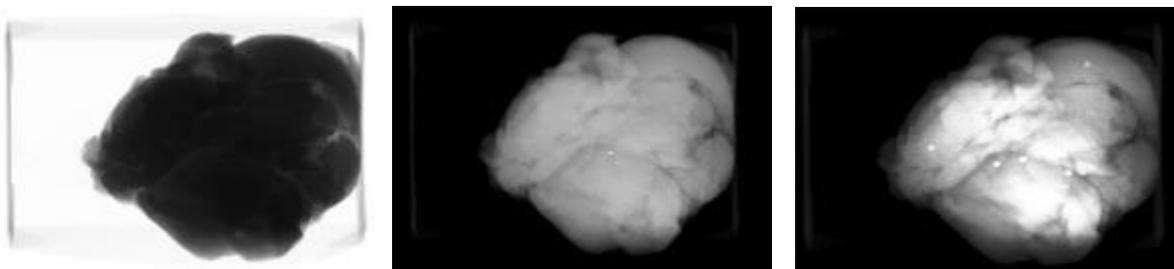
Figure 5: Left to right: Original 2-D transmission image (Meat with 90% Lean), and post-processed images. The bright white spots are contaminants.

After capturing the data from X-ray detector, the images undergo pre-processing. This converts raw X-ray yield images to X-ray transmission images. Figure 5 shows an acquired image plus the images produced after pre-processing has occurred. It can be seen that this improves the contrast in the dark area and small contaminants are easier to see.

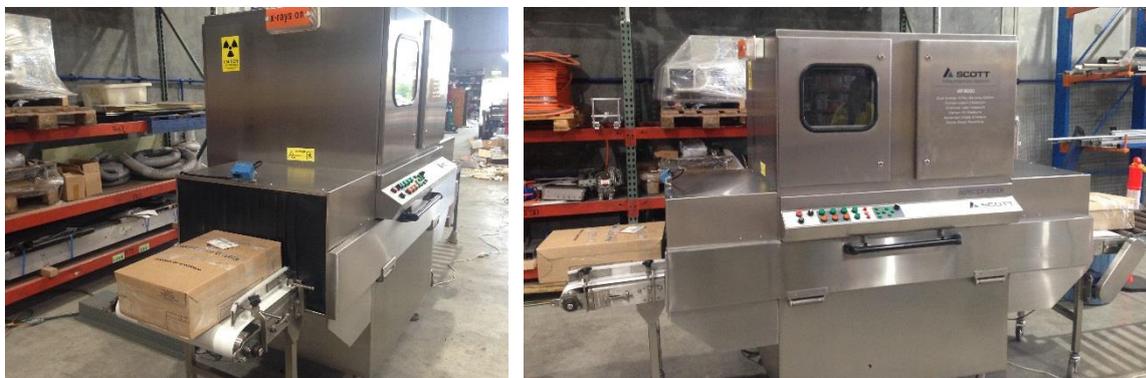
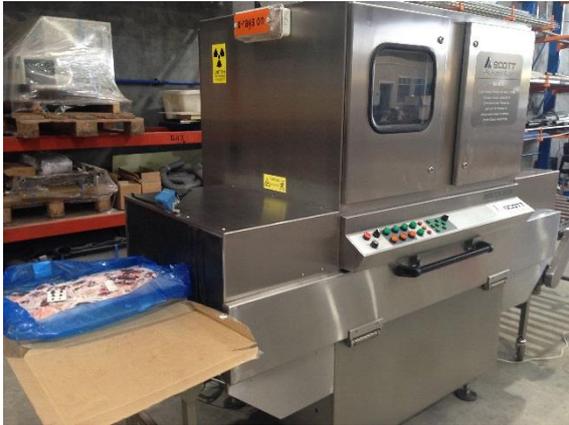
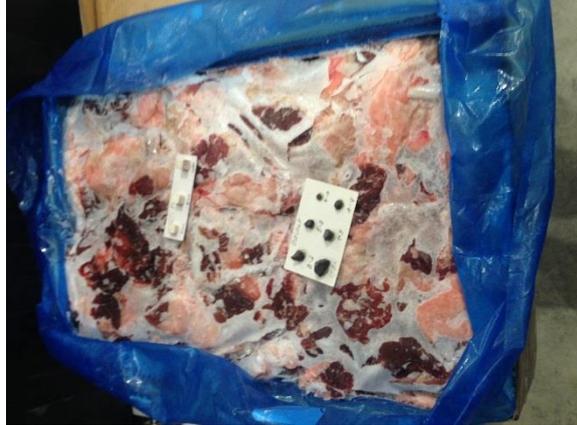
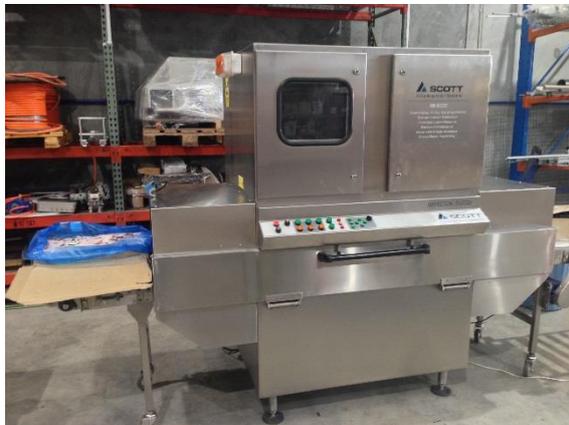
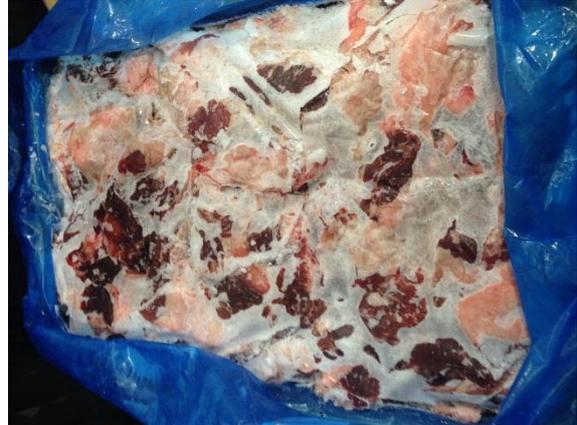
Before proceeding to these descriptions, some images are shown of the system during contamination detection and CL trials.

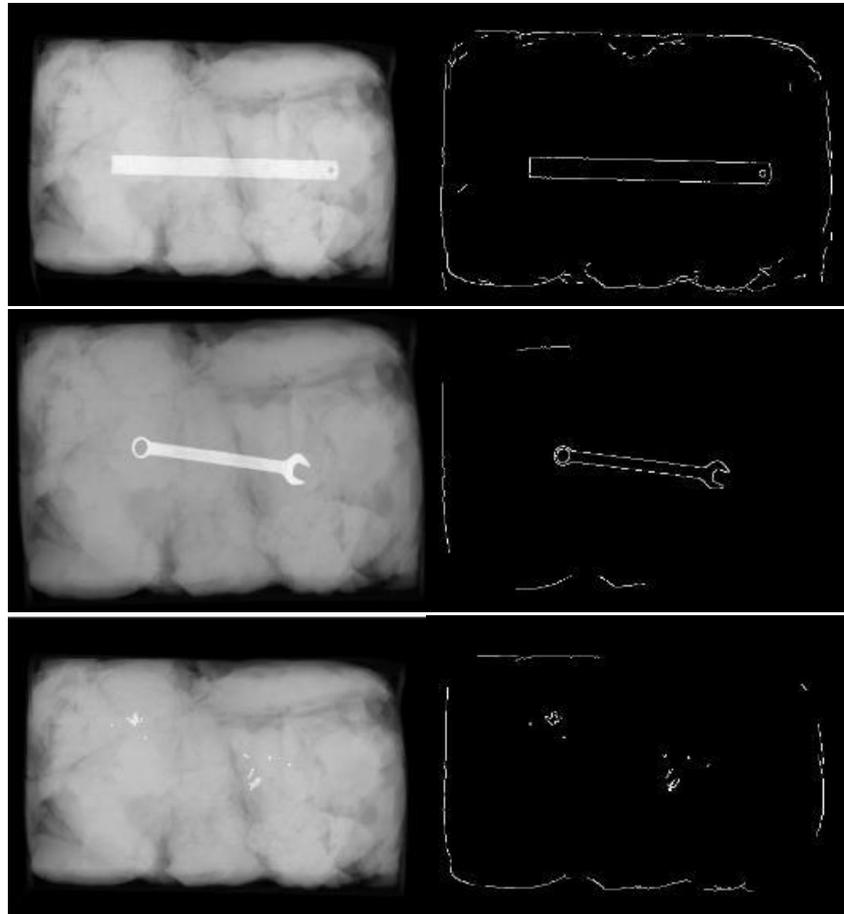
Figure 6: The meat image with contaminant (The stain steel ruler). The features detected after correctly setting the appropriate parameters.

Figure 6 show x-ray images and their features. It can be seen that the contaminants are clearly defined. However, the edges around the border are also detected. This would cause an issue and send false alarm to contaminant inspection. To overcome this, a novel ranking technique was developed to discriminate between features.

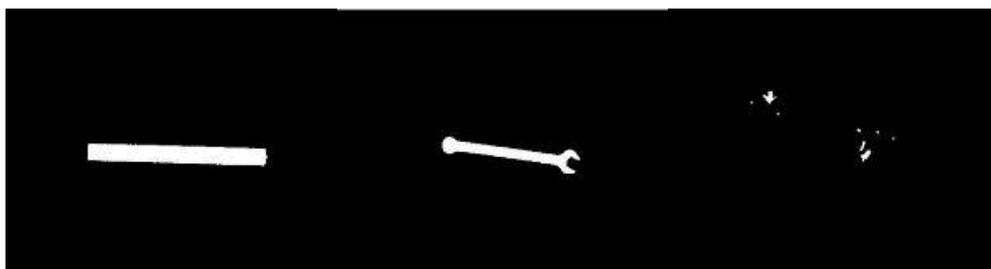
Figure 7: Ranking created from Figure 6.

After the initial features are identified, a ranking system is implemented to further isolate the contaminants of interest, as demonstrated in Figure 7.

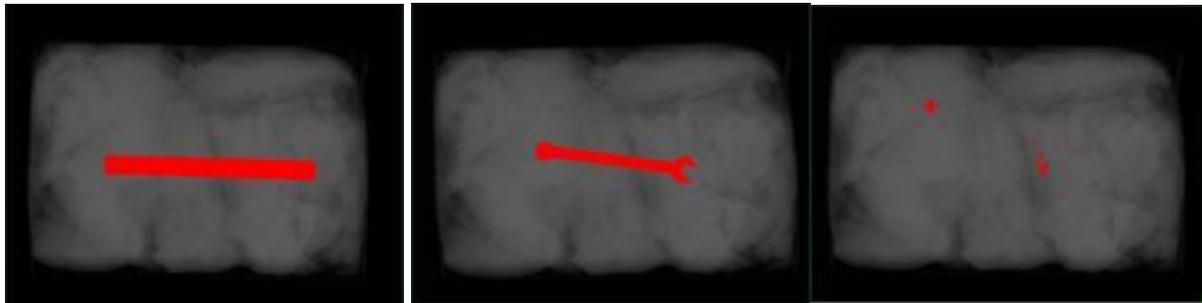
Figure 8: Contaminant labelled in red automatically.

The last step is to show where contaminants are located in a product. The image is annotated with red and either show it as an edge or filled in, as shown in Figure 8. Once detected, the alarm is sounded and the product can be deflected.

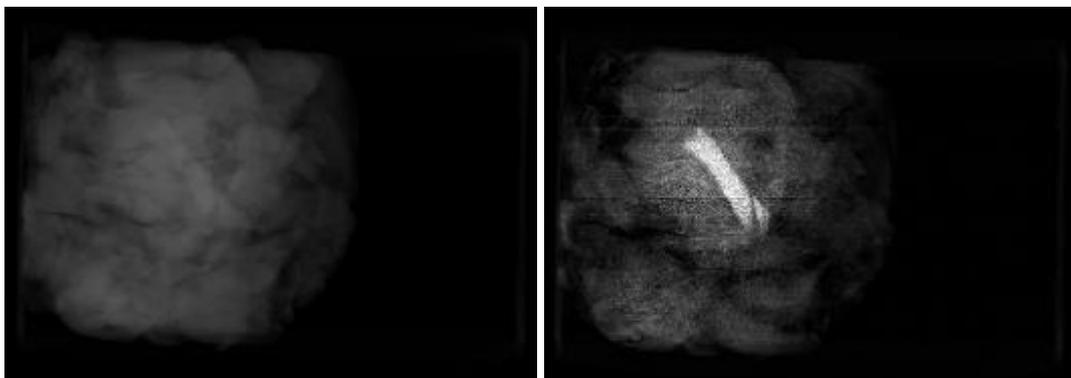
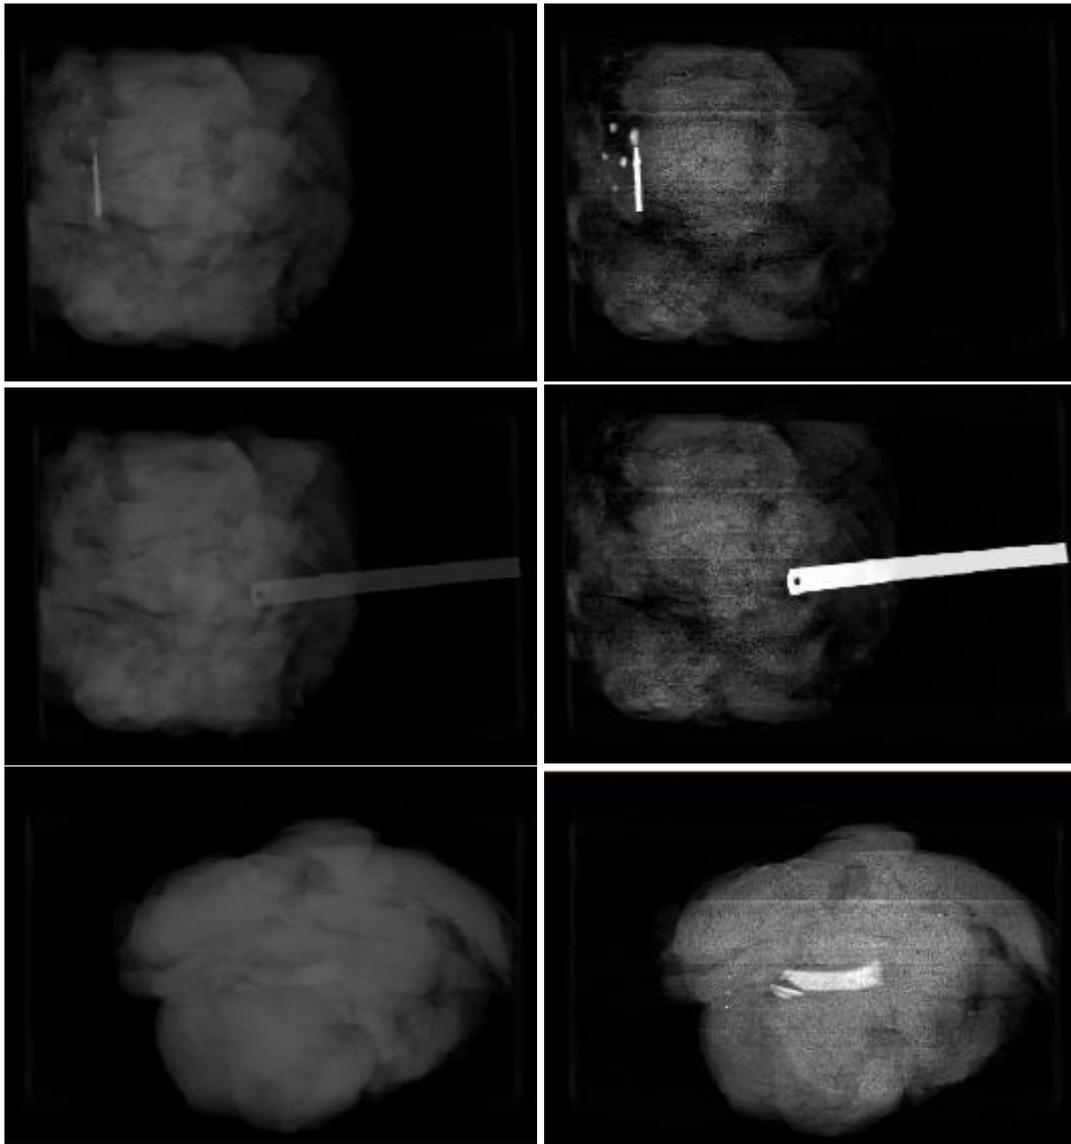
Figure 9: Left: Uncalibrated images with different contaminants including bones. Right: Calibrated images.

As described above, the two images from a DEXA scan can be converted into two alternative images based on the calibration. Any materials that have different X-ray characteristics to lean or fat (eg: many but **not** all contaminants) result in outputs from the calibration that are quite distinctive and provide a strong signature for contaminant detection. Figure 9 shows alternative x-ray images for various contaminants, the right-hand side images after being processed through a calibration procedure. As exemplified below, barely distinguishable contaminants in the uncalibrated image are very prominent and obvious in the calibrated image. Therefore, calibrated images can overcome the contrast issues for several types of contaminants which would improve accuracy in terms of false alarms for contaminant inspection.

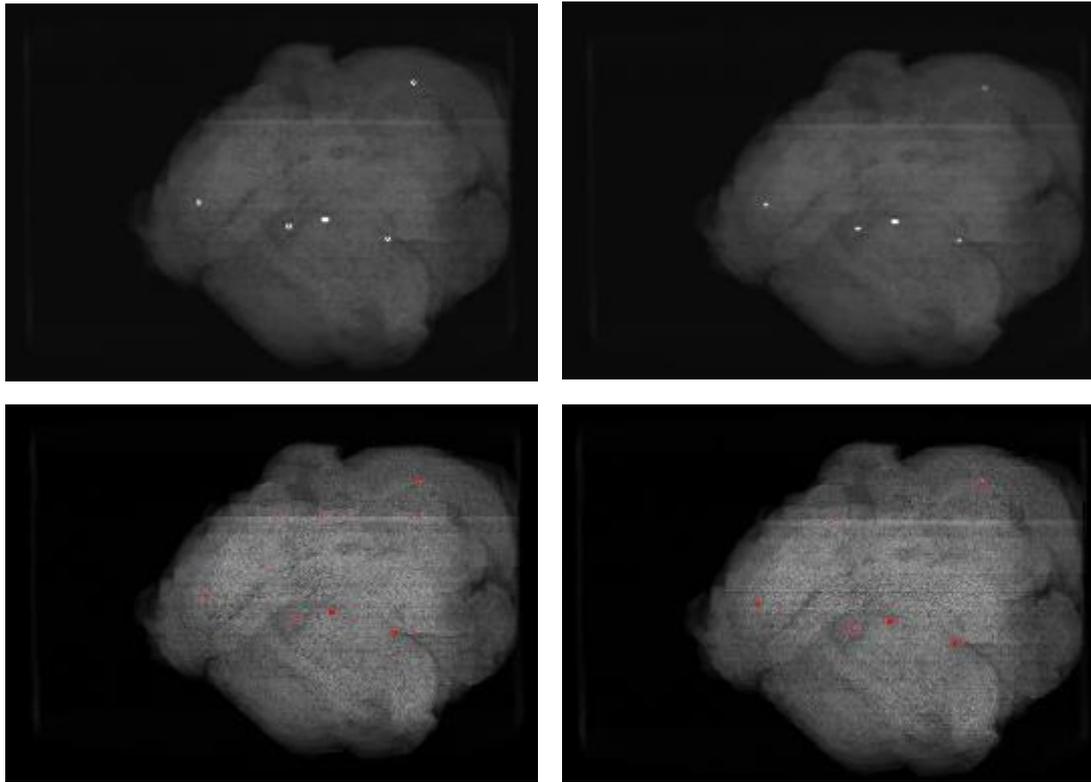
Figure 10: Left: enhanced calibrated image and its contaminant inspection. Right: Post-processing applied to calibrated image and its contaminant inspection..

After generating the calibrated image, the technique described in section 3.2 is used to detect contaminants. The issue with calibrated images is not only is the contrast for contaminants improved, but the noise is amplified. This noise causes issues that can increase false alarms for contaminant detection. Post-processing is used to suppress this noise issue. Figure 10 demonstrates the contaminant detection before and after post-processing of the image.

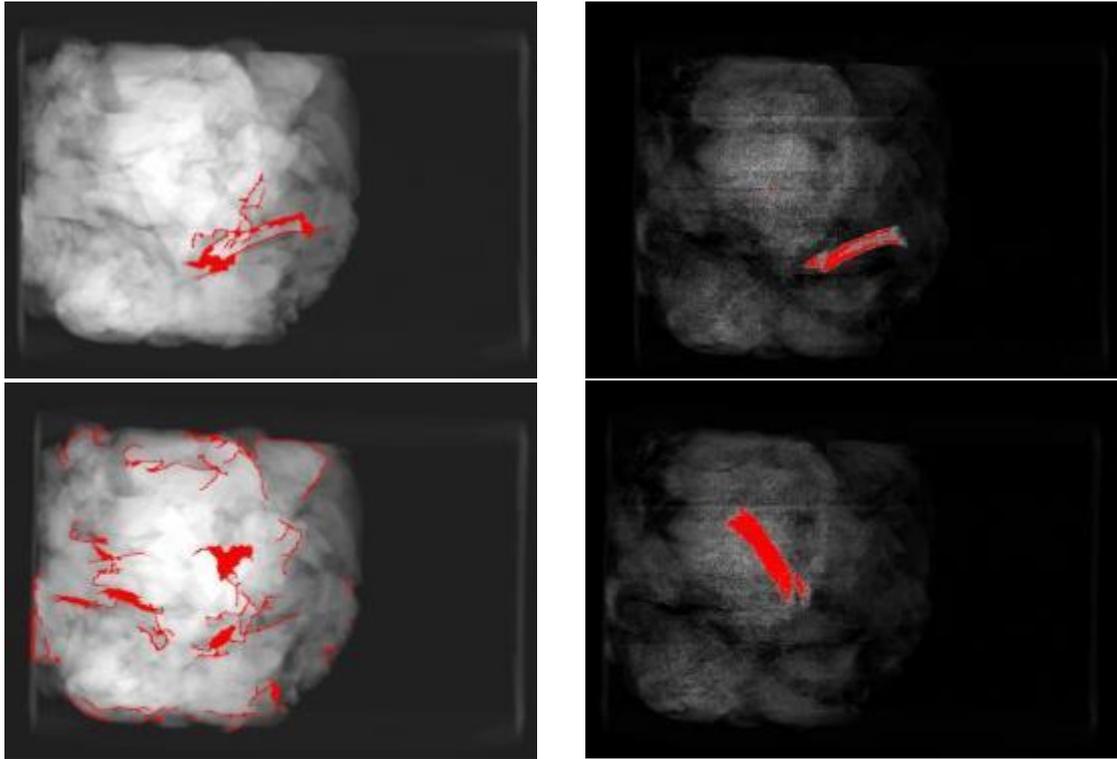
Figure 11: Contaminant inspection for Left: LE image and Right: Lean image.

Images have been captured with the XR8000 X-ray machine for different contaminants inside boxes of meat. Also, different types of meat (65% and 90% CL) were scanned and both uncalibrated and calibrated images were processed to determine the robustness of the contaminant inspection algorithm. The results in Figure 11 show the technique can detect large contaminant in both images. However, for contaminants such as bones or rubber, the technique generates a false alarm in uncalibrated images. Therefore, contaminant detection for calibrated images has outperformed the uncalibrated images.

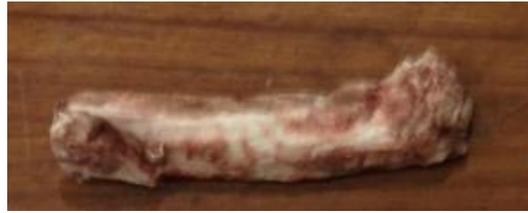
Figure 12: sample of bone (rib) used for contaminant inspection.

The bone was added inside the box of boneless beef meat as a contaminant. The box was scanned with X-ray machine and both uncalibrated and calibrated images are used for contaminant detection. The bone used is shown in Figure 12. After adding this bone randomly, the boxes was scanned and the results shown in Figure 13. It can be seen that the bone can be detected with 90% CL in uncalibrated image. However, with 65% CL, it is not possible to detect the whole bone. Furthermore, the sensitivity is less than 10% which makes it very sensitive to noise and background changes in contrast of the meat texture.

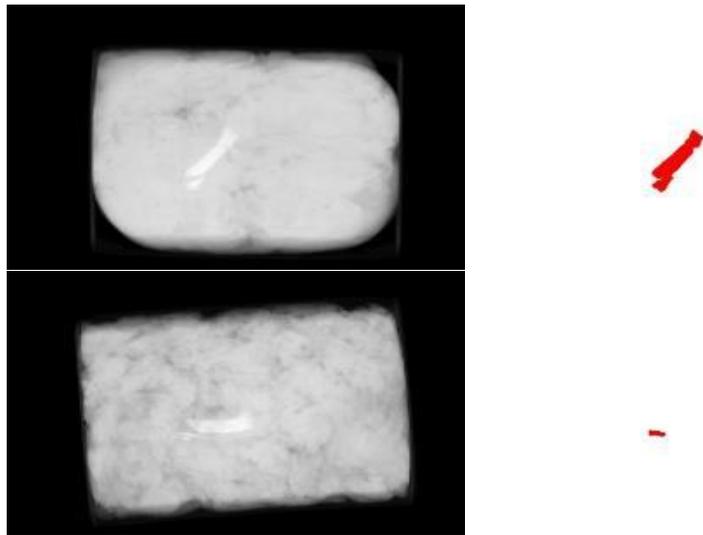
Figure 13: Uncalibrated image with bones added to box of meat with 90% CL for top row and 65% CL for bottom row.

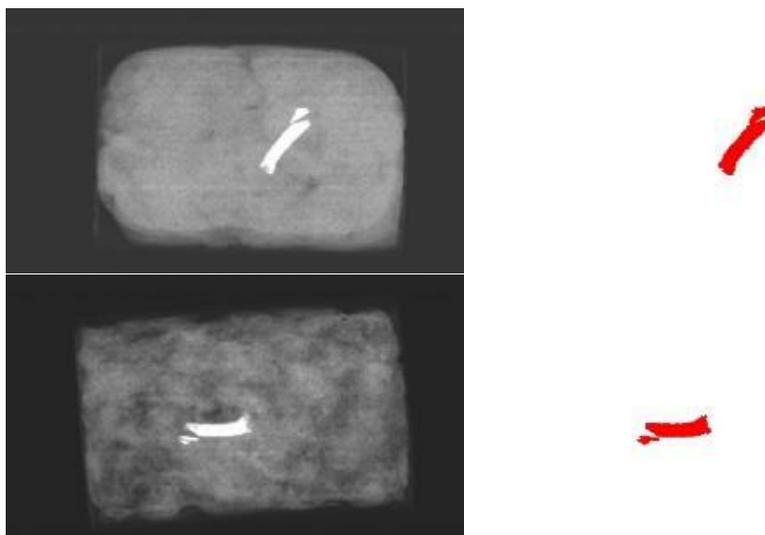
Figure 14: Calibrated images. Top row is 90% CL and bottom row is 65% CL.

Figure 14 illustrates contaminant detection with the calibrated image. It can be seen that for both 65% and 90% CL, the bone is detected accurately and the contrast of bone in calibrated images is higher than in uncalibrated images.

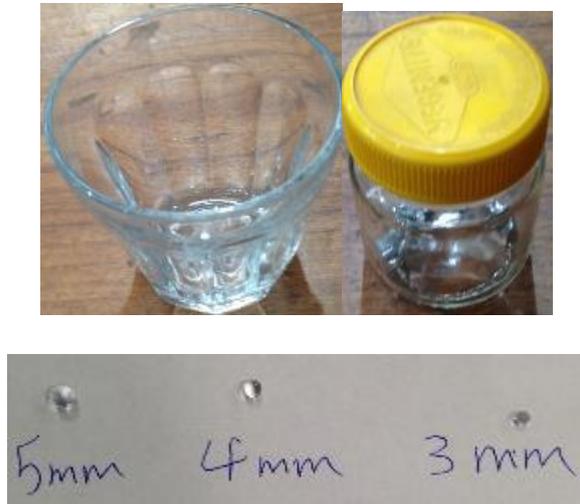
Figure 15: Glass samples used for testing the contaminant inspection.

Different types of glass were used for contaminant inspection in box of meat. Samples of glasses with different sizes are shown in Figure 15.

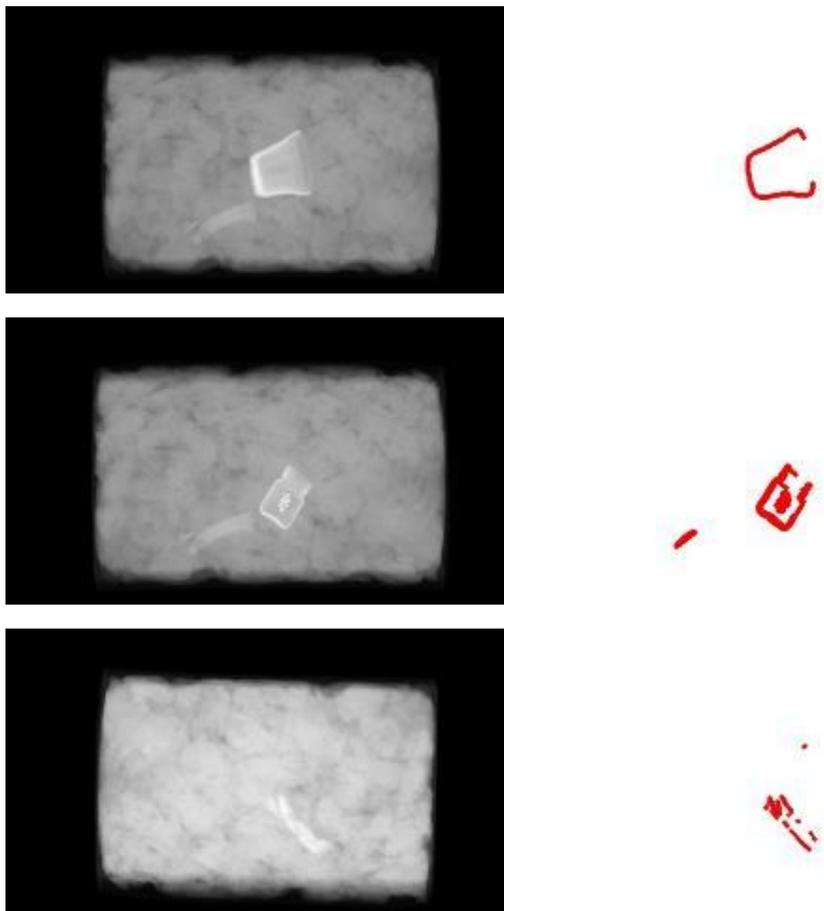
Figure 16: Contaminant inspection of uncalibrated image for glass with different sizes in 65% CL meat.

From Figure 16 and Figure 17, it can be seen that detecting of large glass contaminant is possible in uncalibrated images with different shapes and size, but glass balls with less than 5 mm diameter can't be detected due to low contrast. Calibrated images are shown in Figure 18 and Figure 19. The glass has high contrast and is detected plus it's possible to detect smaller glass contaminants with 4mm diameter. The fact the bone is partially detected in the uncalibrated images emphasises the need to set algorithm parameters carefully, whereas with the higher contrast calibrated images this care is diminished.

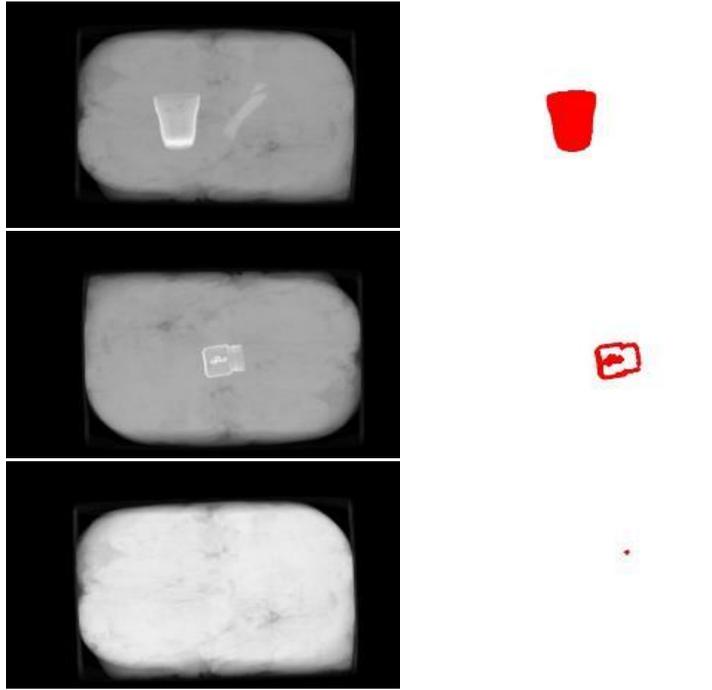
Figure 17: Contaminant inspection of uncalibrated images for glasses with different sizes in 90% CL meat.

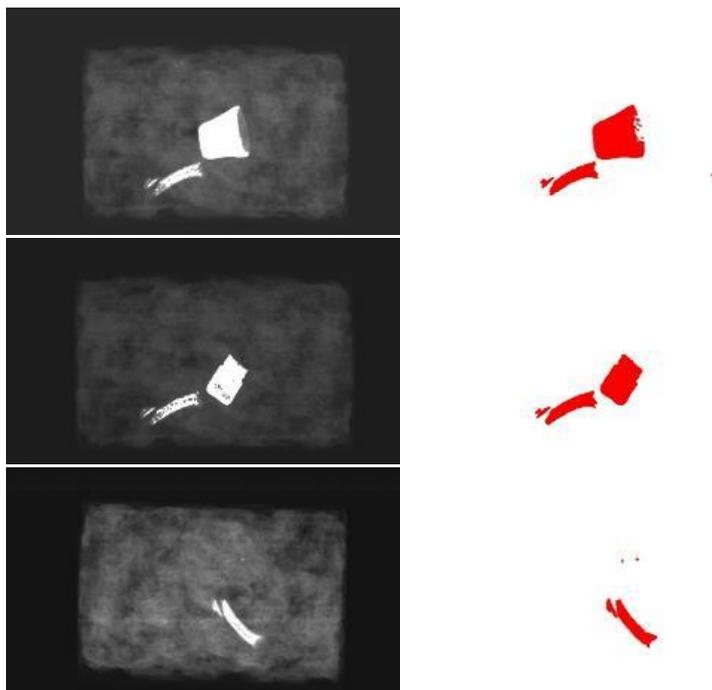
Figure 18: Contaminant inspection of calibrated image for glass with different sizes in 65% CL meat.

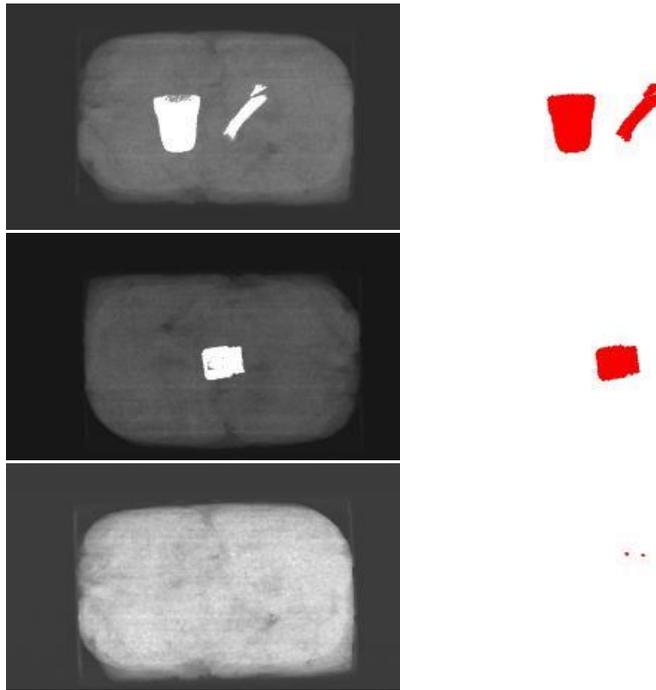
Figure 19: Contaminant inspection of calibrated images for glass with different sizes in 90% CL meat.

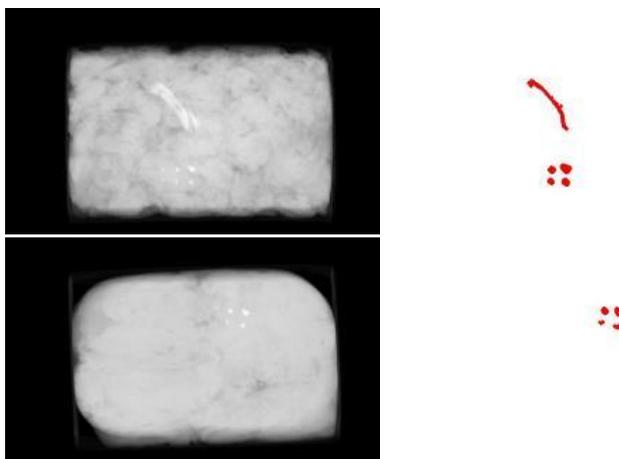
Figure 21: Inspection of uncalibrated image for basalt with different sizes in 65% (Top) and 90% (bottom) CL meat.

Figure 21 shows that basalt is detected in uncalibrated images, but only down to a size of 4.9 mm. Figure 22 show the 4.9 mm basalt detectable in calibrated images. In addition, the bone is also detected in the calibrated image with 65% CL.

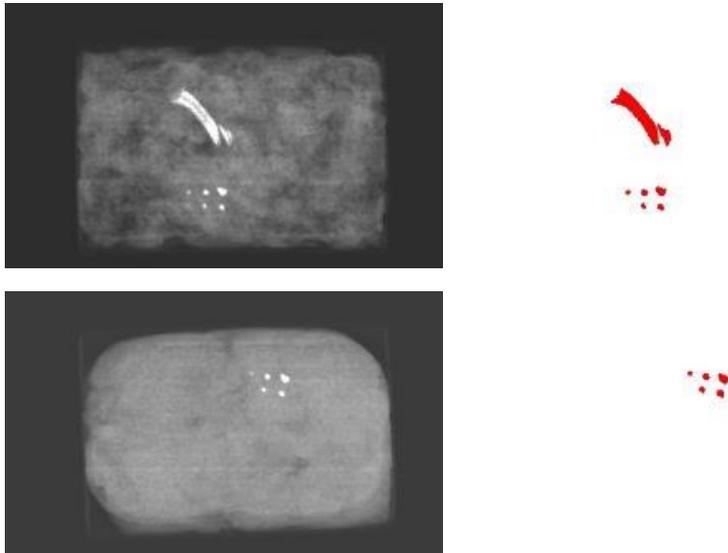
Figure 22: Inspection of calibrated image for basalt with different sizes in 65% (Top) and 90% (bottom) CL meat.

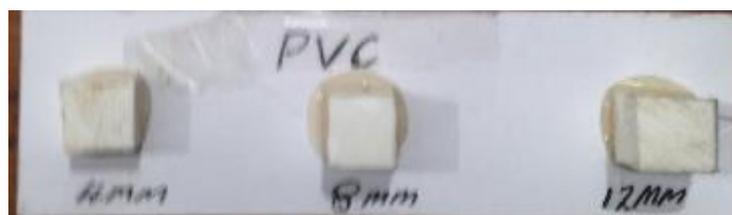
Figure 23: PVC used as contaminant inside the meat boxes.

The PVC and UHDPE materials are used as a contaminant for meat contaminant inspection. Samples of these materials are shown in Figure 23. For uncalibrated images, it is not possible to detect less than 8mm size for PVC as shown in Figure 24. Furthermore, the bone is partially detected for 65% CL. For calibrated images, the PVC with 4mm can be detected and the bone is also clearly detected. Figure 25 shows the results for both 65% and 90% CL meat.

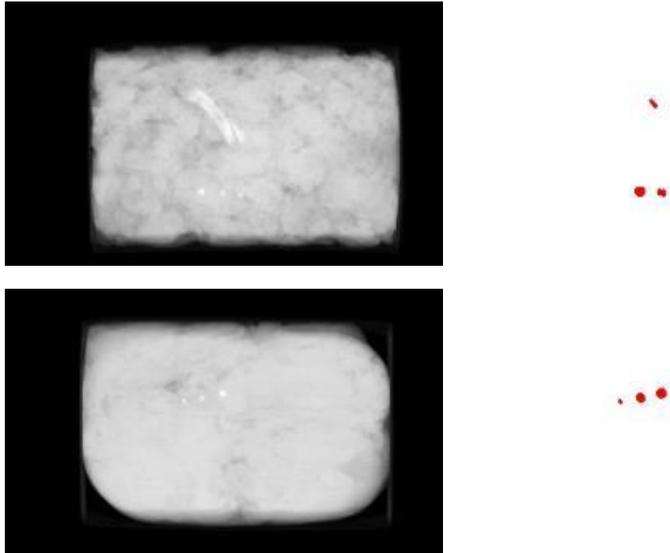
Figure 24: Contaminant inspection of uncalibrated images for PVC with different sizes in 65% (Top) and 90% (bottom) CL meat.

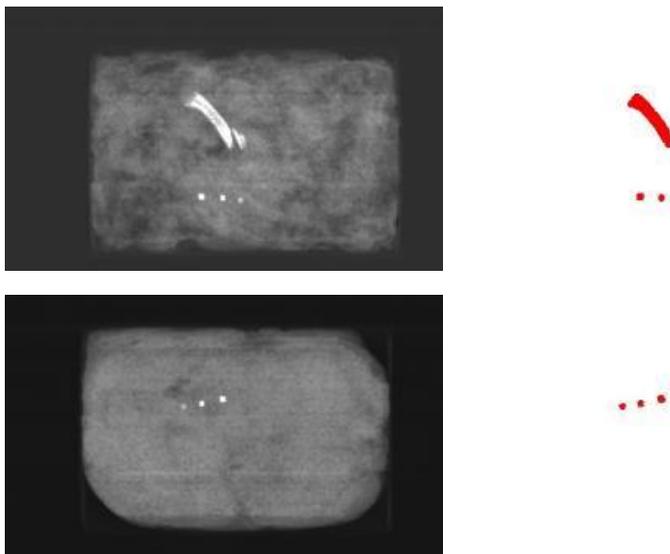
Figure 25: Contaminant inspection of calibrated images for PVC with different sizes in 65% (Top) and 90% (bottom) CL meat.

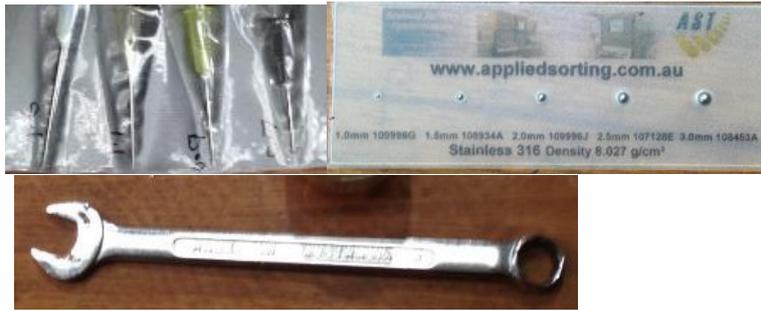
Figure 26: Stainless steel and metals used for contaminant inspection.

The stainless steel ruler, needles, wrench and spheres with different are used as a contaminant for meat contaminant inspection. Figure 26 shows samples of these materials. Figure 27 and Figure 28 show that the large stainless steel contaminants can be detected in LE images. However, for needles it is not possible to detect less than 1.6 mm in diameter. In addition, the bone is not detectable due to low contrast when having large contaminant inside the box. For Lean images, it can be seen that the large objects with bone can be detected. For small stainless steel contaminants needles down to 0.7 mm in size are detected but for spheres it is not possible to detect less than 2mm diameters. This is expected as these tests were done using a 1.6 mm pitch detector.

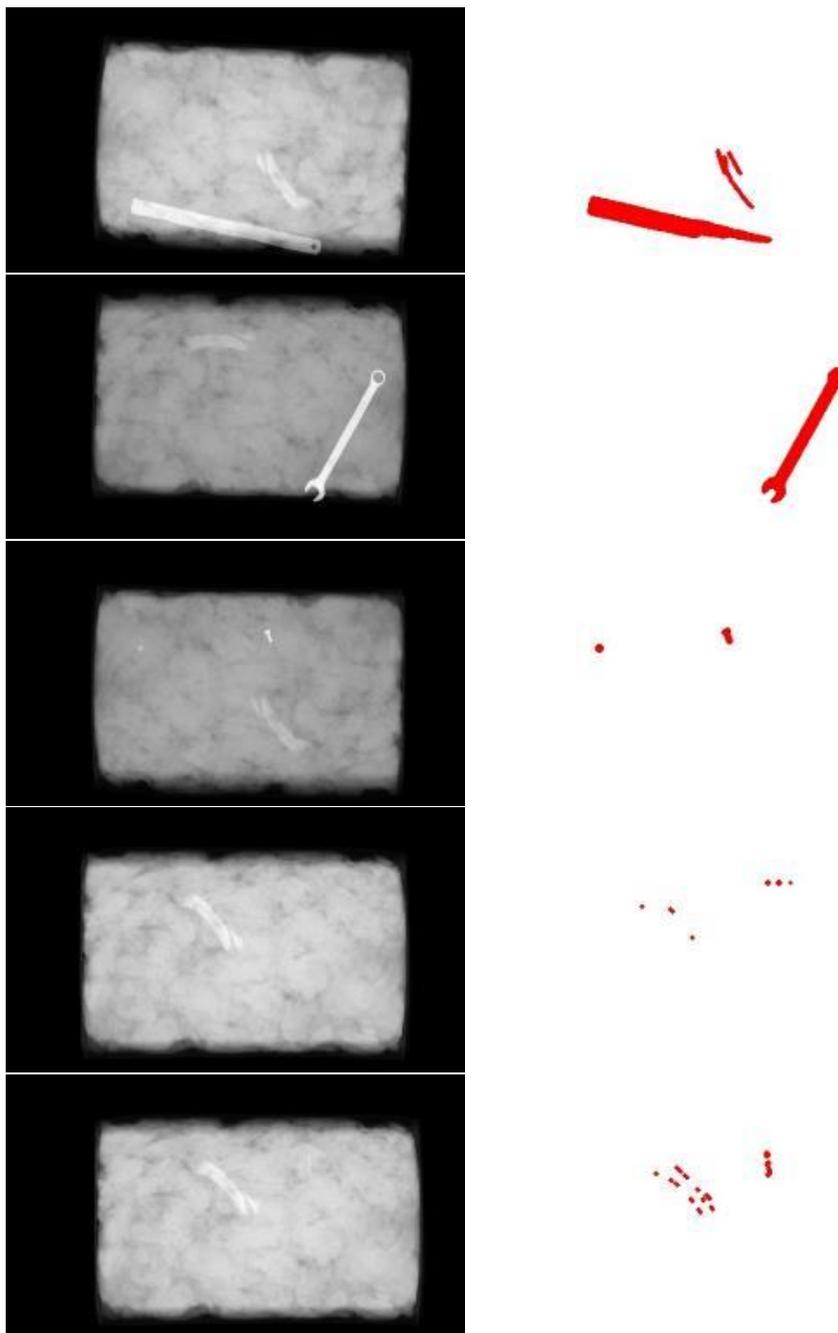
Figure 27: Contaminant inspection of uncalibrated images for stainless steel with different sizes in 65% CL meat.

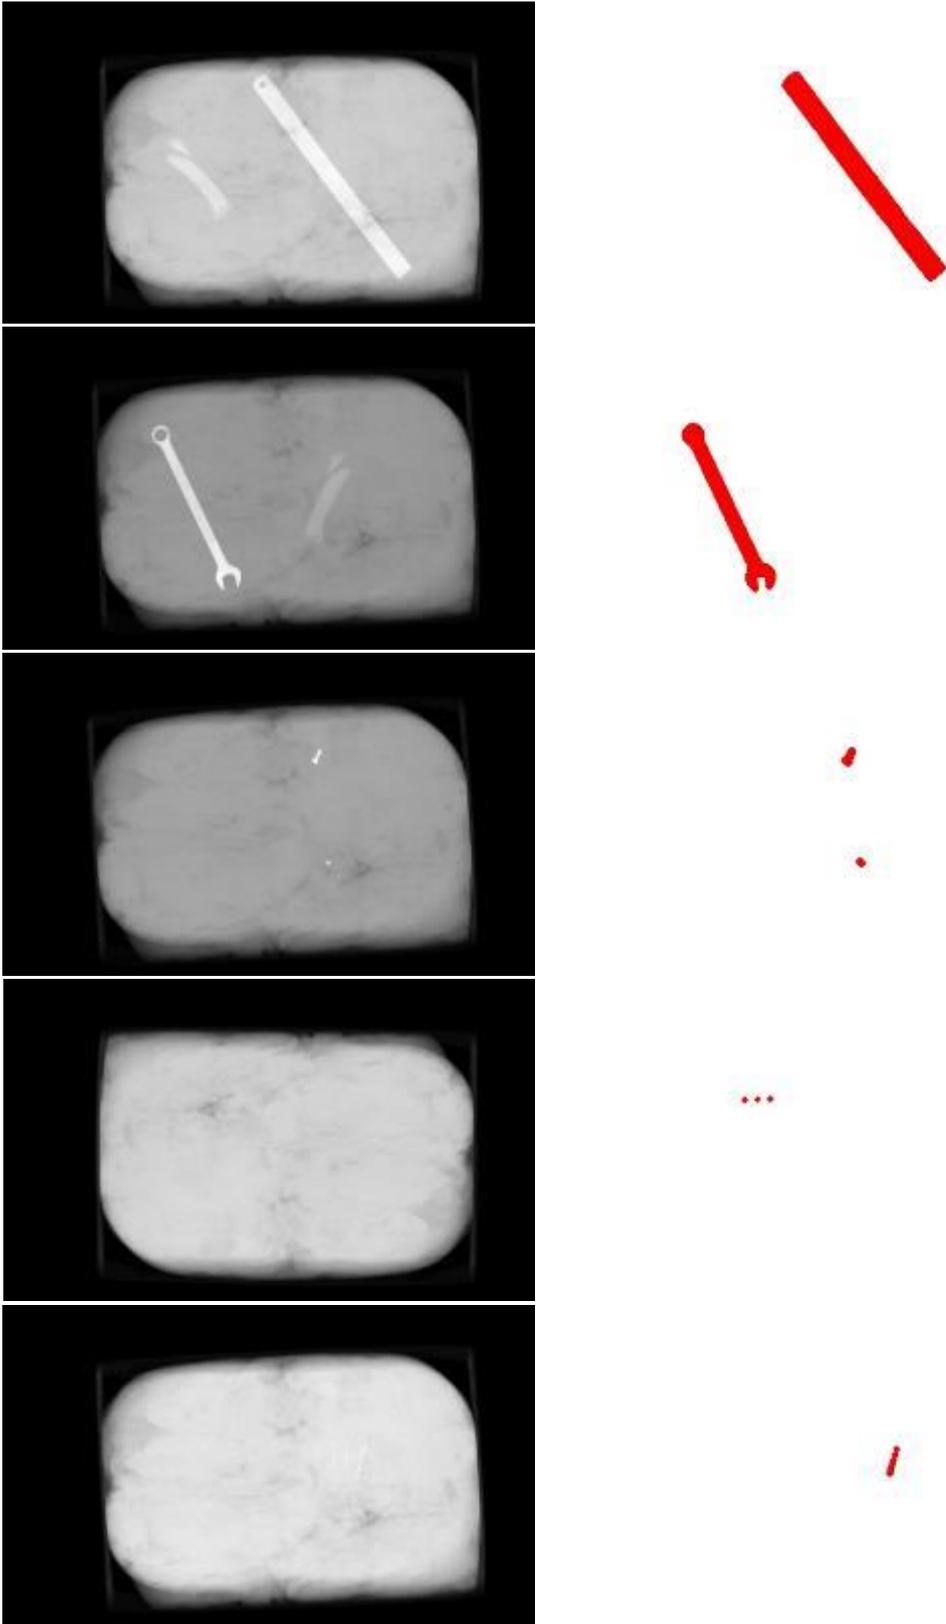
Figure 28: Contaminant inspection of uncalibrated images for stainless steel with different sizes in 90% CL meat.

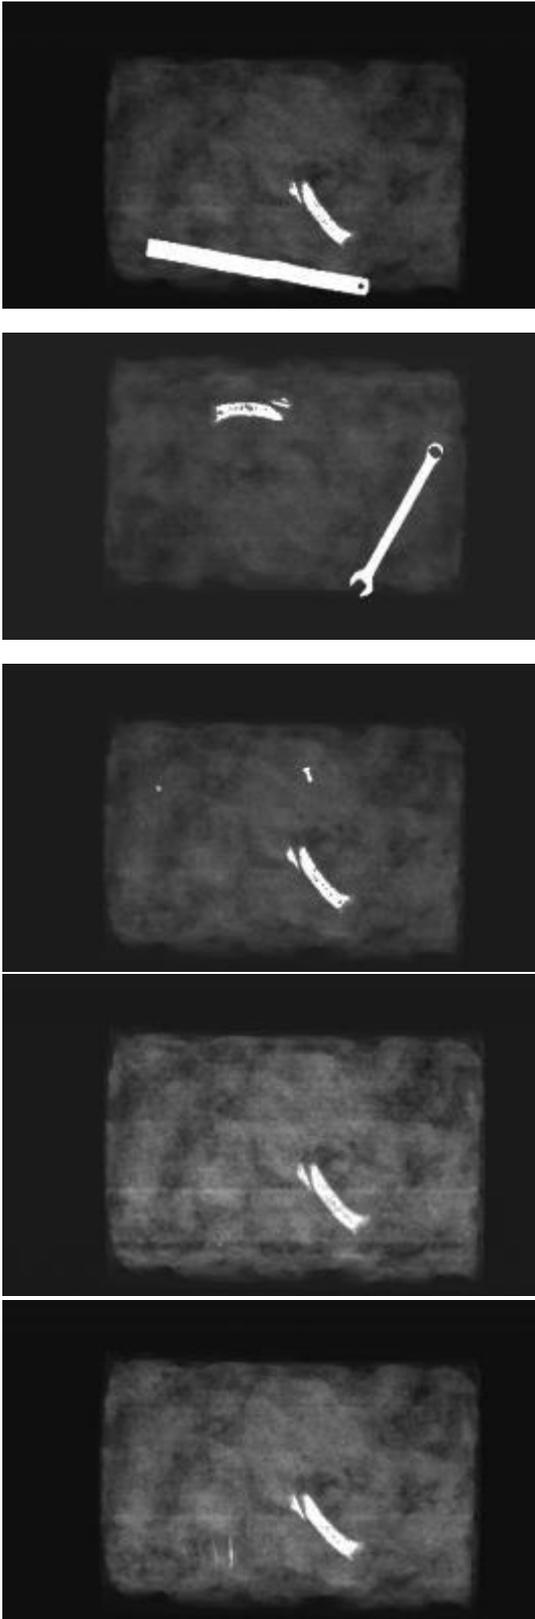
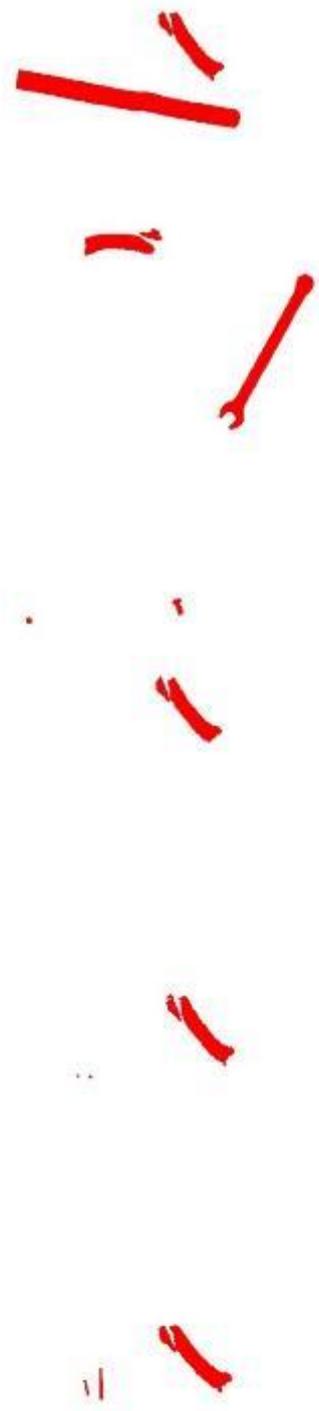
Figure 29: Contaminant inspection of calibrated image for stainless steel with different sizes in 65% CL meat.

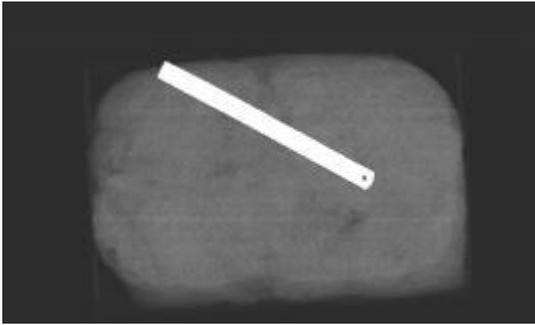
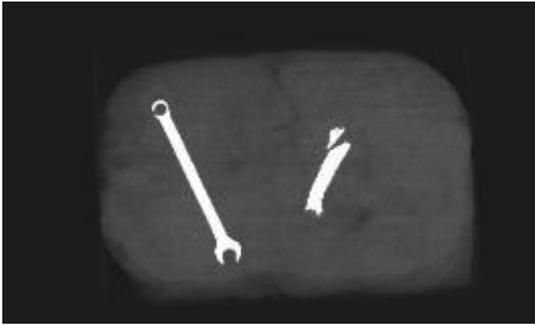
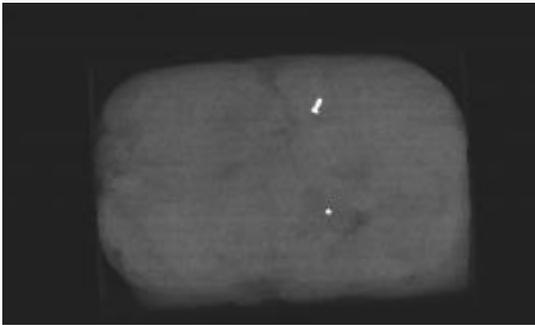
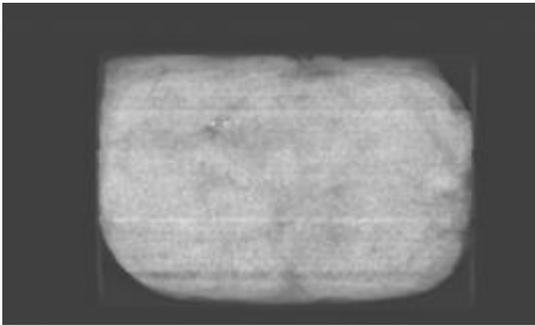
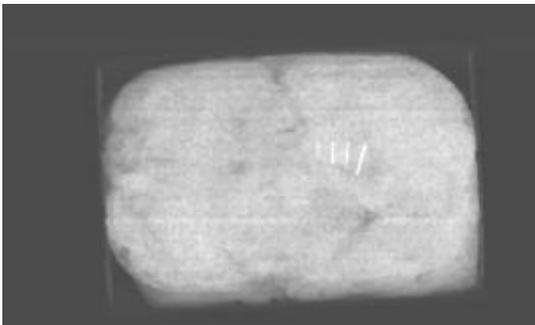
Figure 30: Contaminant inspection of calibrated images for stainless steel with different sizes in 90% CL meat.

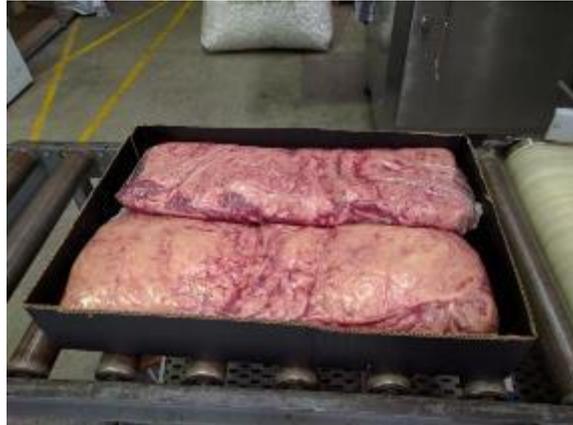
Figure 31: Scan 1 - Two striploins in 545 x 360 x 90 box

PASS – The system would pass this box as being within tolerance.

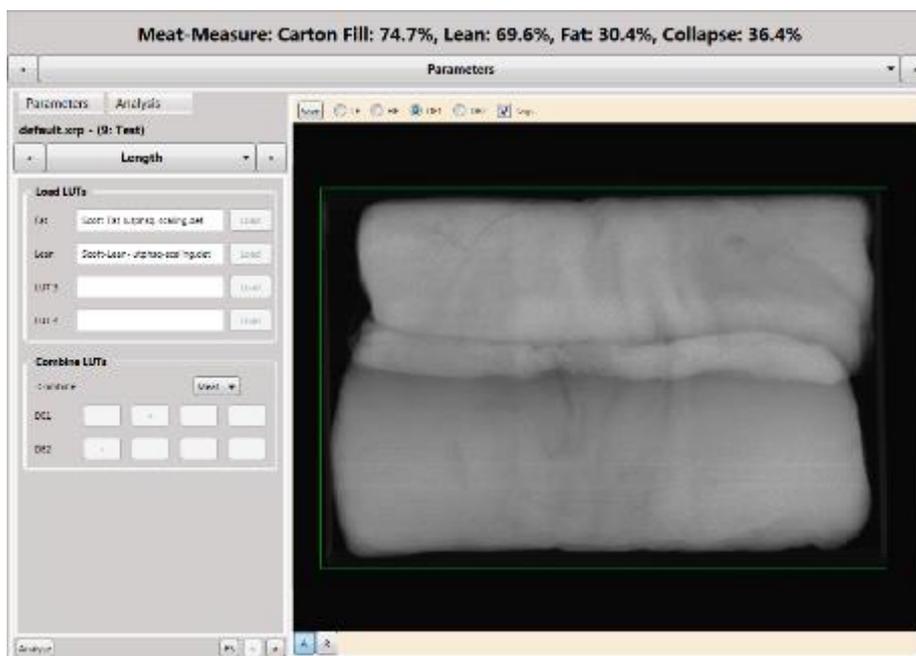
Figure 32: Scan 1 - Scanning Result
