# Final report

Project code: P.PSH.0905

## Advanced Carton Inspection DEXA X-Ray Machine with Extended Analytics

### Final Report - Public Version

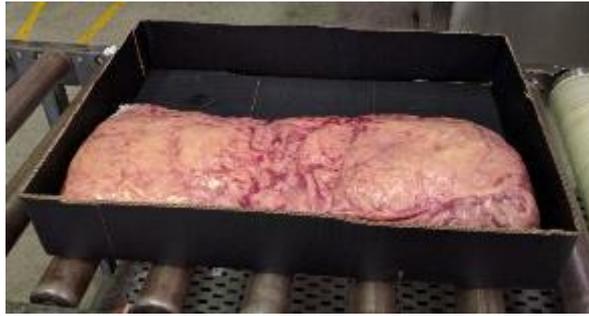
Figure 33: Scan 2 - One striploin in 545 x 360 x 90 box.

FAIL - The system would fail this box - the void on the side of the box was identified and flagged.

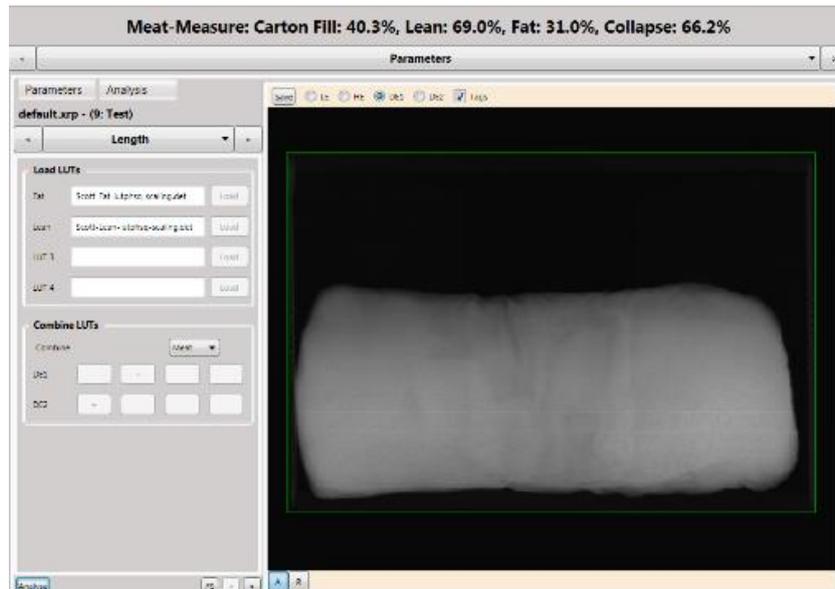
Figure 34: Scan 2 - Scanning Result.

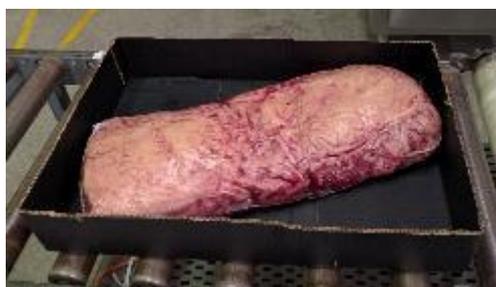
Figure 35: Scan 3 - One striploin in 545 x 360 x 90 box.

FAIL - The system would fail this box - the voids on the corners of the box were identified and flagged.

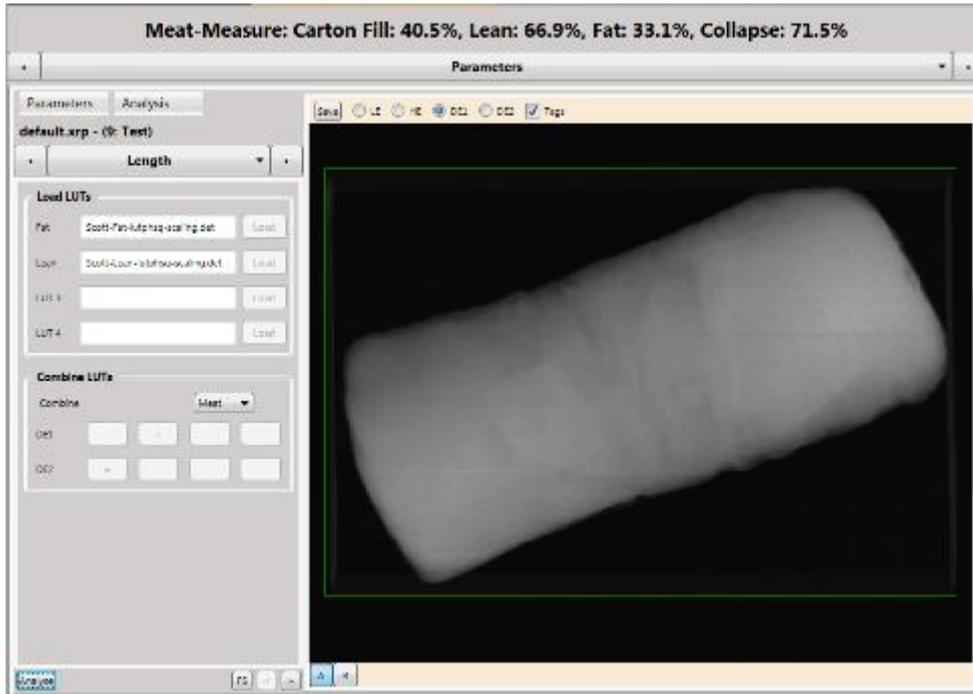
Figure 36: Scan 3 - Scanning Result.

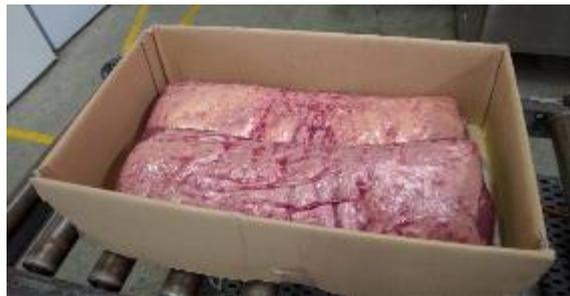
Figure 37: Scan 4 - Two striploins in 585 x 320 x 170 box.

FAIL – The system would fail this box - the box is under filled which has been identified and flagged.

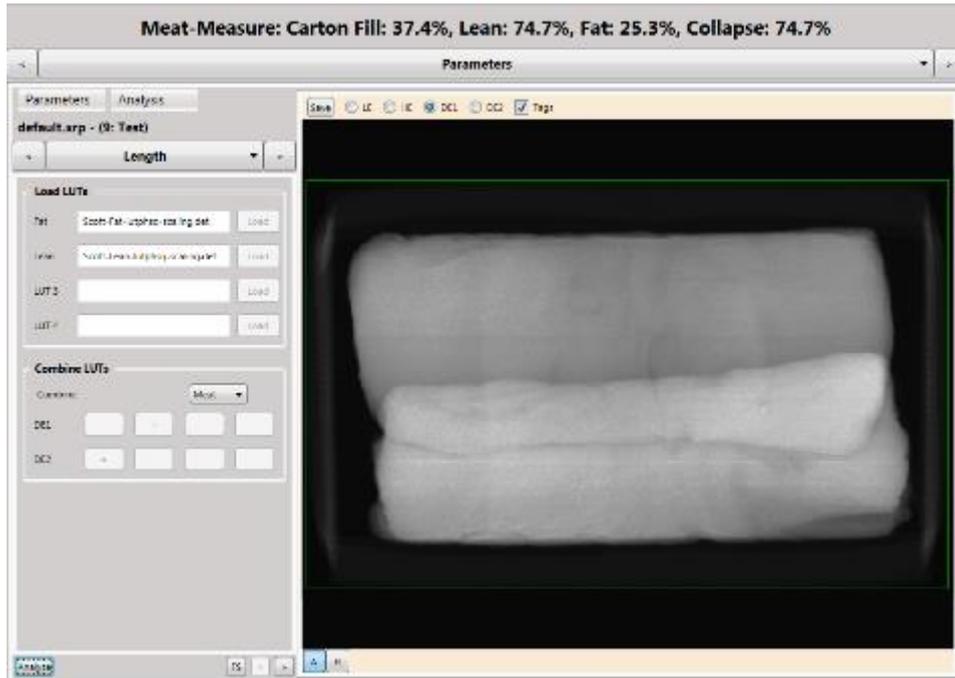
Figure 38: Scan 4 - Scanning Results.

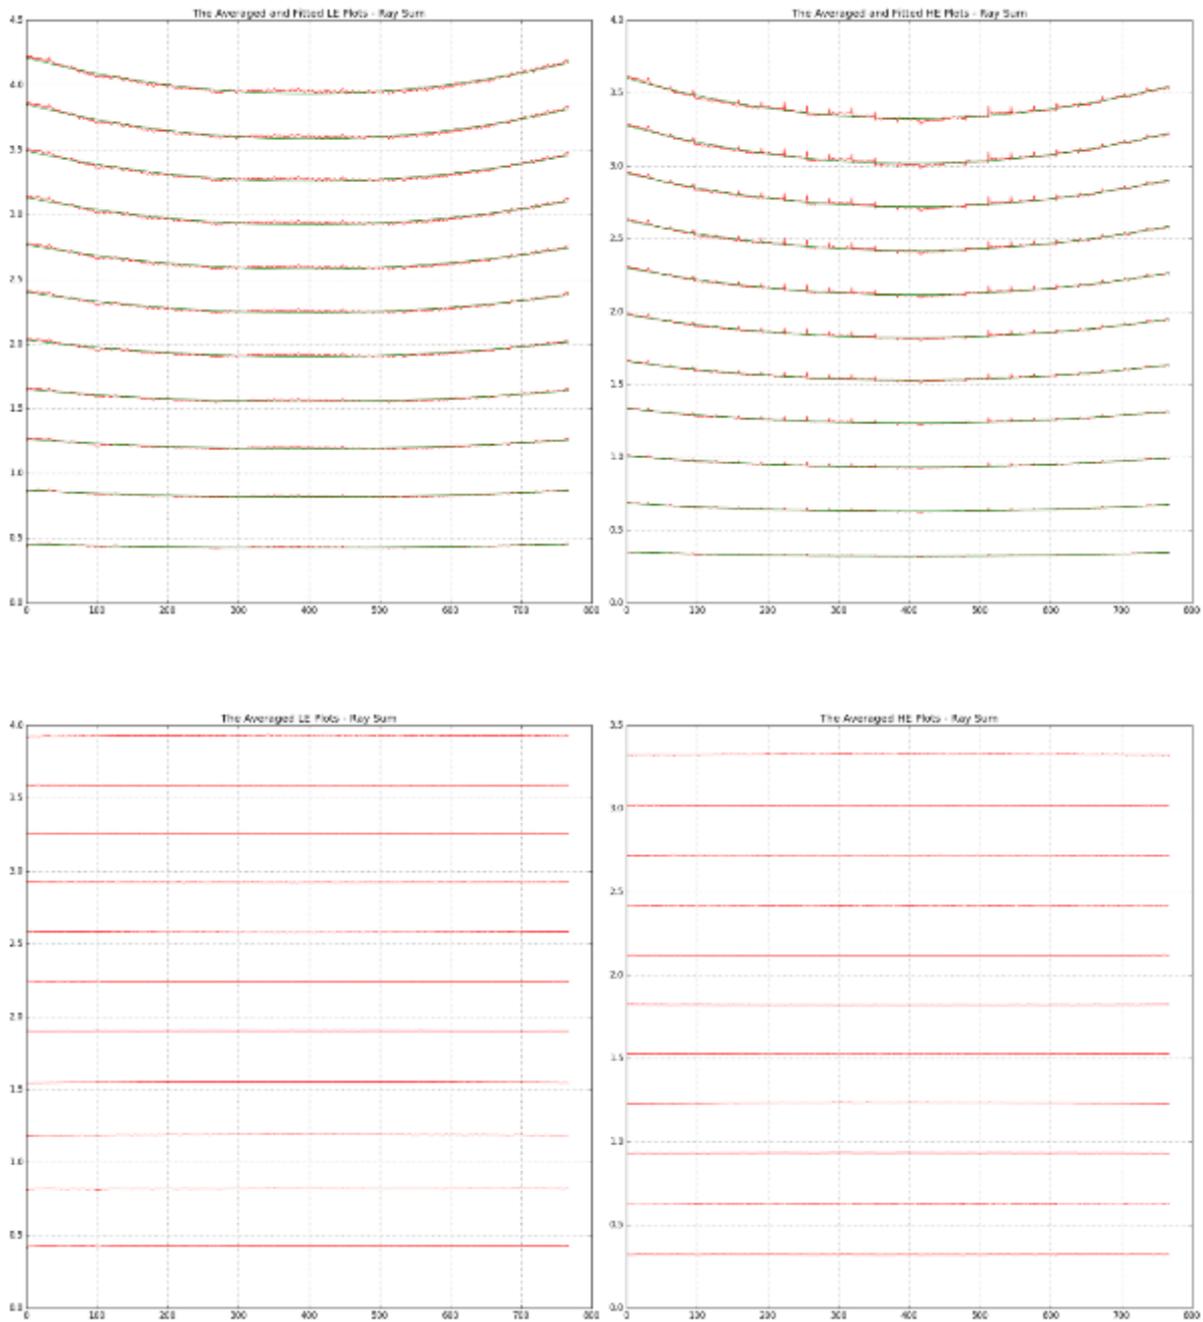
Figure 39: Linearisation calibration object response at every step for every pixel across the detector.

The effectiveness in this approach is demonstrated in the graphs below. The top graphs show the response of each pixel and each step thickness in red. As the thickness of the calibration object increases, the curvature also increases – this curvature must be removed if the CL measurement is to be accurate. Also note the small pixel variations and peaks with respect to the ideal 'green' response due solely to the fan-beam geometry. The bottom graphs show the step wedge measurement after correction.

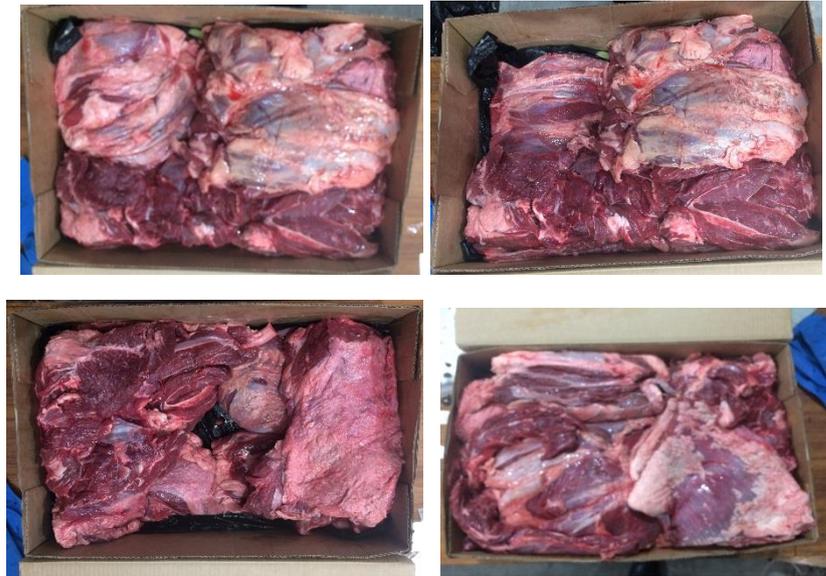
Figure 40: Sample of /meat boxes used for CL analysis and carton fill.

With the calibration files, the tissue images are built from the DEXA data. Coupled with additional geometric attributes of the boxes, measurements of 'Carton Fill', 'CL Content' and 'Box Collapsibility' are assigned to each scanned box. The lean and fat data is generated by using these tissue images. The results are shown in Figure 41, Figure 42, Figure 43 and Figure 44. For each pixel the lean and fat has been calculated and lean only is the fraction of lean over total meat which is lean plus fat. It can be seen that the lean image for 90% CL has more contrast than 65% CL whereas the fat image is reversed.

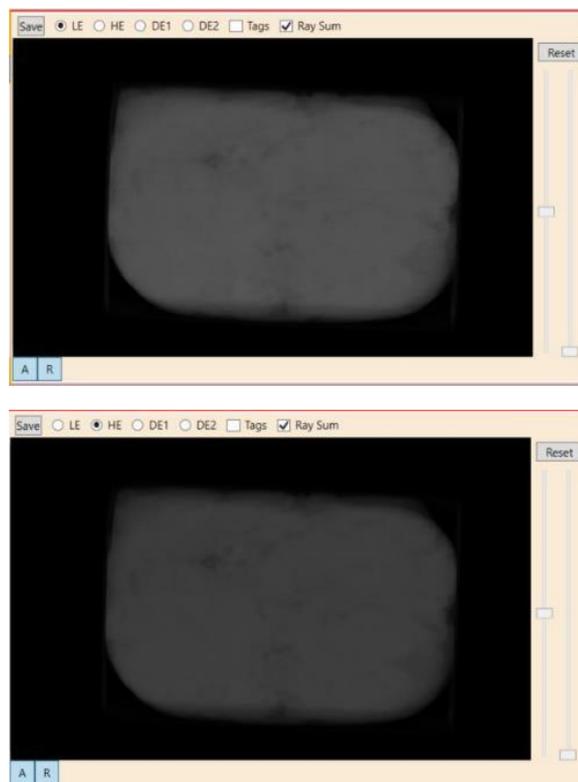
Figure 41: LE (top) and HE (bottom) images for 90% CL.

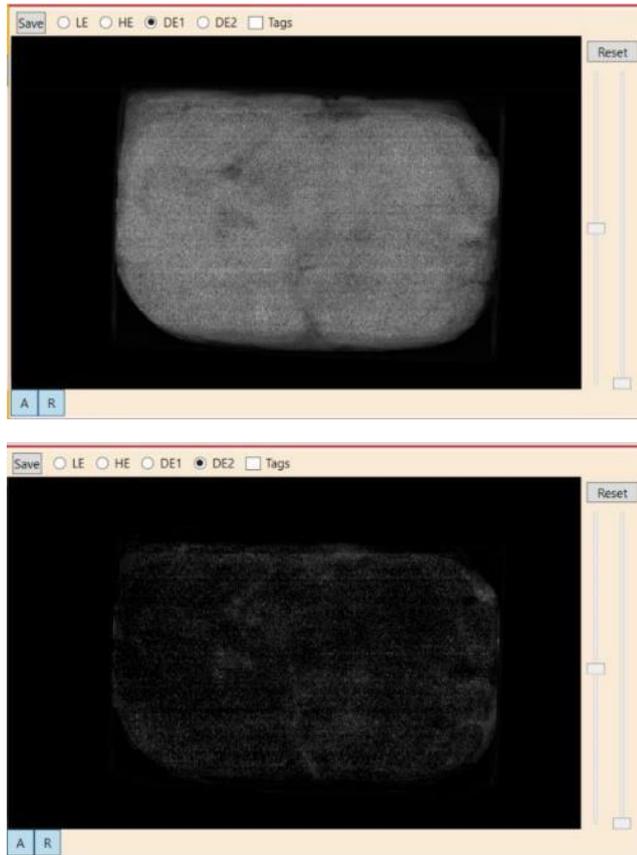
Figure 42: Lean image (top) and Fat image (bottom) generated from Figure 41.

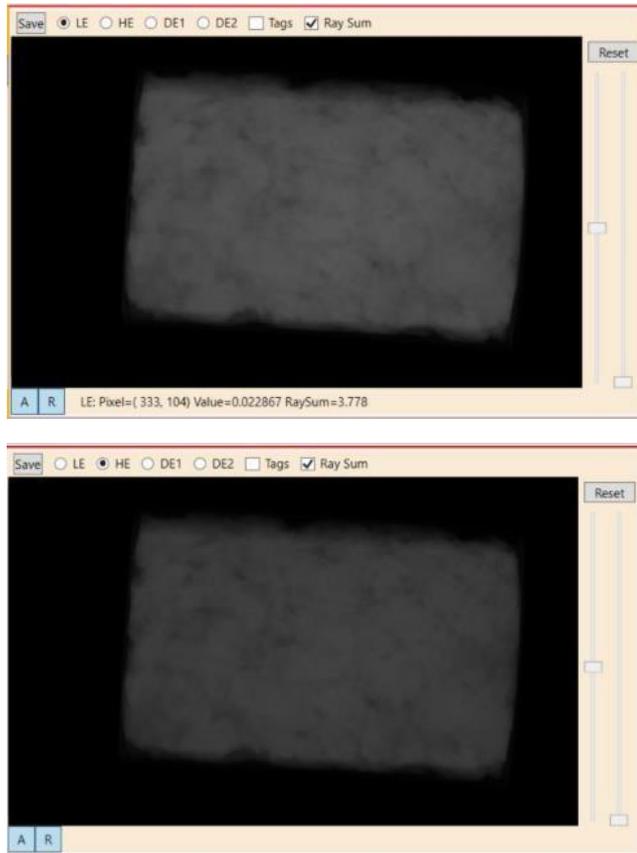
Figure 43: LE (top) and HE (bottom) images for 65% CL.

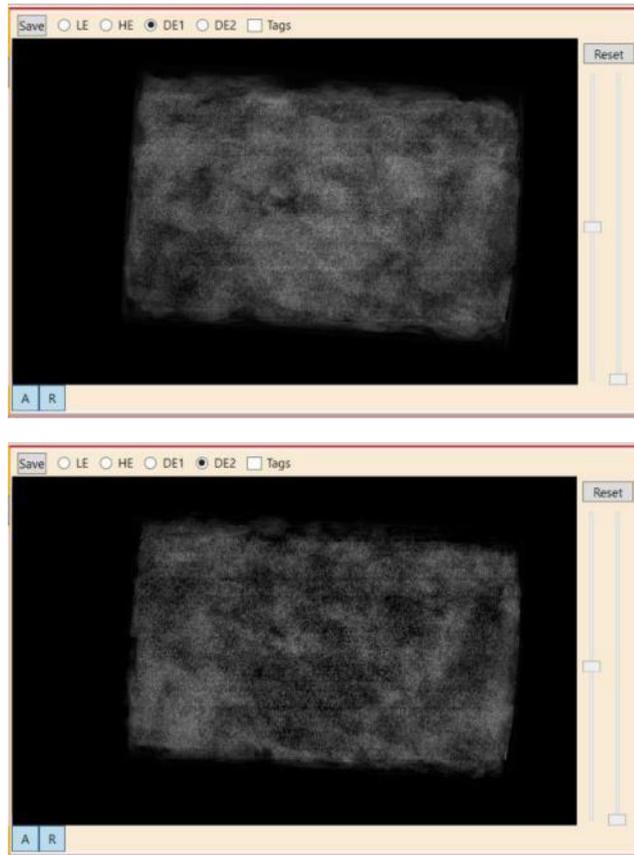
Figure 44: Lean image (top) and Fat image (bottom) generated from Figure 43.

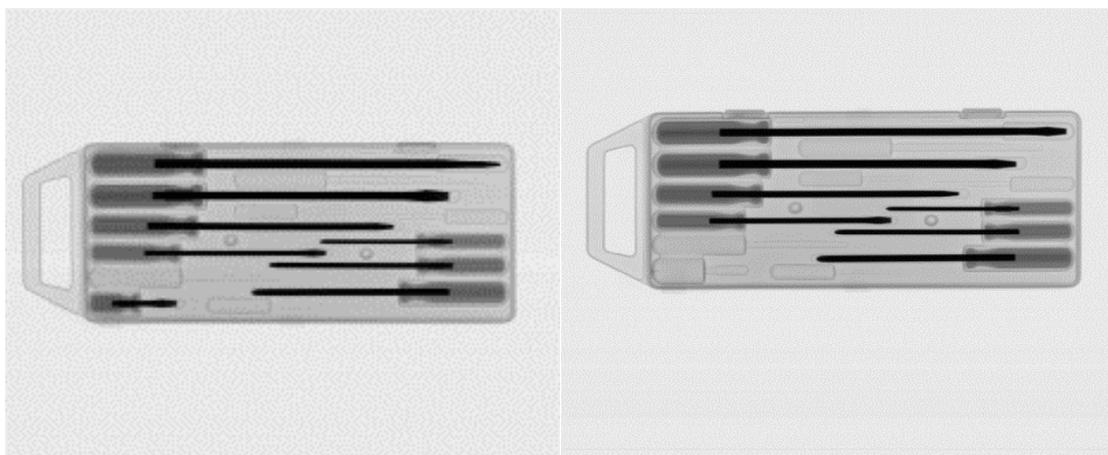
Figure 45: Comparison of LE images of a tool set between the original and alternative detector.

The path to improving contaminant detection size limits whilst also performing CL has been started with the installation of an alternative detector. Below are some X-ray images comparing the scan of a tool set using the current pitch detector (top) and the alternative pitch detector (bottom) – take note of the enhanced image fidelity.

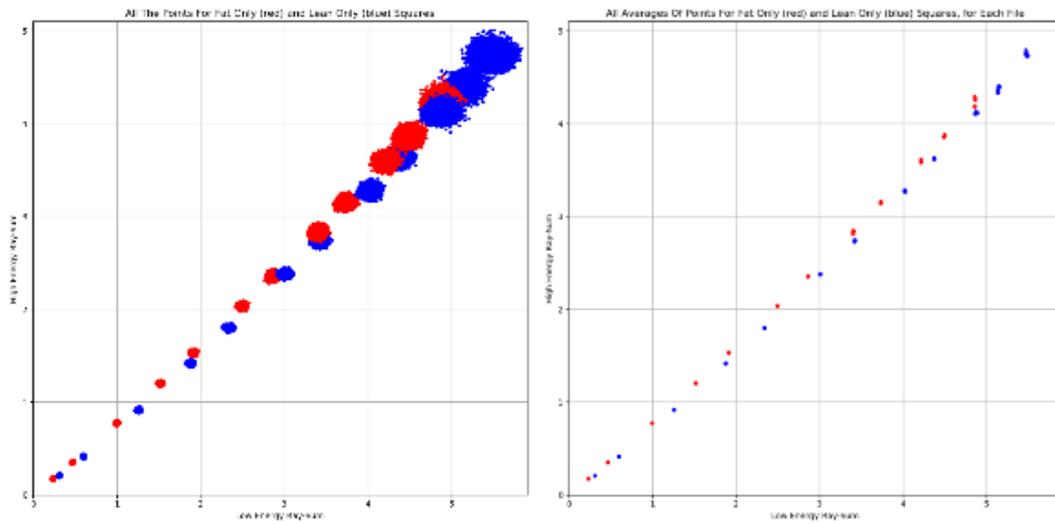
Figure 46: Pixel data from multiple scans of test objects. The left plots shows all the pixels and the right plots show the average of the pixels for each scan.

A light description of the issues encountered with the alternative detector is provided. Figure 46 shows the distribution of LE and HE measurements for a test scan. The left plot shows substantial overlap as the test object thickness increases. The right plot shows the average for each scan – there are a total of 20 scans. As can be seen, even over a period of 15 minutes, the average values also vary. Figure 47 shows the distribution of measurements taken of test objects. The left plot show substantial overlap. Again, the right plots show the average for each scan.

The left plots of all figures exemplify that imaging a constant thickness can result in a multitude of X-ray values, hence making it very difficult to extract accurate data. Any noise in the measured images is greatly amplified. The right plots of all three figures show that even over a period of 15 minutes, the average values also vary. This has serious implications when generating stable calibrations.

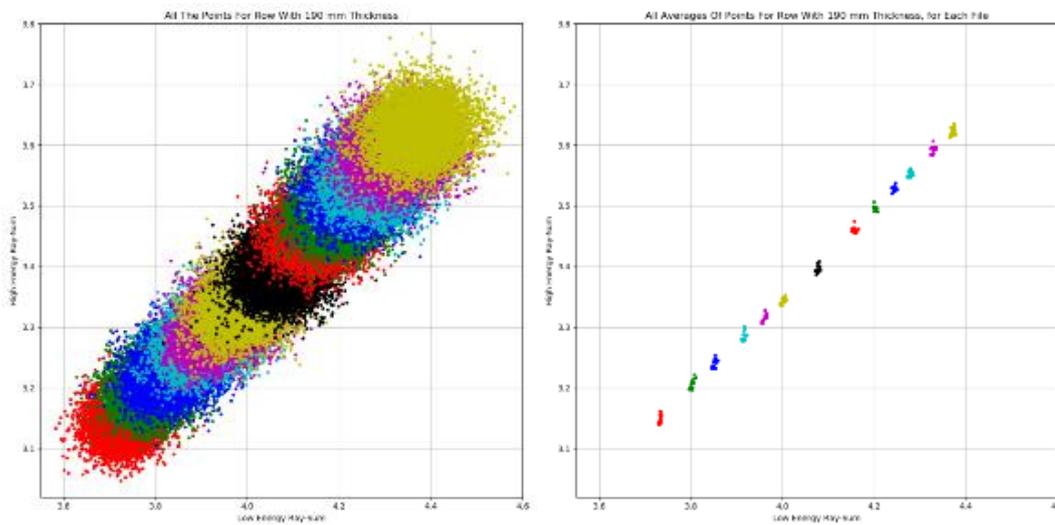
Figure 47: Pixel data from multiple scans of test objects. The left plots shows all the pixels and the right plots show the average of the pixels for each scan. The colour of each cluster / point represents a different test object.
