final report

Project Code: P.PIP.0334
Prepared by: John Mead
Liquid Dynamics
Date published: May 2014

Data collection, base calculations, design and monitoring/SCADA implementation associated with hot water production and distribution upgrade

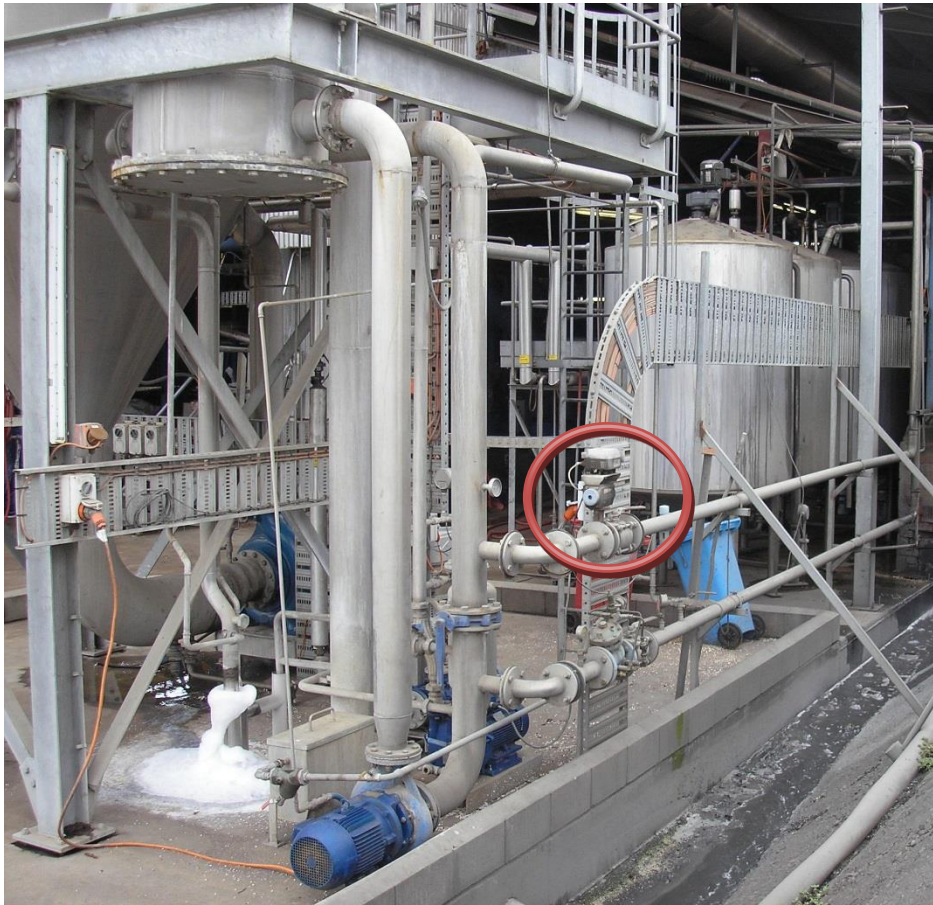
Flue gas heat recovery on rendering

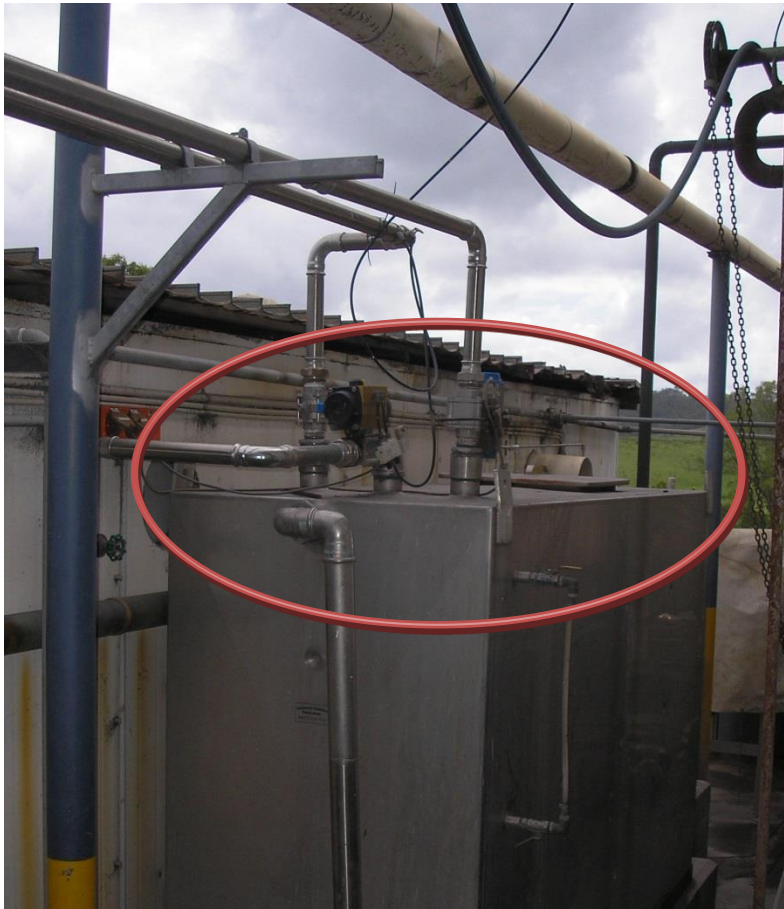
Boiler softener feed water tank with control valves indicated

The primary boiler feed line is the heat recovered water line from the flue gases that junctions via a tee above the gantry at the in feed end of the rendering dryer. The main issue for the boiler water supply was the consistency and quality of makeup water. With the HW process being sparge based limited condensate was being returned to the boiler. No measurement of condensate returned was being collected nor was the mix of heat recovery water versus fresh water being recorded. Only the total amount of makeup water added to the boiler was being controlled with no

reference to its source. The loss of water from the system was not being recorded nor was the overflow of heat recovered water at night.

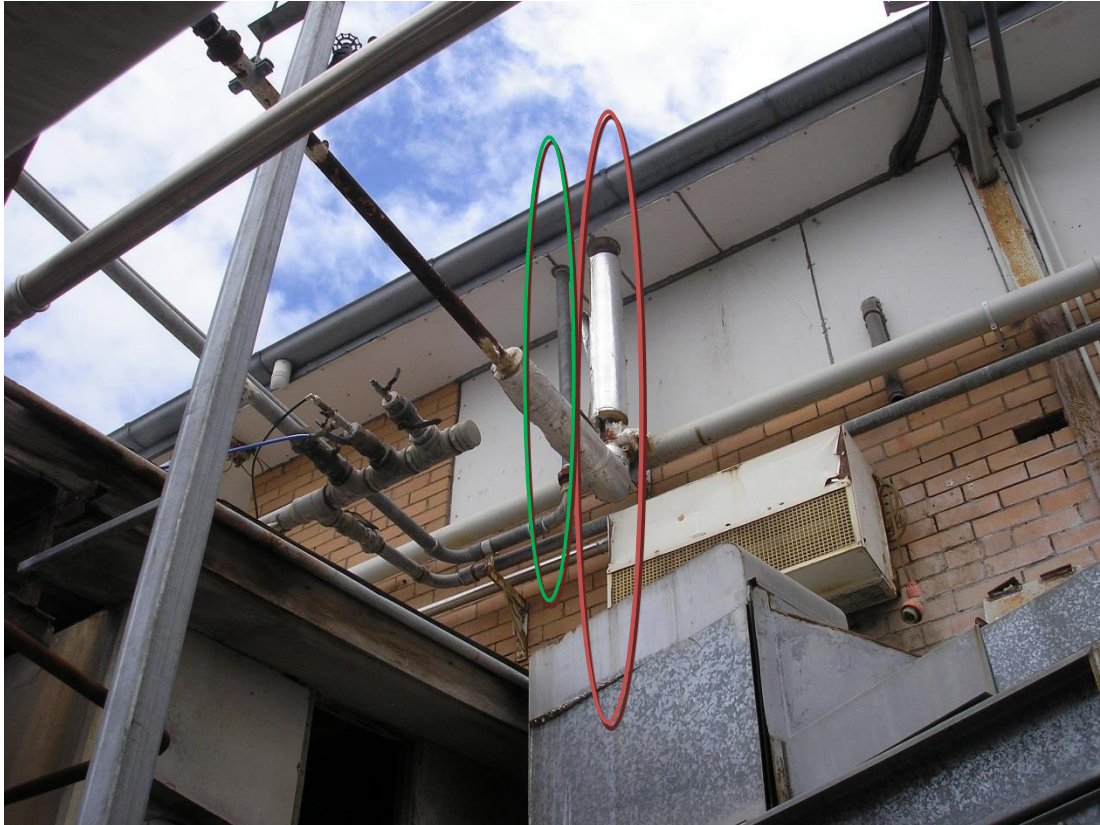
Steam and condensate lines entering and leaving the boning room

- There is a cast iron pipe that is uninsulated and extends from the current water production area back into the rendering plant that has been verbally indicated as being a condensate return line for the boning room (Picture 5 - green circle).
- The steam line for the boning room extends from the 45°C water production steam sparge feed pipe and is only insulated in sections (Picture 5 - red circle).

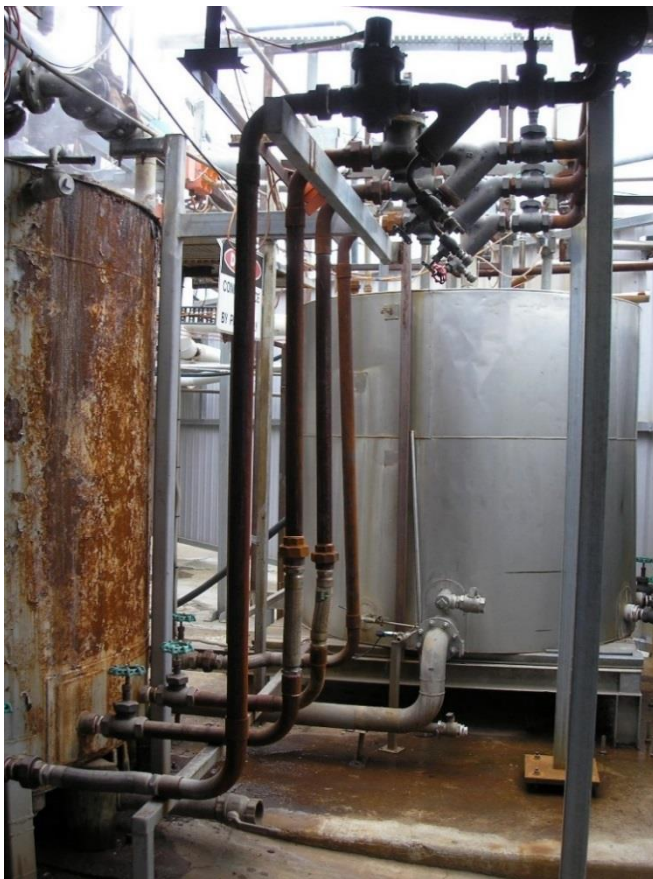
82°C steam sparge system with original tanks

- At 97°C the thermal losses from the tank and the ring main are extremely large. The temperature of the return line from the slaughter floor was measured and found to be 74-77°C. This represents a Delta-T of 20-23°C and represents significant energy losses.

- The tank has been structurally compromised and is close to failure representing a health and safety concern as well as a business risk to the plant with the loss of the sanitizer water production. In such circumstances the plant would be unable to process stock.

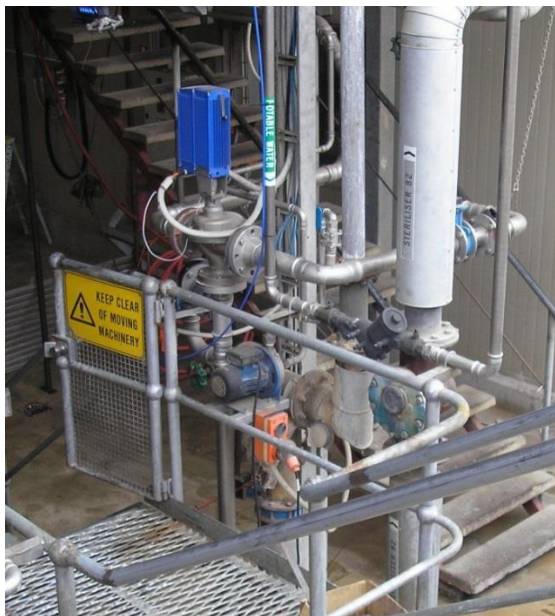
65°C mixing station slaughter floor

Due to the issues with the lack of temperature control in low flow situations, several staff members have been burnt. In response to this situation the plant instigated an over temperature control system on each wash down valve. This consists of a PT 100 positioned post return junction on the output line connected to a butterfly valve with a pneumatic actuator. The PT 100 has been set at 70° and when the output temperature exceeds 70° then the butterfly valve shuts in order to prevent people from being burnt. Unfortunately the methodology behind this safety circuit is incorrect. The fail safe system regularly caused the temperature to over shoot the 70°C set.

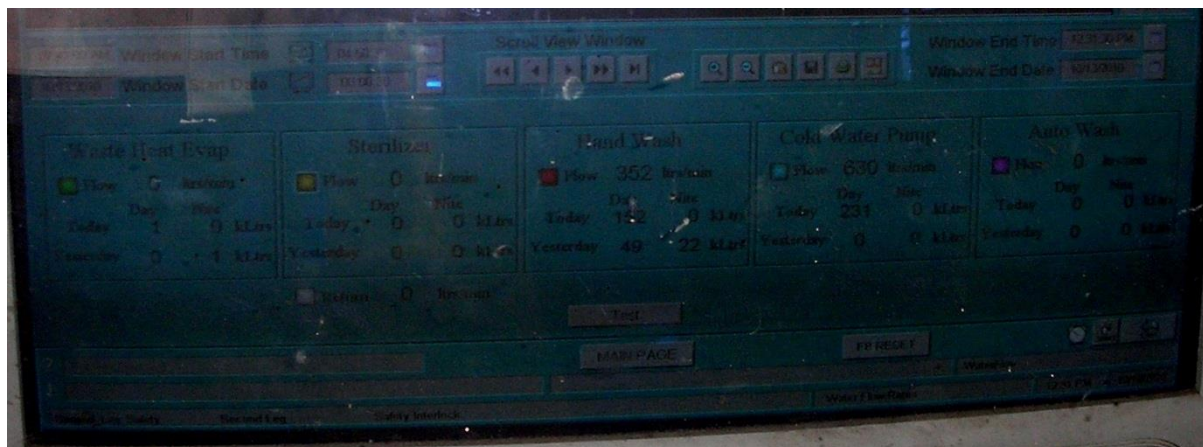
Original SCADA screen display

The SCADA was failing to record flows through the waste heat evaporator, the sterilization water and the auto wash. Whether this was caused by the flow meters failing or a faulty connection to the SCADA is unknown. The cold water pump data appeared to be accurate but there was no historical data for flows available on the summary. The hand wash data collected was inaccurate and there was no trending available. The biggest issue was that the data was spread across a series of screens within the SCADA and the data was presented in a way that provide little meaning or interpretation for staff.

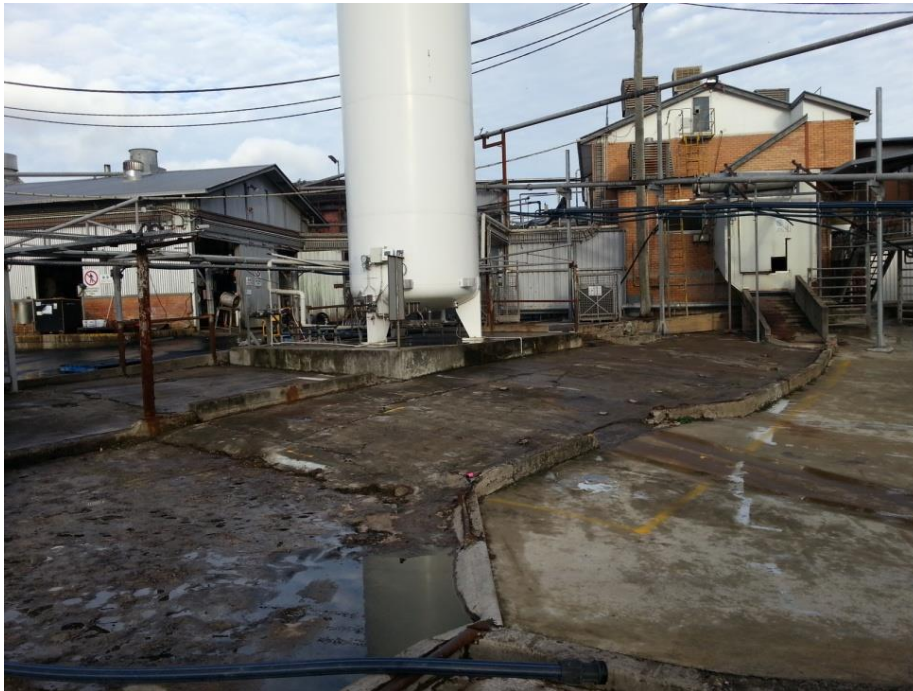
Hot water tank farm and storage facility before construction

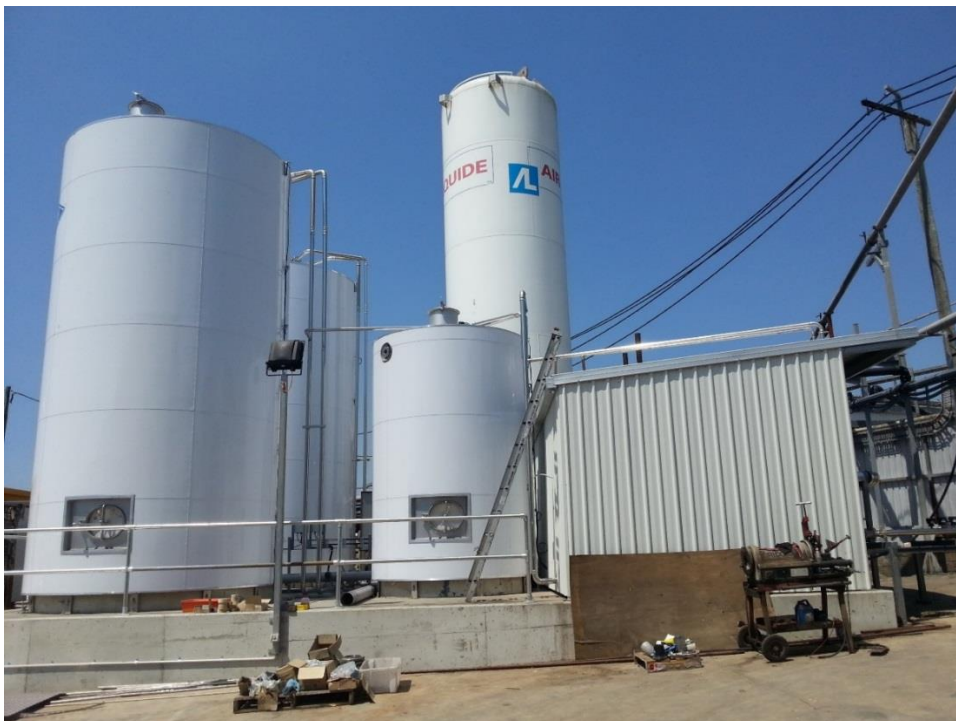
Tank farm and HW plant under construction

A tank farm consisting of two 60m³ tanks for primary storage and a 15m³ buffer tank was constructed and then erected on site. The tanks are fully insulated and sit on insulated plinths. They are connected to the HW shed by a common suction line to the primary pump skid. The HW plant is connected to the boiler via a stain main off take from the rendering department and returns condensate direct to the boiler feed water tank with a dedicated condensate return line.
