# final report

Project Code: P.PSH.0284  
Prepared by: Darren Herbert Jonathan Cook  
Date published: October 2008

## Beef Hock Cutting On Site Sensing Trials

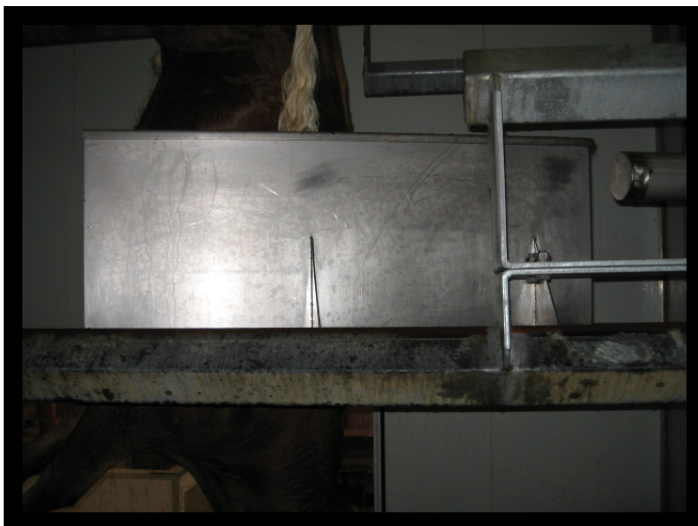
The existing stabilisation system was used as per previous trials except for the addition of a leg diverter added to the upstream stimulation rails. This diverter proved effective in it's intent to ensure legs don't hang up on the bottom stimulation rail, but caused undue swinging in medium to large size carcasses.

Figure showing leg diverter.

A relatively minor alteration to this diverter would reduce it's swinging effect on the carcasses while still ensuring legs are not getting hung up.

As mentioned previously, the leg diverter requires modification to prevent the carcasses “hanging-up” on it.

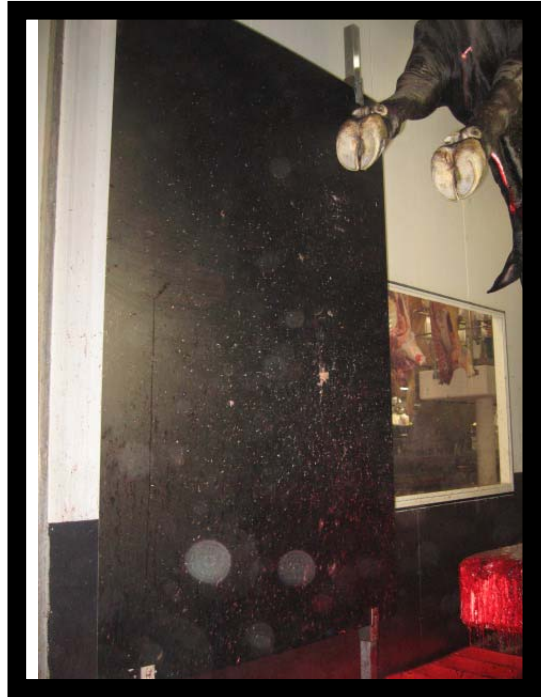
A thermal backboard was used to give a consistent background to the thermal images, the board was 2400mm H x 1500mm W and painted matt black to give the lowest possible emissivity.

Figure showing backboard setup during trials.

The thermal backboard was considered successful both for the thermal image collected and the 3D data. Due to the featureless appearance of the backboard the 3D camera had difficulty resolving measurement from it and therefore uncluttered the data.

A possible explanation for the different contrasts of the thermal images at the same temperature ranges is that the backboard became covered with particles

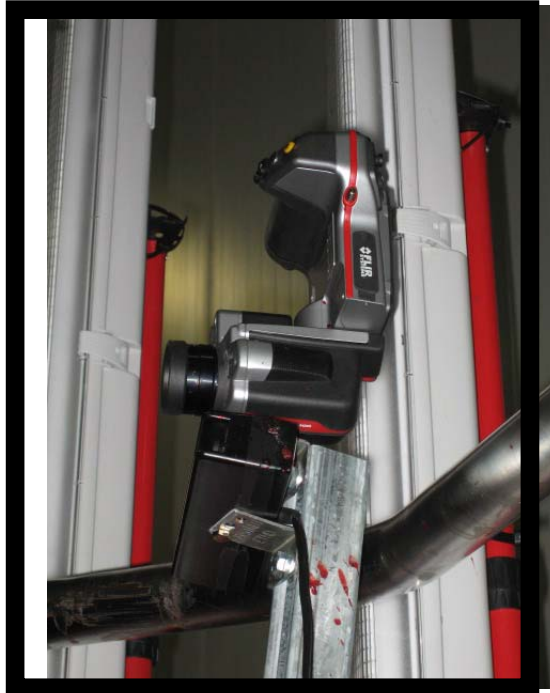
Figure showing mounting arrangement of the Thermal Camera (above) and TYZX Camera (below).

The cameras were fixed mounted on a movable stand with their lens mounted as close as practical to one another.

From the results it is further proved that the best location for the camera equipment is as per Set 2 of the data below. This setup provides the best position to prevent leg occlusion including suiting the thermal cameras field of view and site mounting requirements.

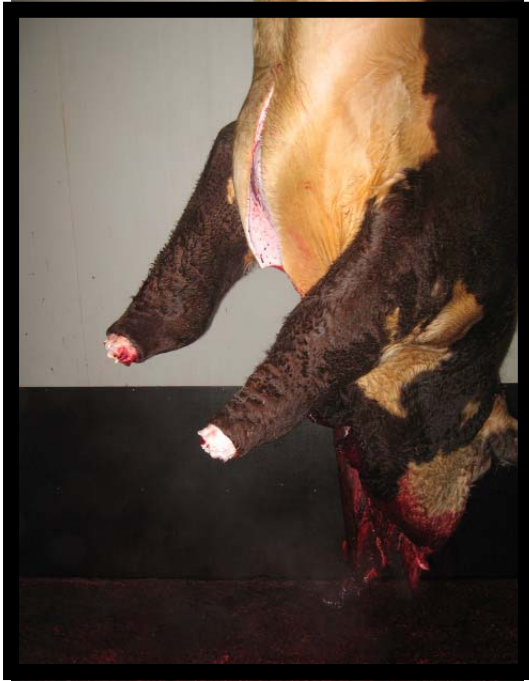
Image showing cutting region of a bull or Friesian Cow.

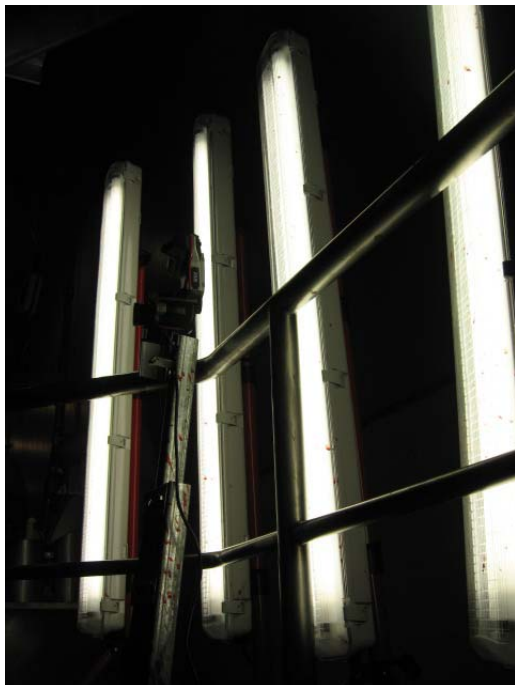
Image showing TYZX camera lighting.

The 3D camera lighting used was 4 off twin 4' cool white 36W fluorescent tubes driven by high frequency ballast and enclosed in IP56 poly enclosures.
