final report

Project code: P.PIP.0211
Prepared by: Gavin Inglis
Machinery Automation and
Robotics
Date published: March 2010

Robotic Front Sani Vac at Castricum Bros, Dandenong Victoria

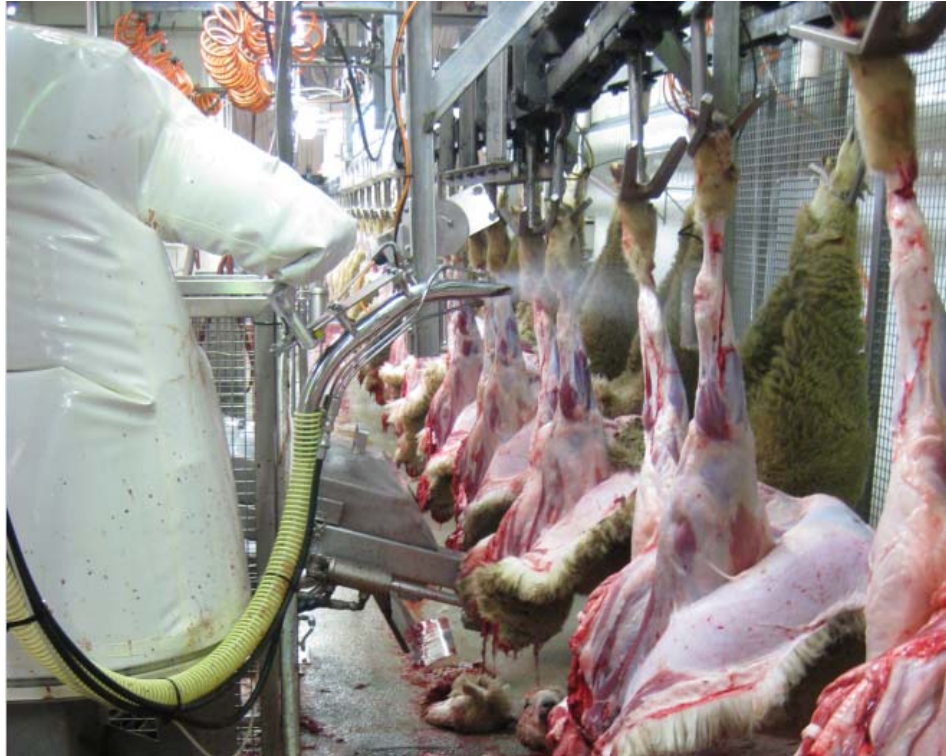
The Robotic Front Sani Vac System was installed and commissioned at Castricum Bros in Dandenong Vic during October and November 2009. The images in Fig. 1 and 2 show the installed system:

The 'new' tool is shown onsite in Fig.1 above with a closer view shown in Fig 4 below.

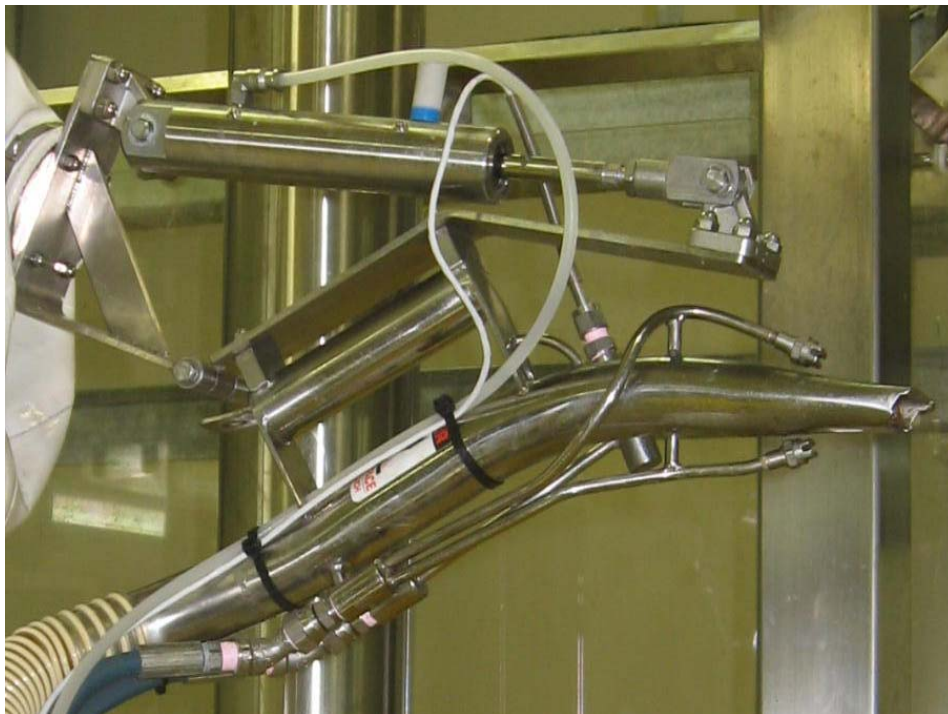
The 'old' tool is shown in Fig.3

Modifications made to the tool have improved the compliance of the tool thus reducing the 'pushing' effect of the tool on the carcase. This in turn has resulted in greater stability of the carcase and hence a more accurate Vac Saning process. This modification has also reduced the weight and complexity of the tool allowing the system to

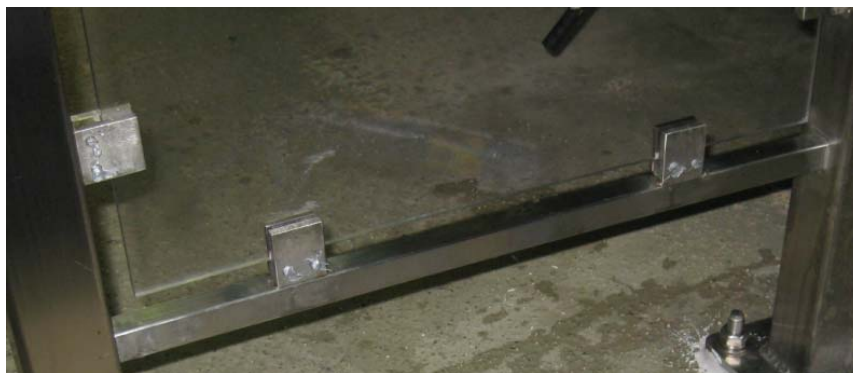
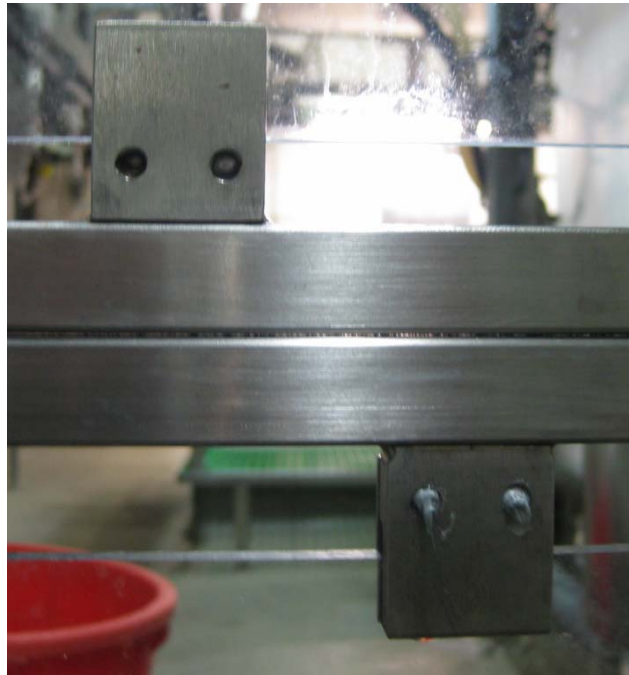
Modifications were made to the method of securing the Perspex guarding in place. It can be seen below in Figures 5 and 6 that the guarding is retained by a 'holder' rather than a clamp allowing the Perspex the ability to expand and contract in line with temperature changes during cleaning without causing cracking. This is an improvement in the old method of holding the Perspex where it was securely bolted into position which resulted in cracking of the Perspex as it expanded and contracted due to temperature changes.

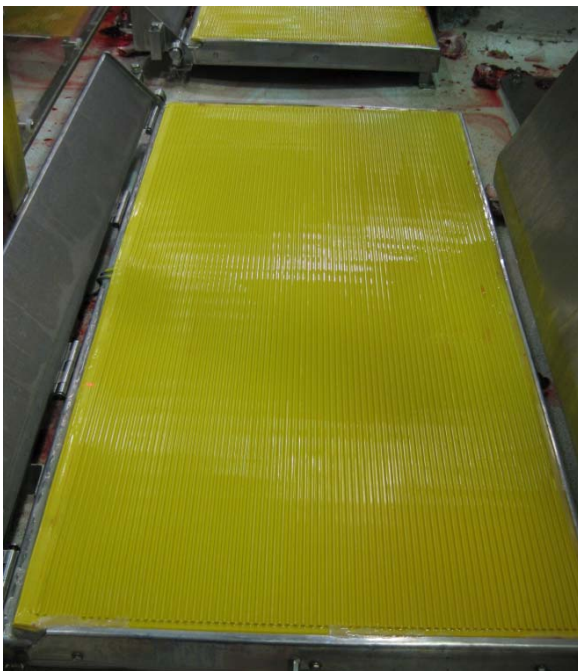
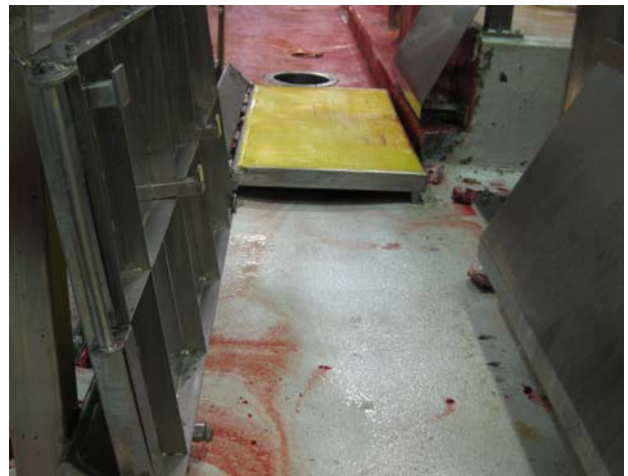
For the previous installations at Peel Valley and Burrangong, the safety mats had been mounted onto hinged platforms. This allowed the safety mats to be relatively low to the ground and allowed them to be lifted for cleaning as shown in figures 8 and 9 below.

This has caused issues with faults occurring with the safety switches required to ensure the platform was in the lowered position before production commenced. For the installation at Castricum Bros, a change was made to mount the safety mats on fixed platforms shown in Figure 10. The platforms were raised higher off the ground to enable cleaning underneath and are fixed in position, hence avoiding the issues with safety switches previously encountered.

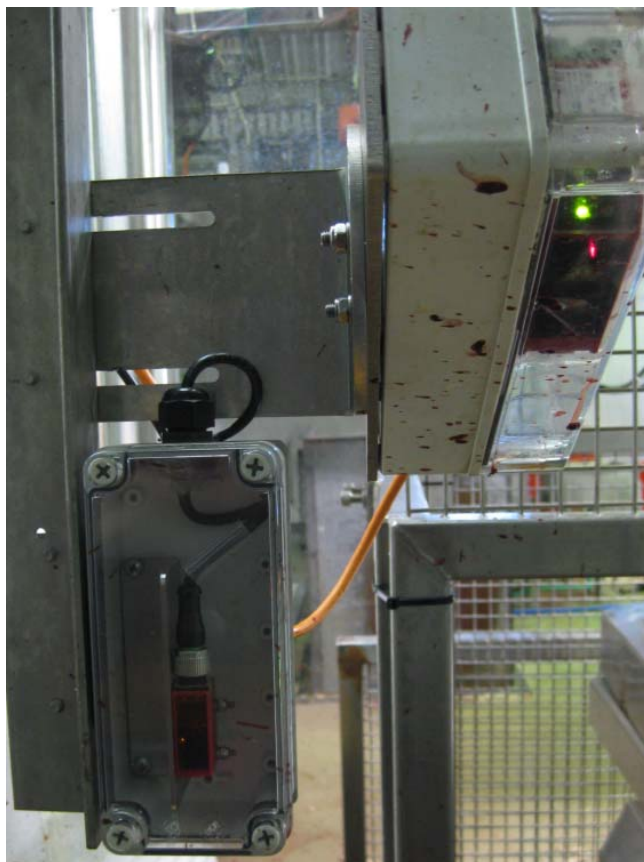
Fig.12

Due to issues with water ingress into sensors on installations at Peel Valley and Burrangong, sensors have now been placed inside enclosures, as shown in Figure 12 below, to protect them from the high pressure wash down water. In addition, the sensors are mounted at a higher position relative to the carcass due to gambrel design and line speed. This will also assist in eliminating any erroneous readings that may be experienced due to the water and steam from the vac san tool.
