Final report

LEAP IV Middle System Performance Upgrades and Value Engineering

Project code: P.PSH.1303

Prepared by: A. Soundy, M. West, S. Maunsell
Scott Automation and Robotics

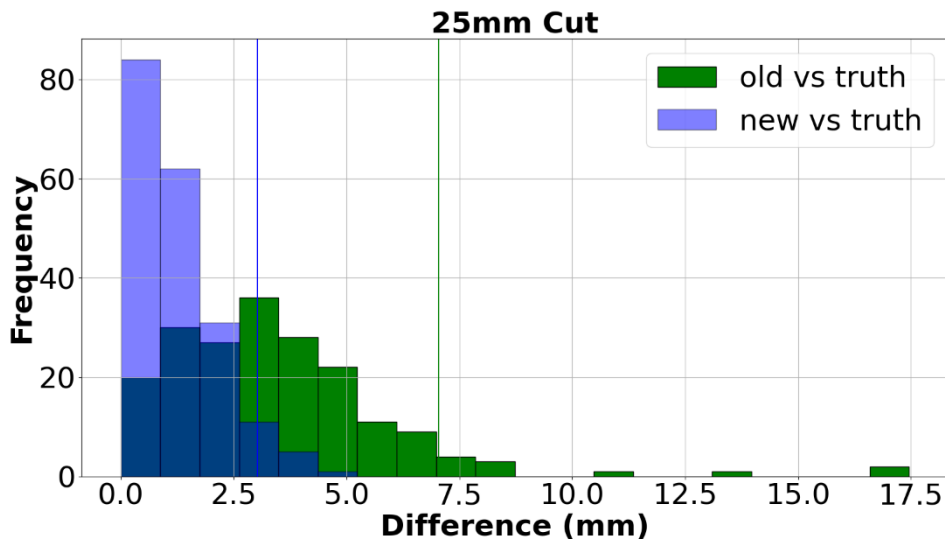
Figure 3: Comparison of the errors in the new analysis (blue) and the existing analysis (green) for the 25mm rack flap cut. The vertical lines show the 95th percentiles for each analysis.

Histograms for the rack cuts are shown below with the 95th percentiles shown in vertical lines in order to better visualise the improvements offered by the new analysis.

A key metric of interest in the results above is the 95th percentile. The 95th percentile is used to specify the accuracy of Scott machines for any given cut. For example, the rack flap cut is currently specified as 95% of products within the range of ± 7 mm. This aligns well with the results of the existing analysis, where the median value across the four cut lengths for the 95th percentile is 6.85mm. For the new analysis the median value across the four cut lengths for the 95th percentile is 3.2mm. In terms of machine performance, these results show the new analysis to be more than twice as accurate as the existing analysis.

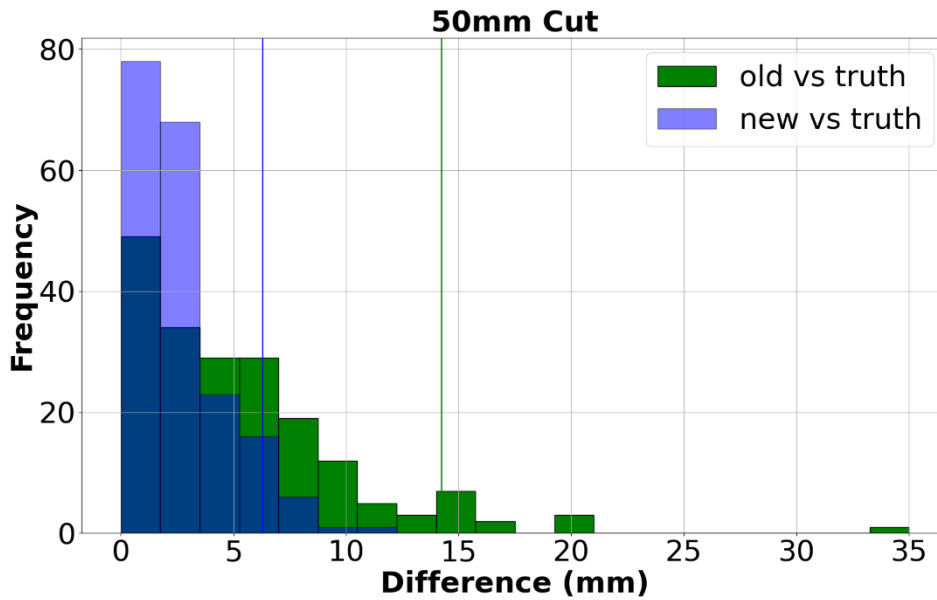
Figure 10: Comparison of the errors in the new analysis (blue) and the existing analysis (green) for the 50mm loin flap cut. The vertical lines show the 95th percentiles for each analysis.

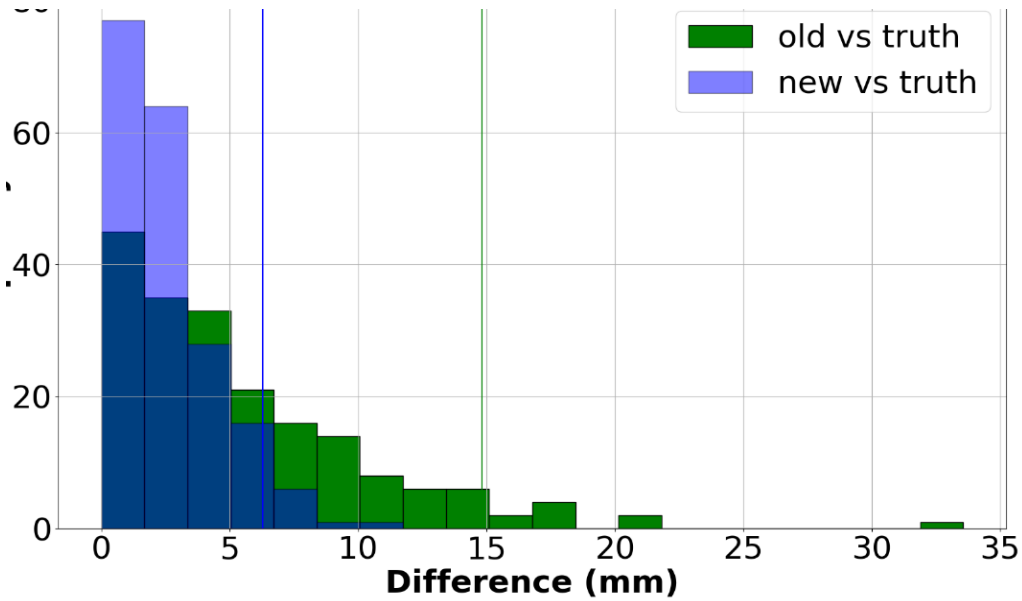
Figure 11: Comparison of the errors in the new analysis (blue) and the existing analysis (green) for the 75mm loin flap cut. The vertical lines show the 95th percentiles for each analysis.

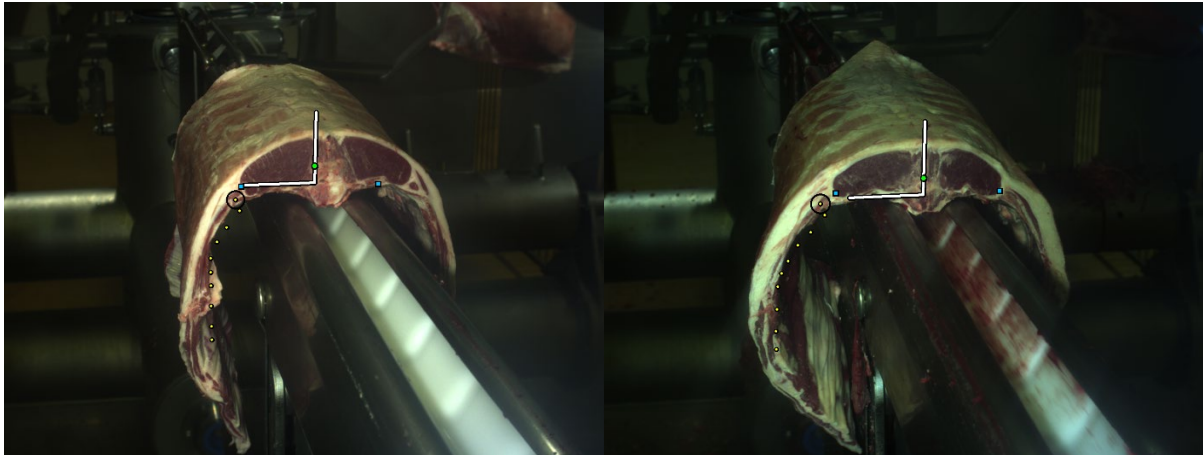
Product position – Source of Error

Figure 13. Currently the position of the front face of the product at camera 3 (half camera) is calculated from x-ray data and provided to the middle analysis. If this is incorrect (and it is incorrect by up to $\pm 20\text{mm}$) then the image appears like the left-hand image where the projected axes do not align with the featherbone and the bottom of the product (see the right-hand side for where the axes should be). This error means that the pixel to mm calculation is off and so even if the eye meat is found correctly then the cut position will still be incorrect.

An example of an incorrect product position is shown in the left-hand image of Figure 13.

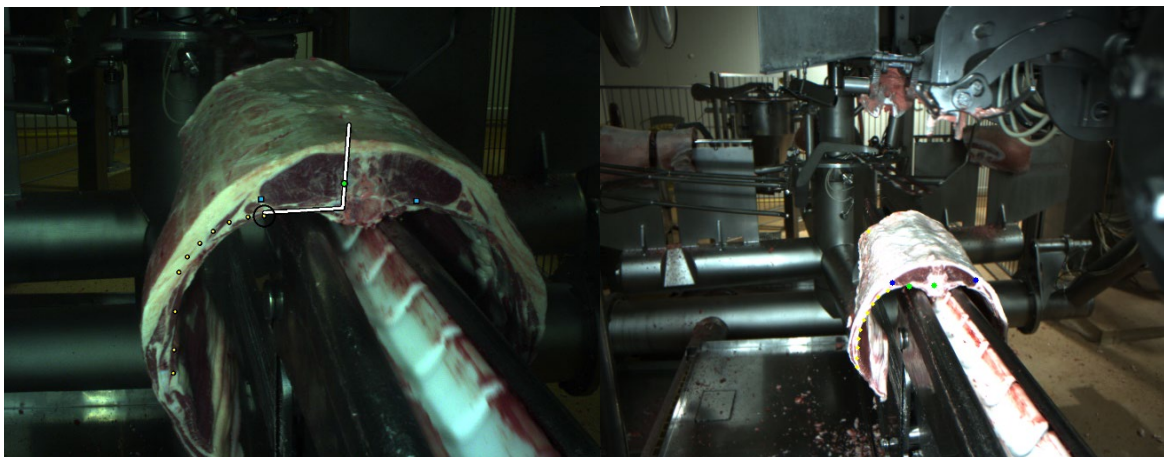
Figure 16: The left-hand side image shows the existing analysis using the provided product position, which shows the face of the loin being further forwards than expected. The right-hand side image is from the and has directly measured the product position.

Figure 16 shows the existing analysis (left-hand side) and the analysis from the (right-hand side). The green point in the centre of the product indicates where the spinal cord hole should be, note that the existing analysis has the point on the left-hand side of the spinal cord hole which indicates that the product face is further along the rail than expected. Note in the new analysis that the spinal cord hole indication (the right-hand green dot) is in the centre of the product.

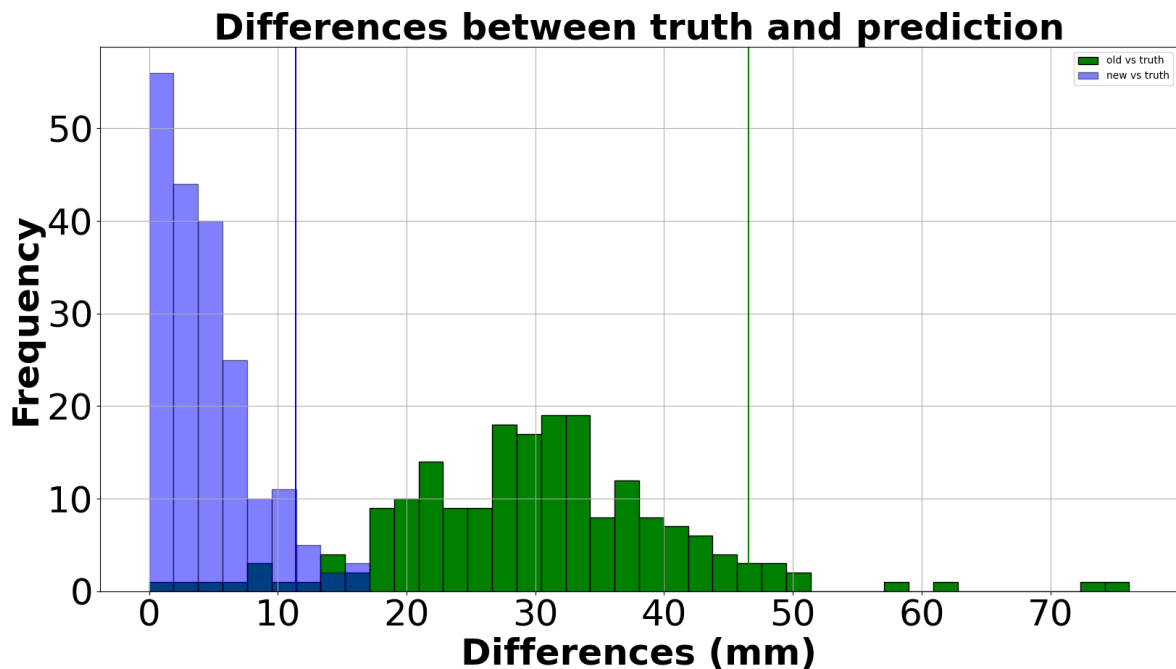
Figure 17: Comparison of errors in x-ray derived product position (blue) and AI technique derived product position (green). The 95th percentiles of both are shown as vertical lines.

In the histogram below it is clear that the derived product position represents a significant improvement, not just on average but especially for the maximum error. With the maximum error of the derived product position at approximately 16mm, the maximum error of the x-ray derived product position is more than 70mm, representing an improvement of more than a factor of four.

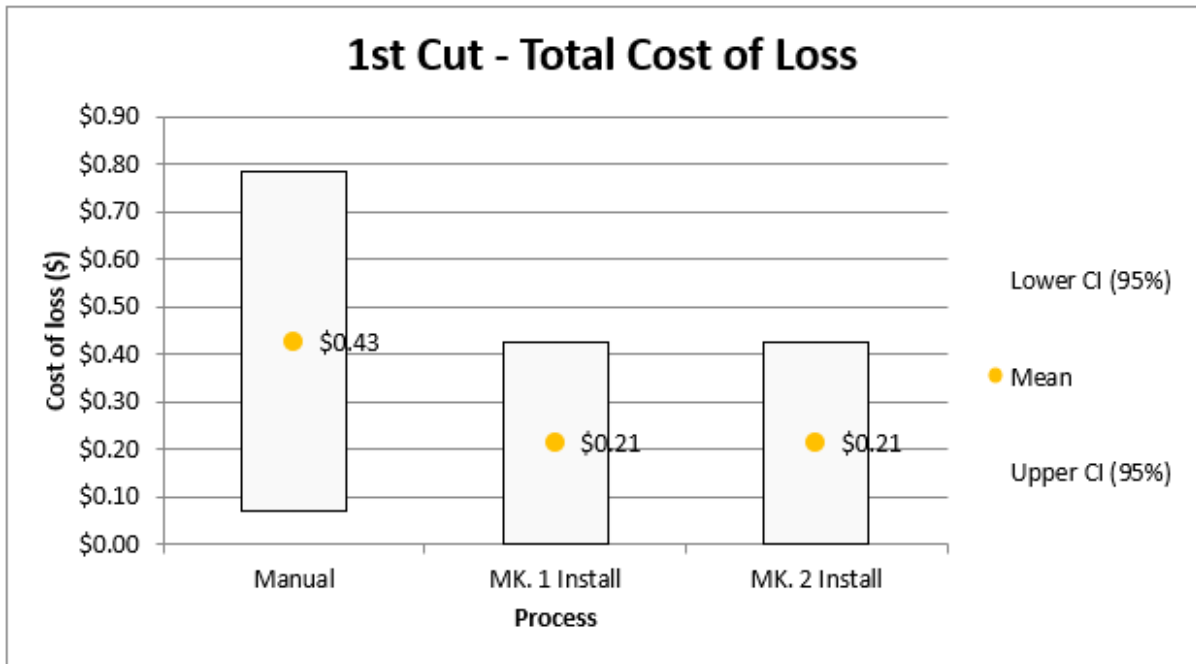
Figure 19: Total cost of loss for the removal of flaps from racks.

The combination of the 7 different cutting specifications were used to calculate the value of loss attributed to the savings as shown in Figure 19. The yield benefit across these specifications has caused substantial reduction in the cost of loss between manual and the automated performances in Figure 19.

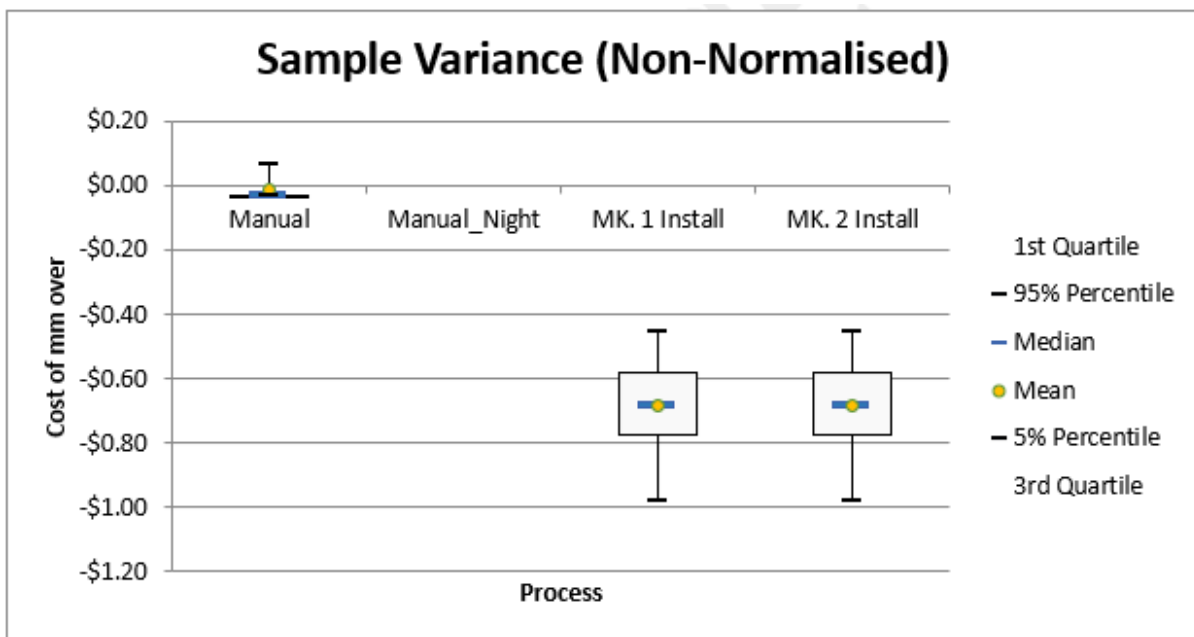
Figure 21: Total value of loss due to the variation in the angle of the shortloin pair to rack cut.

The total value of loss per head demonstrated by this cut is between \$0.64 and \$0.70/hd according to ex-post results.

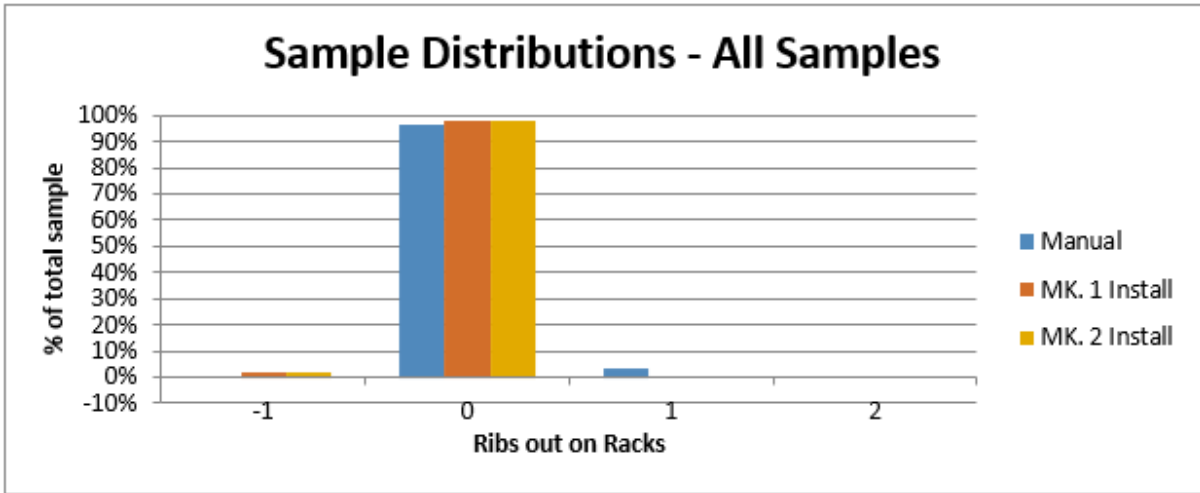
Figure 22: Value of loss associated with cutting the incorrect number of ribs, the peak at 0 is the ideal number of ribs and the “1” peak is 1 additional rib.

The variations in costs shown below are only for an 8 rib rack which demonstrated the greatest variation of all the cutting specifications.

The two peaks in Figure 22 are representative of 0 and 1 ribs missing from left to right respectively.

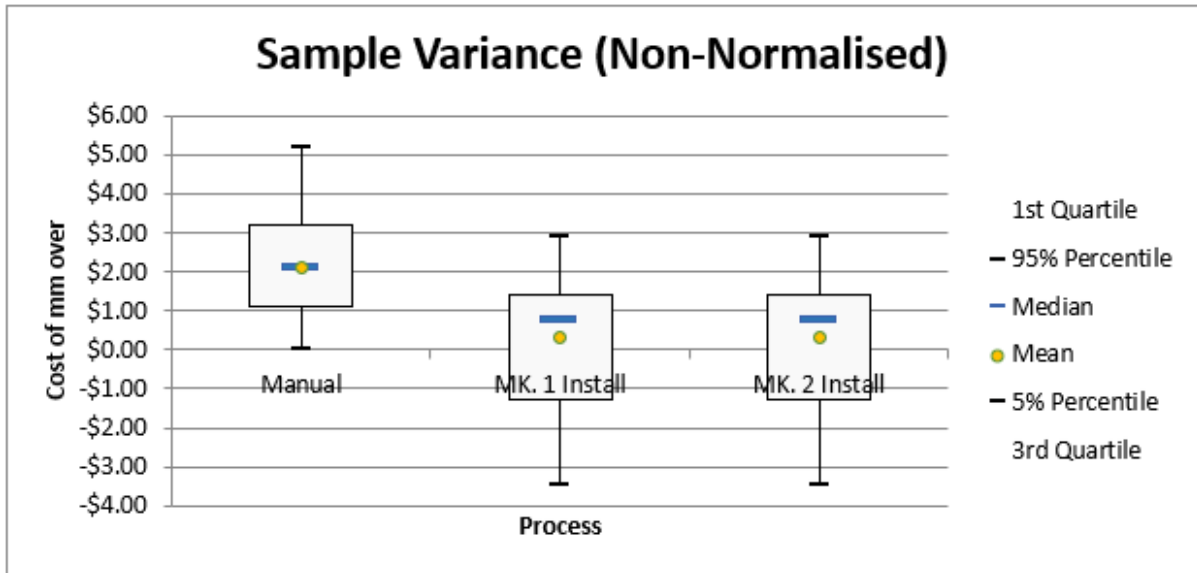
Figure 24: Value of loss attributed to maximising the weight of the rack from the shortloin.

Optimising this cutting line represents the largest value opportunity of the automated system. The variation on this cut can be observed in Figure 24. The ideal location of this cut varies between cutting specifications. For 9 rib racks the maximum width from the 8th rib is 100mm whereas with a frenched 8 rib rack the maximum width is only 22mm. The value of loss was estimated by maximising the weight of the rack without causing a half rib to protrude into the frenching line.

The automated system demonstrated it was able to identify the ideal location of the cut on unfrenched products. The variation in value attributed to this cut for the 100mm frenched rack is shown in Figure 24.

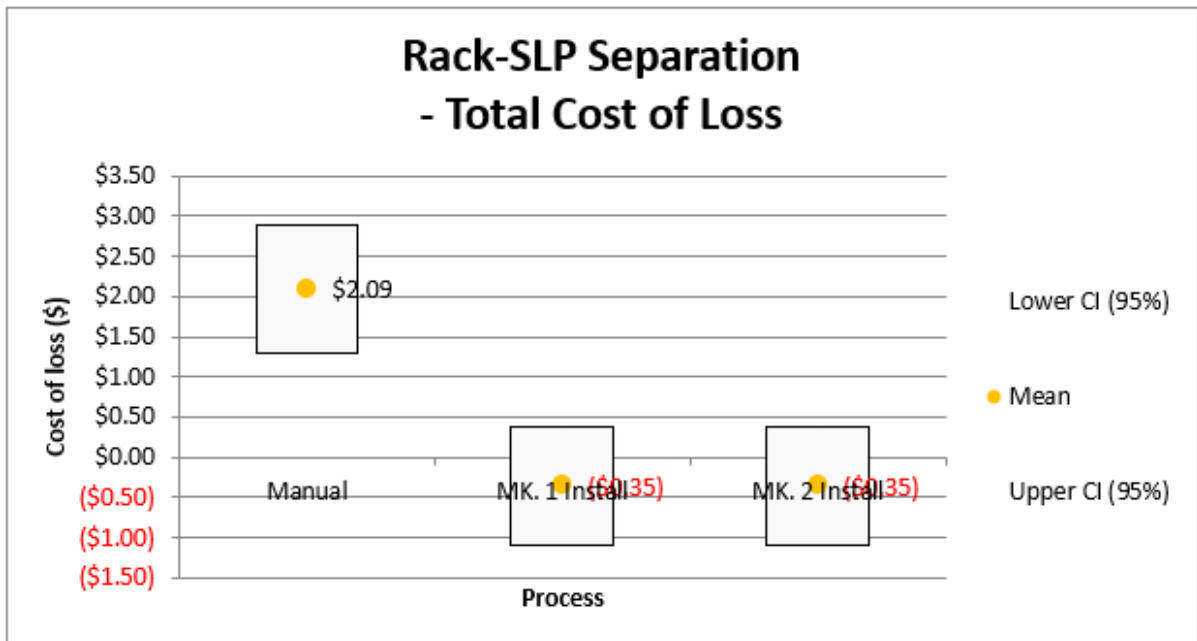
Figure 25: Total value of loss attributed to separating the shortloin pair and rack.

The total value attributed to the cut between the Shortloin pair and the racks for all 7 cutting specifications can be seen in Figure 25.
