# final report

Project code:	P.PIP.0036
Prepared by:	Chris Sentance
	Food Safety Services Pty Limited
Date submitted:	April 2007

## Novel meat meal and cake handling to prevent salmonella contamination and growth

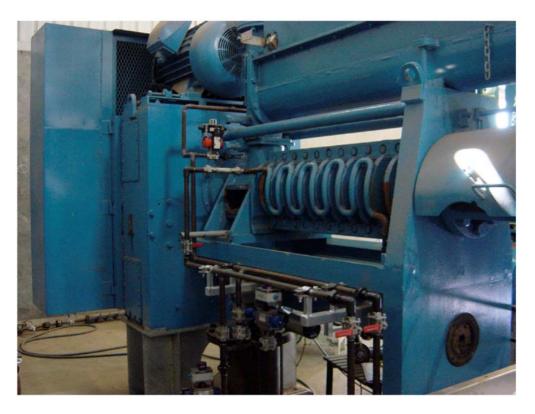
*Photograph 1* -. Press steam supply. The upper feed supply is direct to the press throat, the lower to the barrel preheating coil • Steam preheating of the presses.

Provision of direct steam injection to the press feed throat has provided the ability to reduce load on press drives more rapidly than by opening the choke. The addition of heat and moisture effectively reduces the press load. Steam supply to the throat is by an automatic control loop activated by the amperage load of the press motor.

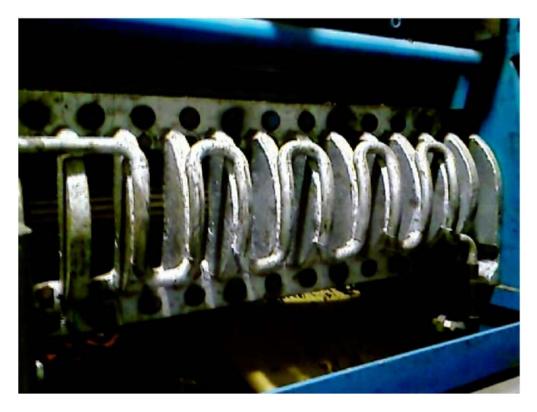
Photograph 2 - Preheater coils welded to the outside of the press cage

The attachment of steam coils to the outside of the press cages and supply of steam at 2 bar pressure has allowed the press to be preheated and 'sterilised' prior to commencement of production. This has allowed the minimal collection of reprocess material at start-up. Less than half a wheelbarrow load is recycled at press start-up. This material has been heated sufficiently to eliminate the need to fully reprocess it so that it can be returned with the decanter fines to crax screw and blended with pre-press material.

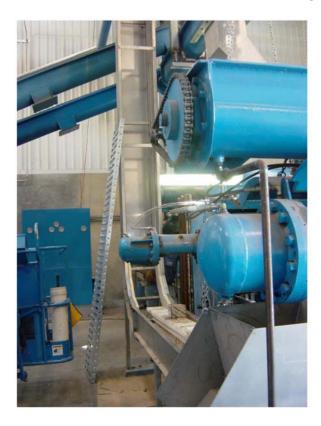
Photograph 3 - The lower press discharge section frame

• Intralox belts from screw press's to cake bins. A single piece Intralox belt elevator effectively carries cake from the presses to the cake bins without the use of enclosed screws that can trap condensation. The horizontal lower (exiting the presses) section and the upper (entering the bins) section are able to remain uncovered to allow maximum ventilation, as they pose no safety risk. The vertical section is enclosed but is open at top and bottom to maximise ventilation. This system is very effective at transporting cake. No sign of condensation has been evident even though the system is naturally ventilated without the need for forced ventilation.

Photographs 3, 4 and 5 show the components of the Intralox belt elevator during construction. Photograph 6 shows the Intralox elevator in use.

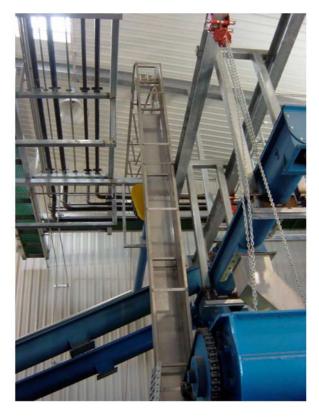
Photograph 4 - The vertical section and upper horizontal section frame

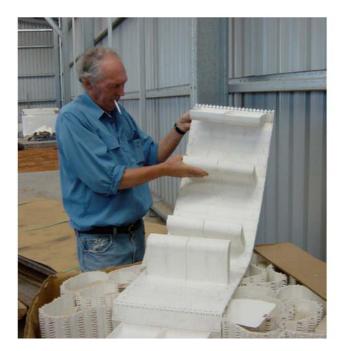
Photograph 5 -. Anton Reiter demonstrating the flexibility of the Intralox belt

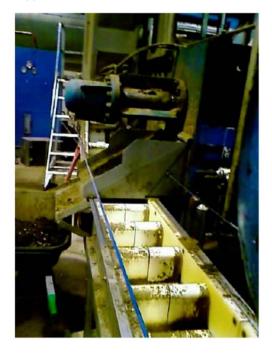
Photograph 6. - The Intralox belt elevator in use
