final report

Project Code: PRTEC.007

Prepared by: Philip Boyce, Kym MacRae, Jeff Owen & Peter Ring
Food Science Australia

AUTOMATIC CARCASS SPLITTER: Trial and Optimisation of Commercial/ Works Prototype

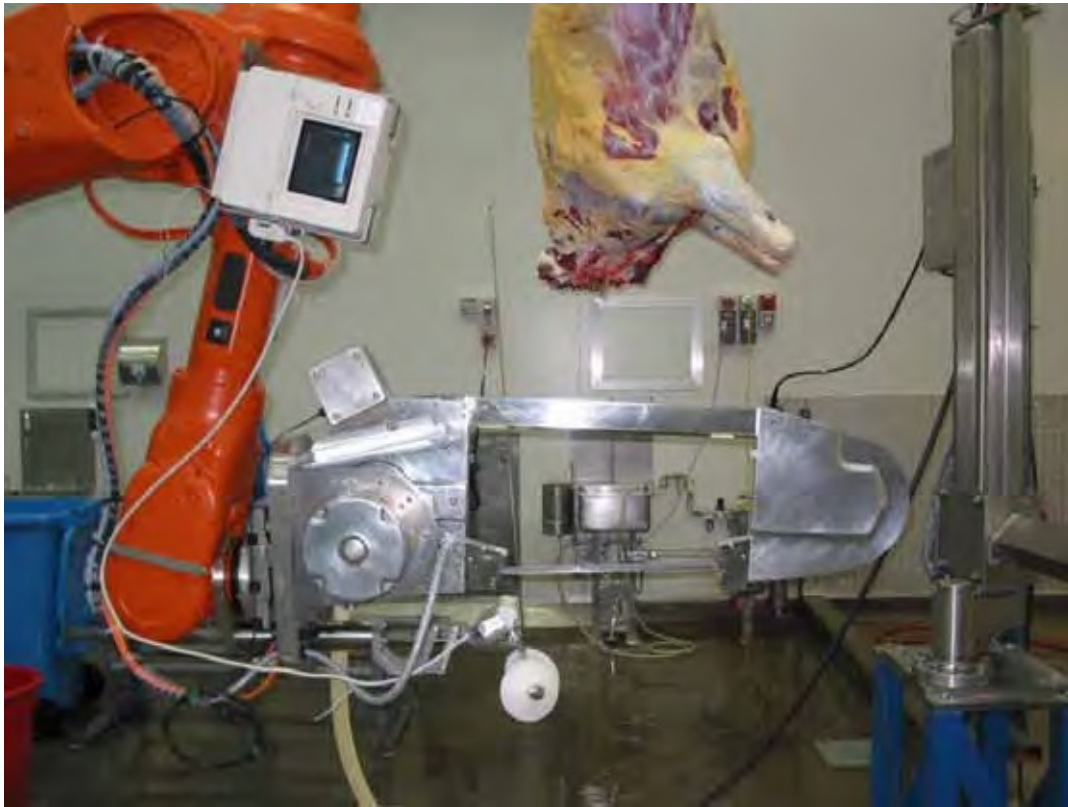
Figure 2-1 Ultrasound Mount

Off the shelf ultrasound units of the type selected are supplied with a 2m long tuned cable. A cable of this length requires the fragile ultrasound unit to be mounted out on the robot arm where it is subject to vibration and violent motion. All attempts to find a manufacturer who would supply a longer cable were unsuccessful. Attempts to lengthen the cable on the original Shimadzu probe showed some promise, but significant signal degradation occurred and it was decided that the standard cable would be used. It was also decided that, rather than trying to lengthen the cable, future commercialising work would include remanufacturing the essential components of the ultrasound unit into a smaller, more robust industrial enclosure that would be mounted on the robot arm.

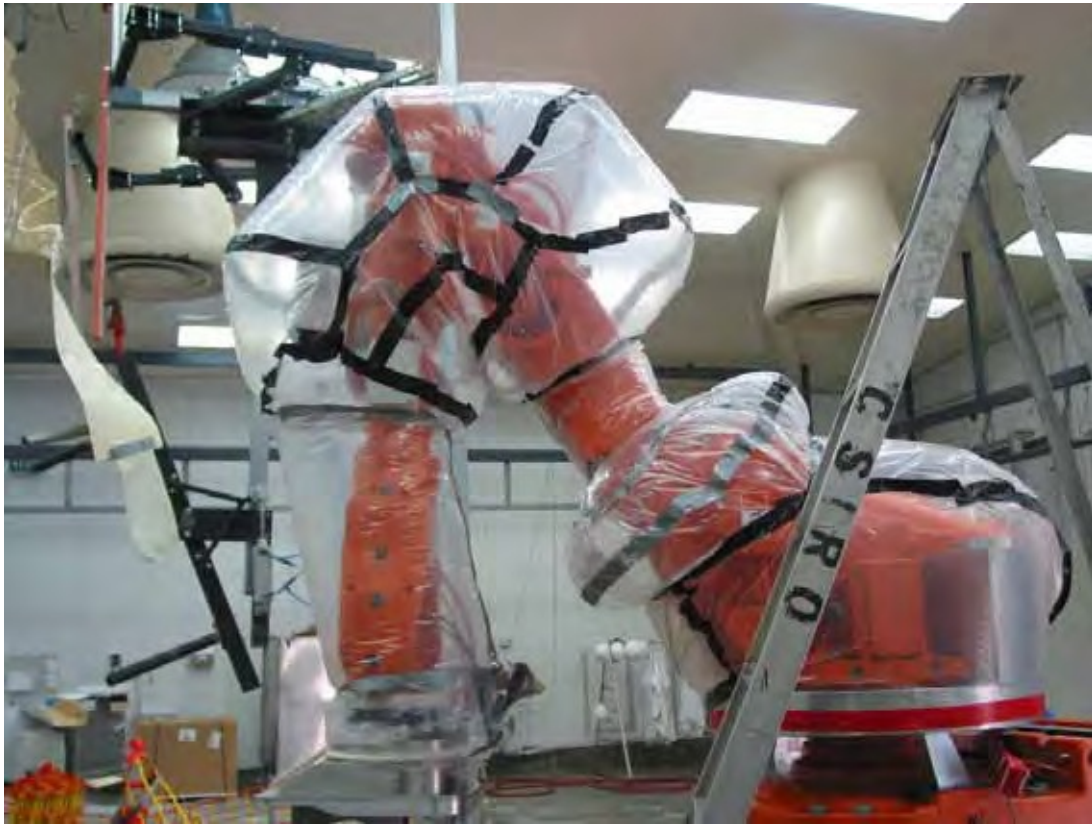
Figure 2-7 Cover Template

A spray-on silicon was applied to the inside of the bag and allowed it to slide over the robot. This assists installation and removal of the bag as well as well as reducing wear while in use.

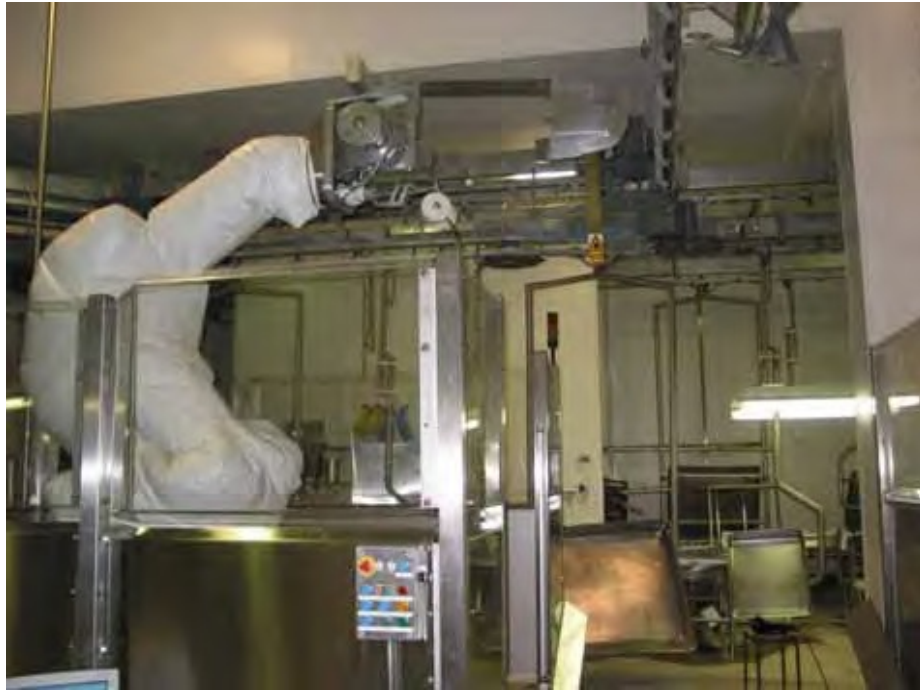
Figure 2-8 Safety Cell at Ralph's Meat Company (Note: Main control panel)

- To maximise the safety of any operators using this equipment it was decided to have 2 operator panels. The main panel contained the manual positioning functioning keys as well as the “Emergency Stop” and “Start” buttons; these were also located on the secondary panel. To start automatic operation of the system both operators must activate the “Start Auto” buttons with the robot in the correct position after conducting a visual inspection that the robot cell is vacant. Residual risk of a person being left inside the safeguarded space during restart was minimised by a pre-start warning consisting of flashing light and ensuring that 1 operator cannot operate both panels as they are located at the entry and exit sides of the cell and there is a time for activation constraint built into the system. The main panel also had a keyed isolation switch restricting operation to authorised trained personnel.

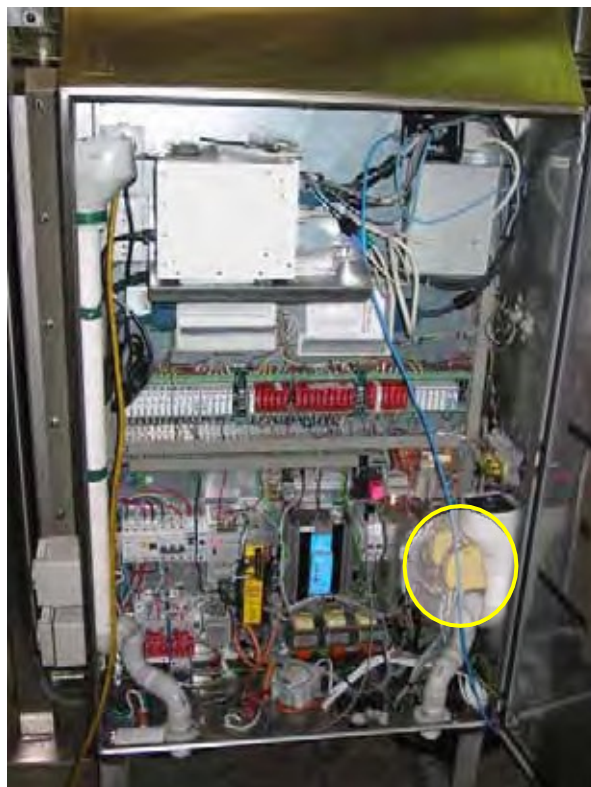
Figure 2-10 Inside slaughter floor control cabinet showing location of safety relays

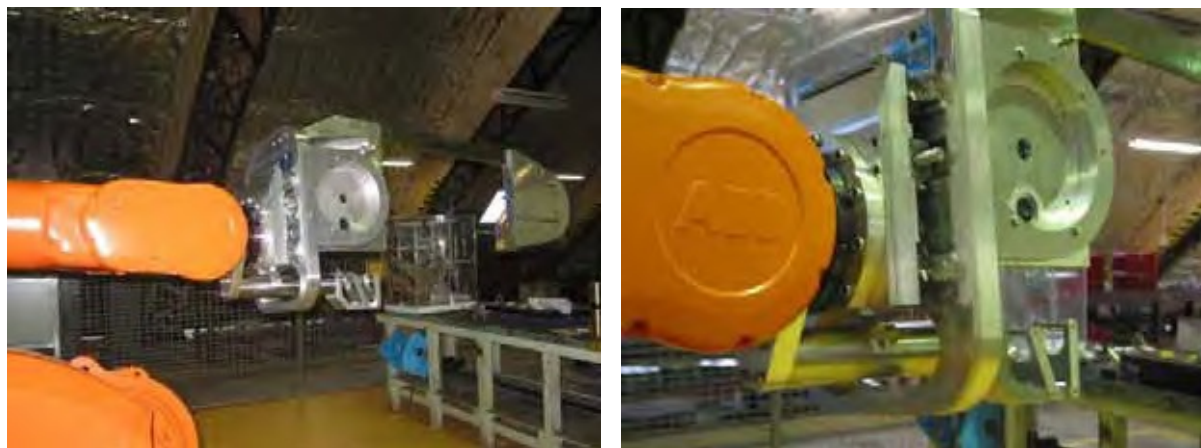
At the end of each split the traverse position was recalibrated by performing a travel to one of the limits of the travel, then returning to the centre of travel. This removes any inaccuracies of the position of the traverse systems that may have occurred due to creep.

Figure 2-13: The traverse motor controlled the movement of the saw from side-to-side and was part of the robot end-effector

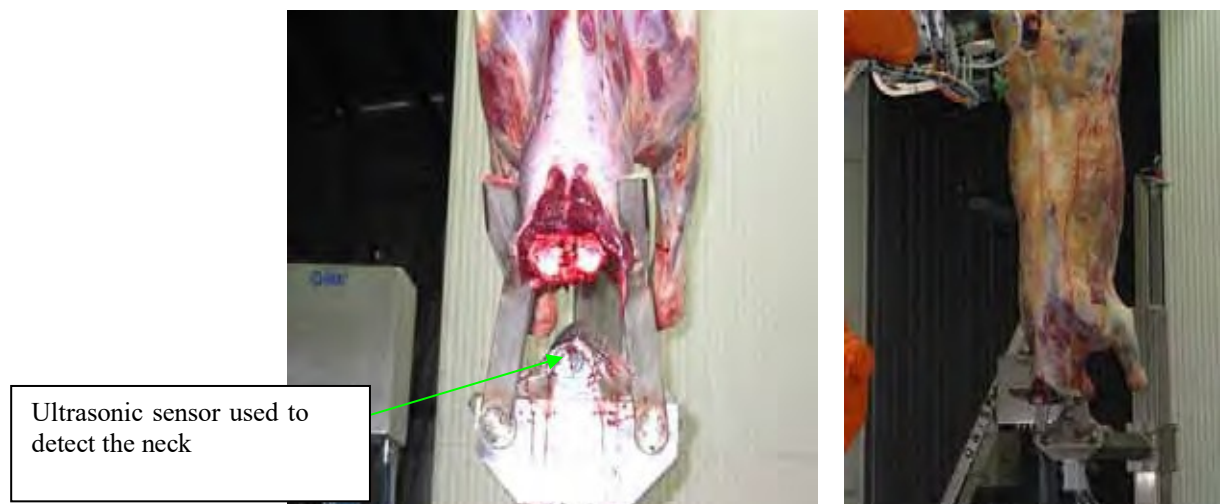
Limiting the minimum downward speed and selecting a balance of when to disengage the neck stretcher had to be found, to allow enough time to get the neck stretcher safely out of the way of the saw path. To help alleviate some of the problems encountered with the carcass swinging during the saw tilt, and during the neck release, the speed of the in / out movement was reduced at the saw tilt point.

Figure 2-17: The neck stretcher in place showing the ultrasonic sensor used to detect the bottom of the carcass and the jaws pulling the carcass down during the cut

One of the problems encountered was the slowing of the cut speed at step 12. If the saw cutting speed halted or got too slow when the neck stretcher released the carcass, the carcass had tendency to swing away from the saw. This was caused by a combination of the ultrasound parallelogram pressure pushing the carcass, and there being a reduced amount of product for the saw blade to cut. The partially cut carcass was also more flexible and moved more easily. The robot tried to compensate and chased the carcass forward. However during that time the carcass had swung back and the saw now had product to grab and pulled the carcass harder towards itself further compressing the ultrasound parallelogram. The robot/ control system overcompensates, tries to move away from the carcass, but by then the parallelogram is pushing the carcass away, and a resonant frequency starts to take effect causing the carcass to move out of control.

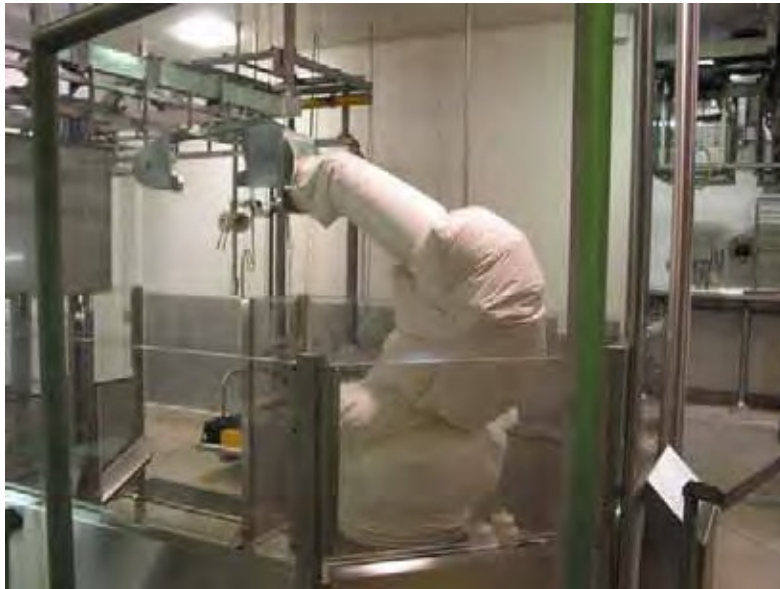
The automatic splitting saw system was installed in a category 3 safety cell on the Ralph's Meats slaughter floor.

Figure 2-20: Automatic splitting system installed at Ralph's Meats in a category 3 safety cell.

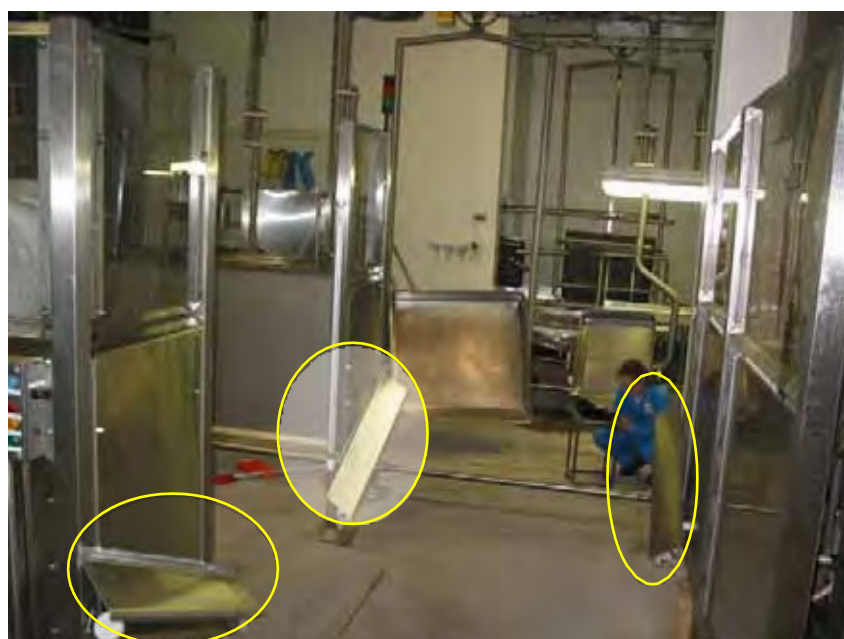
- the saw be protected by 2 safety contactors
- the robot S4C controller required full safety chain connection to both inputs of its twin safety chain comparison monitor
- the safety cell must be isolated from person entry

Figure 2-24: The safety cell entry is protected at entry and exit by light curtains

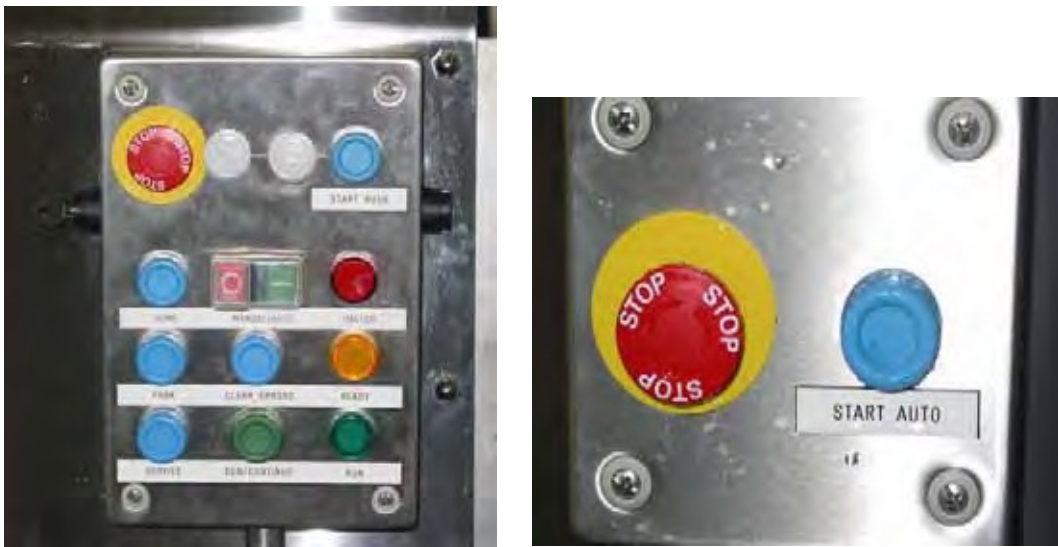
The reason for having two slaughter floor control panels was to meet safety requirements. This meant two people were located at the entry and exit of the safety cell, and those operators using visual inspection could ensure that there are no people inside the cell before the splitting saw was placed into the automatic cutting mode.

Figure 2-25: The Primary and secondary slaughter floor control panels provide the operator interface in the harsh environment of the slaughter floor

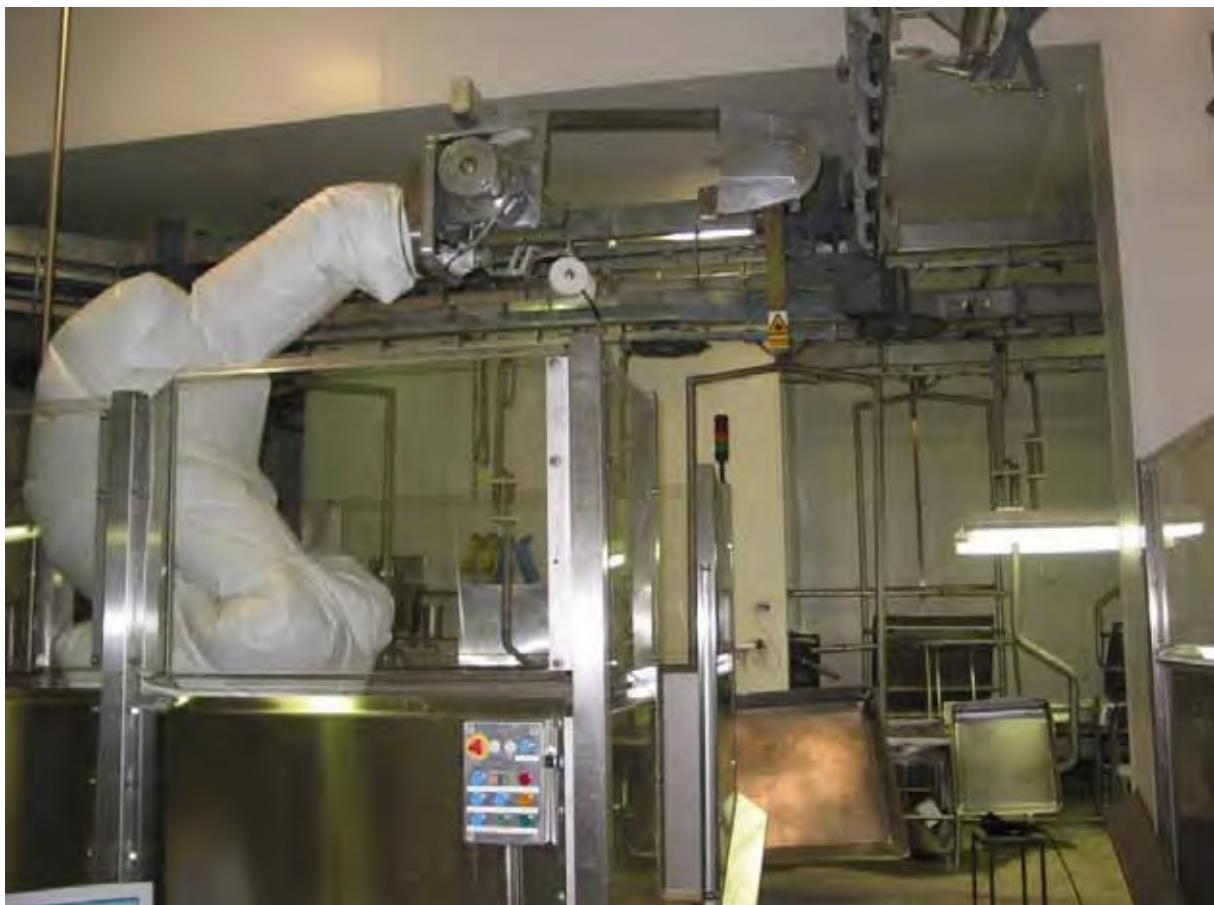
The primary slaughter floor control panel has the operator interface to allow “manual” driving of the splitting saw as well as the interface for resetting the splitting saw. The secondary control panel has only an emergency stop button and automatic mode start button.

Figure 2-26: The primary slaughter floor control panel is located at the exit of the safety cell

- **Clear Errors**
 - This button resets the light curtains at the entry and exit of the safety cell when pressed. All software stoppage errors (saw error / communications errors) are also then reset. When the button is released a set of timed signals is transmitted to the S4C controller to reset the robot errors (caused by a break in the safety chain for example) then to place the S4C controller back into automatic mode.

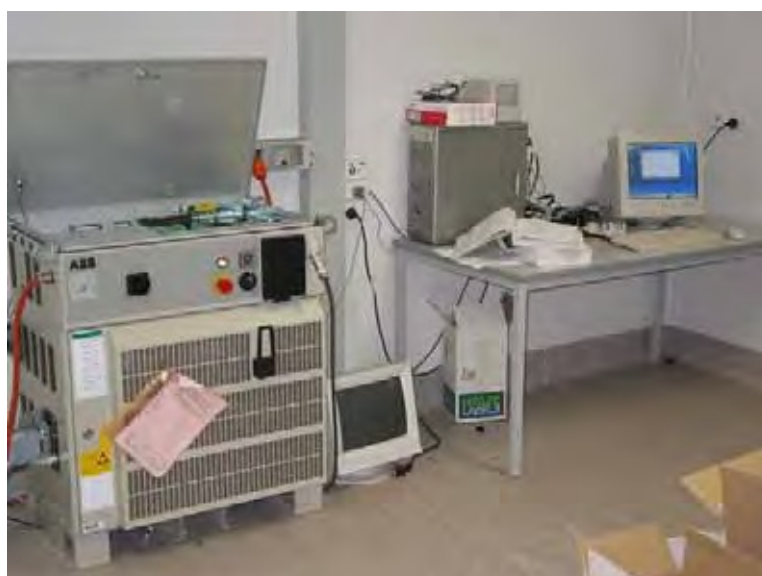
Figure 2-28: Inside the control room electronic components could be protected from the harsh environment of the slaughter floor. Later the screen and keyboard for the PXI controller would also be located in this room

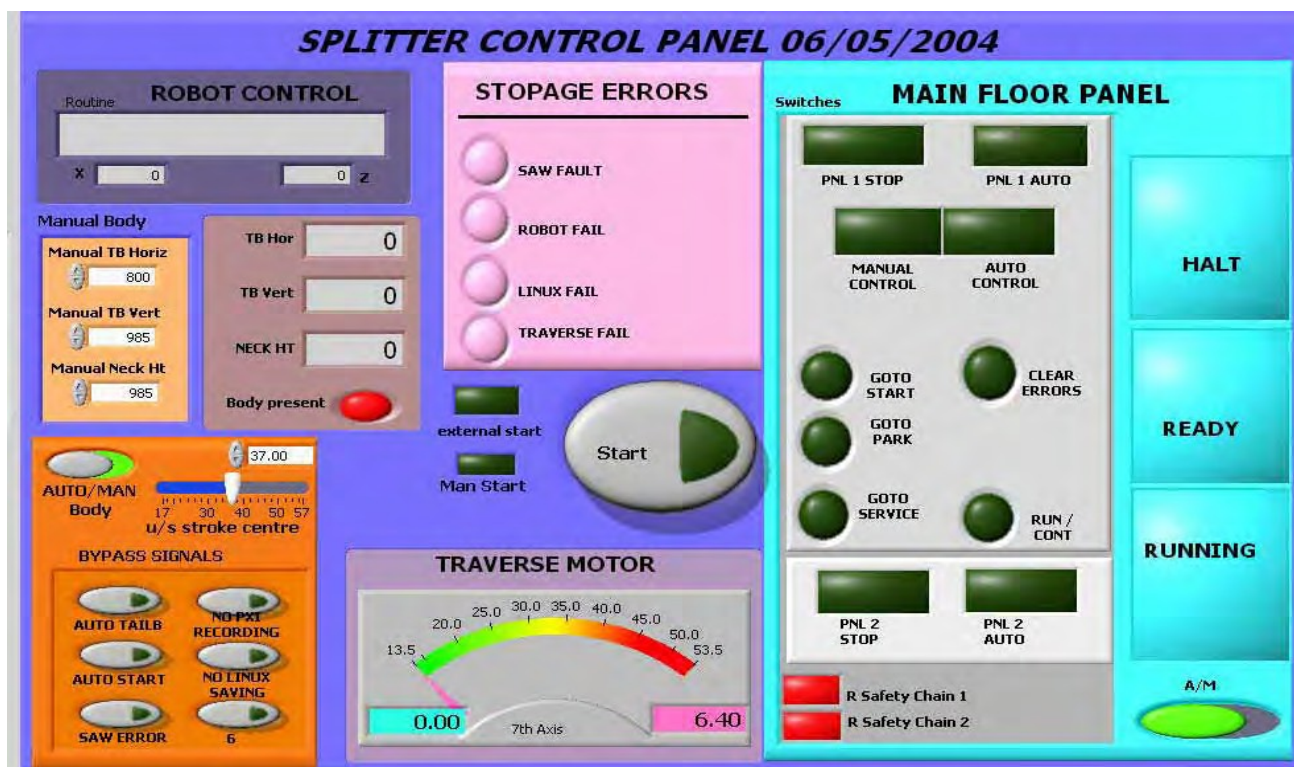
As part of this project a technical user interface providing information on the status of the splitting saw system was developed. The user interface panel was a graphical display similar to most standard windows operating system software. Figure 2-29 and Figure 2-30 show this technical operator panel.

Figure 2-29: Technical user interface for the main PXI control unit

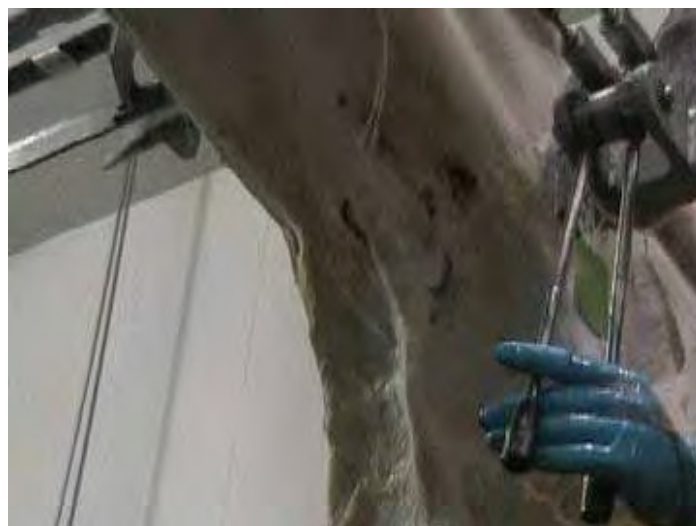
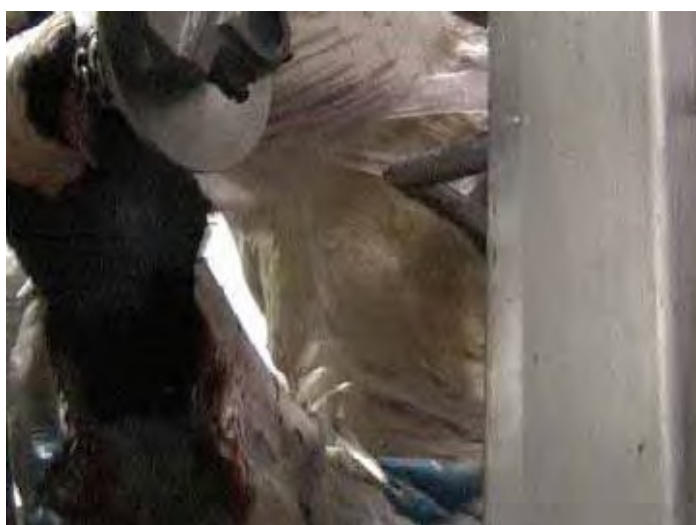
Figure 3-8 Upward Hide-puller at Ralph's (top)

In plants processing large numbers of animals within minimal times (approximately 60 seconds cycle time for Ralph's) a hide pullers are used. Carcasses at Cannon Hill are hand-skinned with a knife. An attempt was made by project staff to simulate downward hide pulling using a forklift which showed comparable results to knife prepared carcasses. However, in view of developments during commissioning of the machine at Ralph's, it is believed that automatic hide pulling separates the fat layer from the underlying muscle tissue (Figure 3-8, Figure 3-9). Investigation indicated that "bubbling" occurs at the subcutaneous interface which causes interference to the transmission of ultrasound signals. The result is extremely poor ultrasound image quality very different from trials conducted at Cannon Hill.

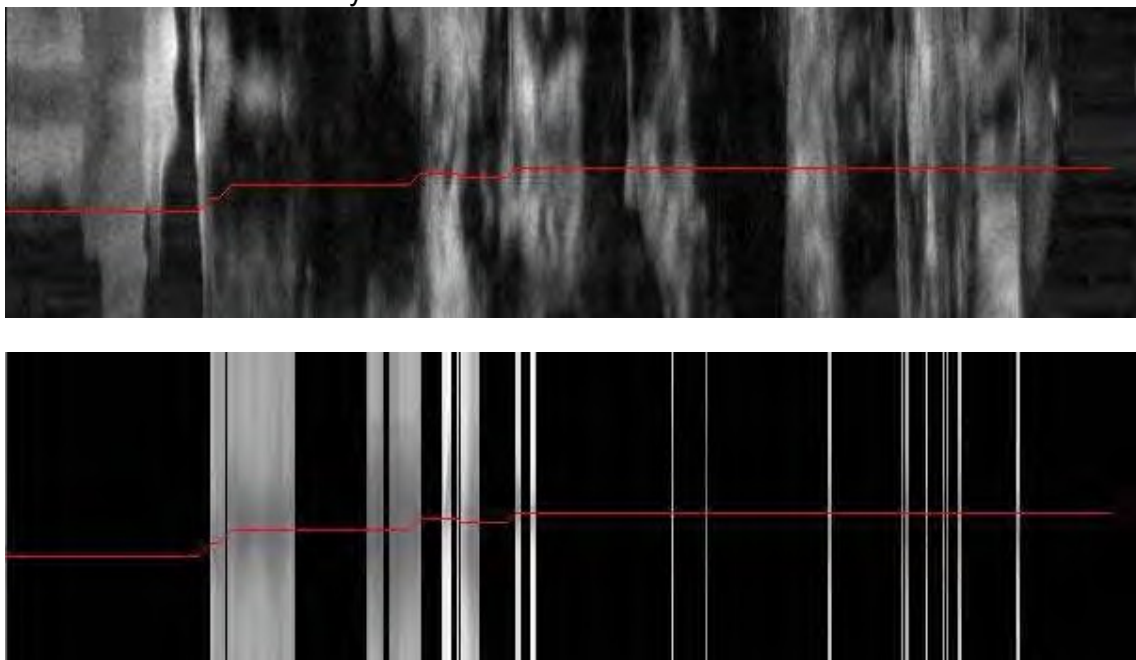
Figure 3-12 01-06-04 @ 10:31 Projection

Following are examples of unusable ultrasound input images and the associated image projection from the same trial (Figure 3-12 and Figure 3-13). Note the dark "shadows" caused by air bubbles.

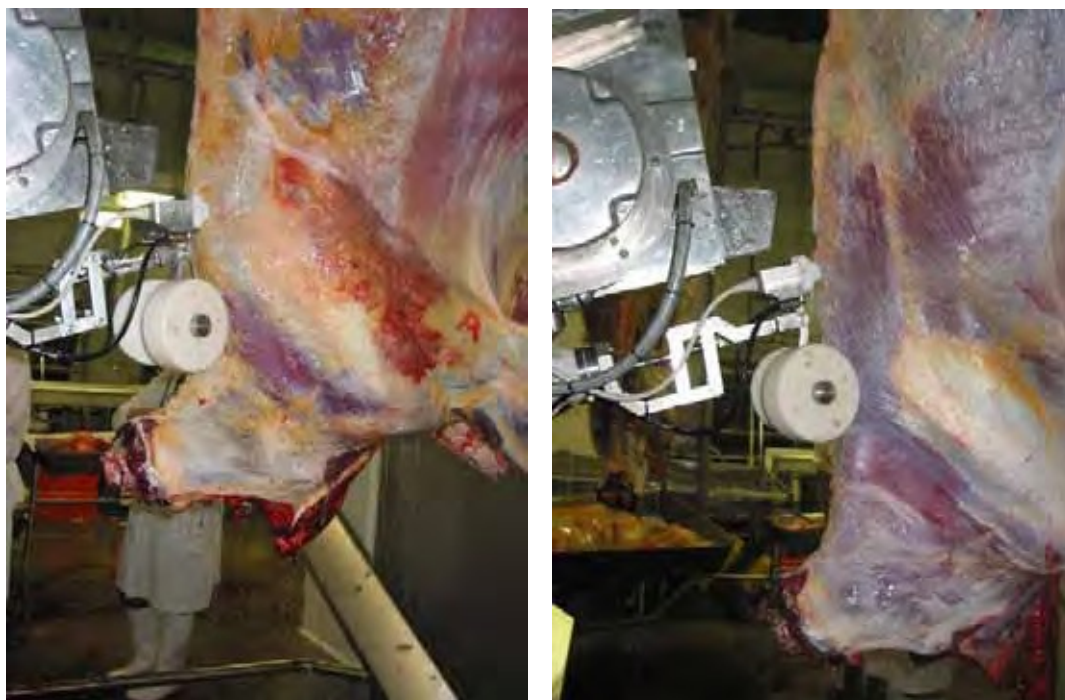
The splitting saw system was developed to account for all types of carcasses and simulating soft tissue with water will not work with fattier or flat backed carcasses. Any further work in this area would only benefit the lean carcasses.

Figure 3-14: Water sprays were fitted below the ultrasound head to wet the carcass surface

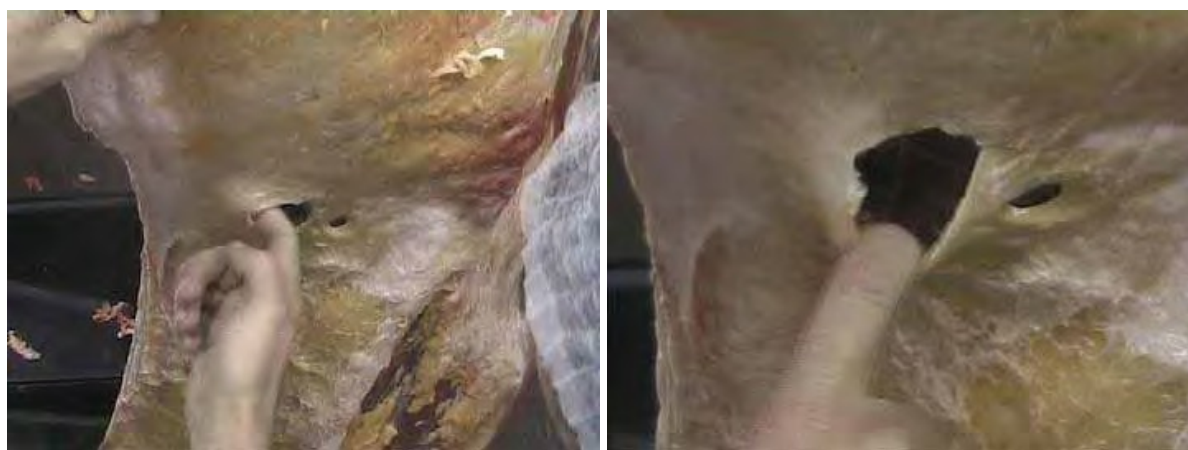
Figure 3-15 Fat Layer Separation

Severe bubbling of the fat layer and surface tissue was occurring due to the hide pulling action. Further investigation showed that more bubbling was occurring in the subcutaneous tissue layers (see Figure 3-15 and Figure 3-16). This caused improper ultrasound signal coupling at the air/material interface producing an unusable image.

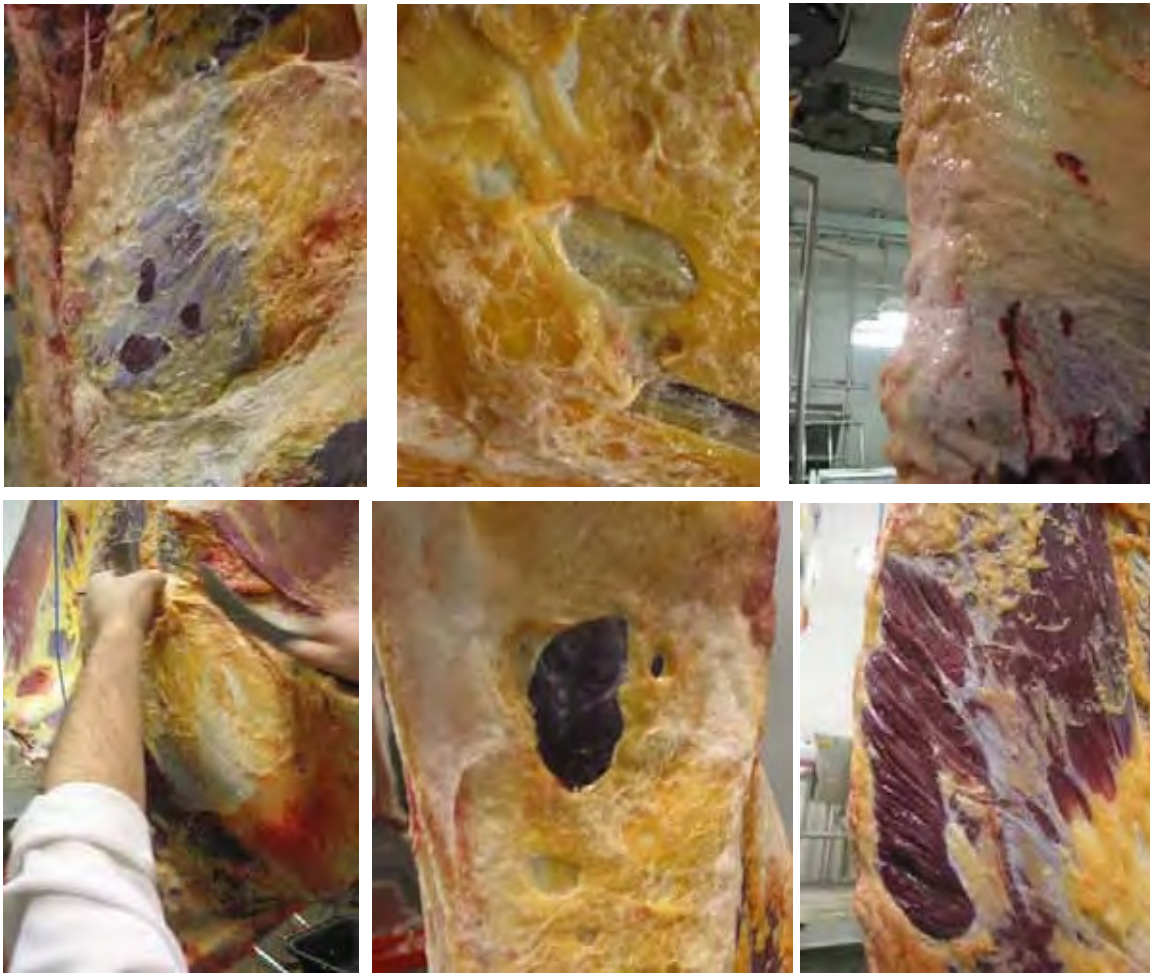
There was a clear indication that air bubbles and tissue separation was the difference between the hide pulled and the manually pulled carcasses.

Figure 3-16 Examples of surface and subsurface bubbles and tissue separation

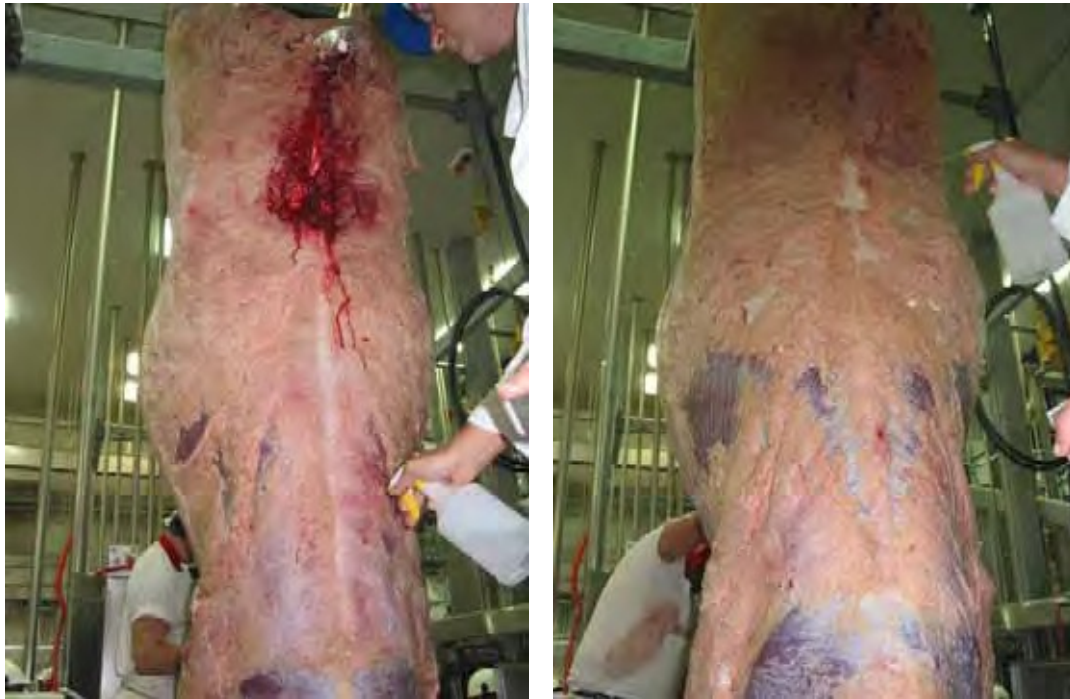
The ultrasound probe was manually applied to the carcass surface. Water was applied to the carcasses, as the surface fat and tissue was drying and becoming 'sticky' making it difficult to drag the ultrasound probe down the length of the carcass by hand.

Figure 3-17 Examples of the sample animals tested at Valley Beef
