final report

Project code: P.PIP.0260
Prepared by: Gavin Inglis
Machinery Automation and
Robotics
Date published: June 2012
ISBN:

Bladestop – Phase 4 Final Report

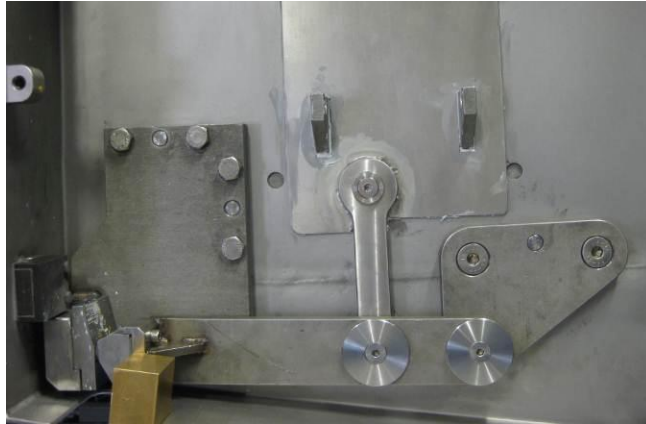
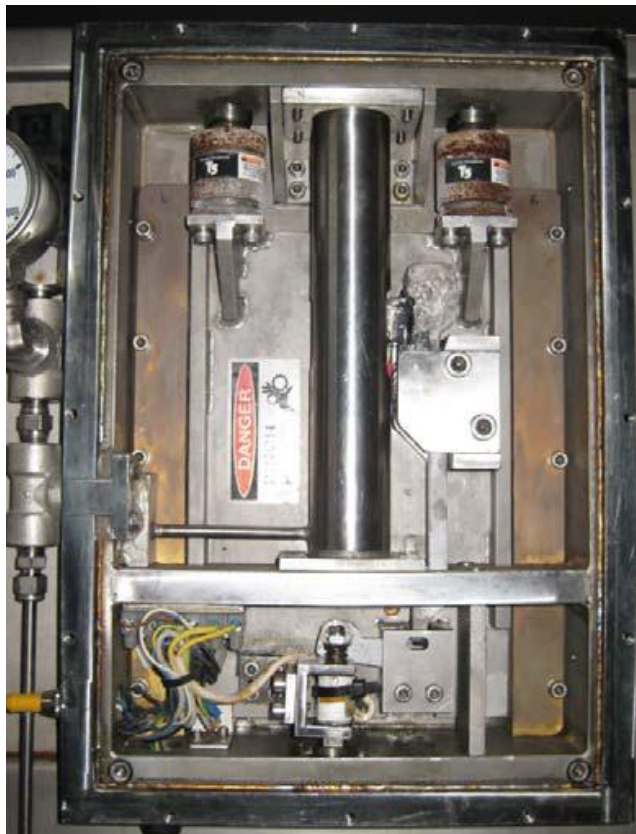
Fig. 1 Front view of Mechanism

Fig. 2 Rear view of Mechanism

The criticisms of this system were that it was complex and contained a large number of parts, the latching mechanism was wearing and the system was very difficult to disassemble repair and reassemble so that the mechanism worked correctly again.

The new concept design saw the rear mounted gas strut and hydraulic latching mechanism removed and replaced by the front mounted spring tensioning and linear slide mechanism shown below.

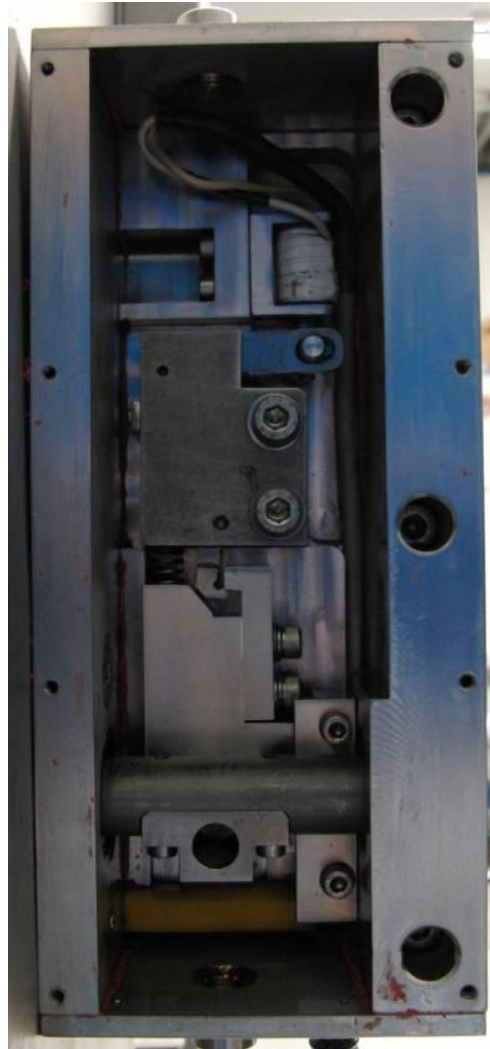
Fig. 7 View of the back half of the NCMC mechanism

Following feedback with regard to the access and serviceability of the back half of the mechanism during installation and commissioning of the NCMC saw this area was also redesigned during the design and manufacture of the ACC saw. As can be seen from the images below the new design allows much easier access, enabling the whole mechanism to be removed from the housing if required. The new design also reduces the probability of ingress of water to the coil area and leakage of oil from this area.

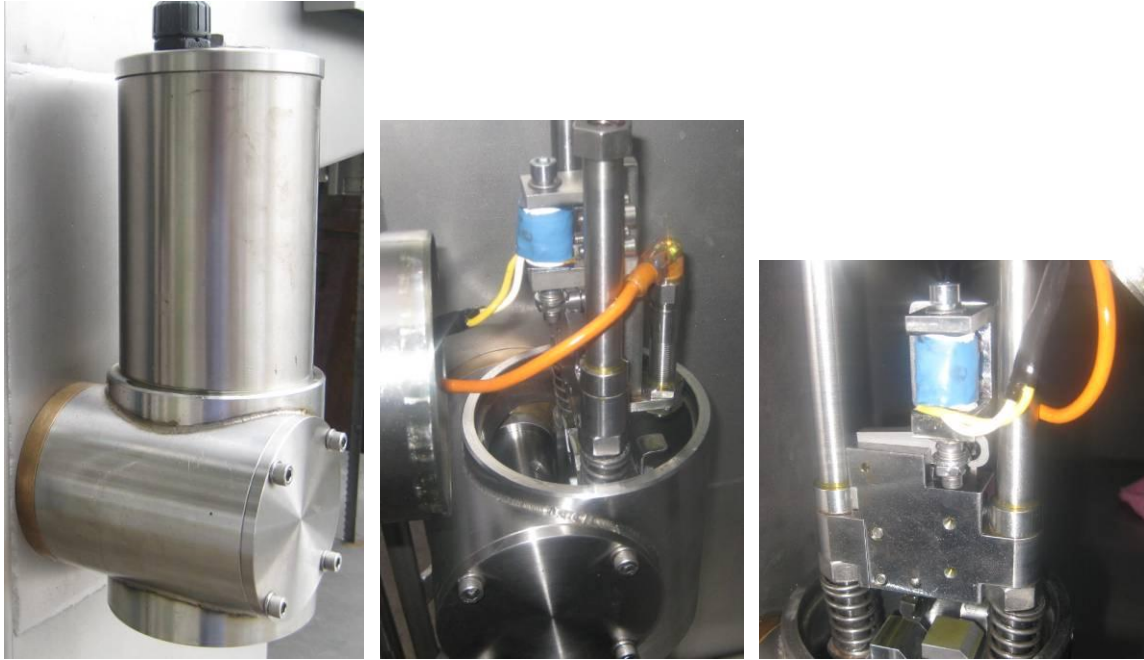
Fig. 8 Views of the inside and outside of the new back half of the Bladestop mechanism on the ACC Saw

Also as can be seen from the images in Fig. 8 the proximity sensor for the system has been moved out of the production environment and within the protected area of the back half of the mechanism with the coil.

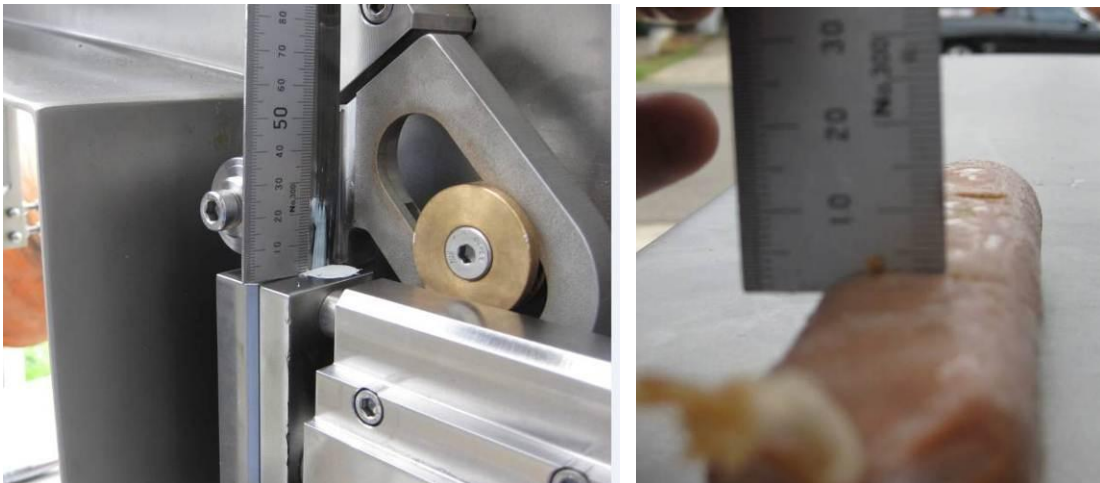
Fig.11 Sausage and paint run through test conducted with MLA on ACC at MAR's workshop

The images below show the paint and sausage tests conducted during the testing process. The run through, 25mm, and depth of cut, 3mm, were well within specification for the Bladestop project.

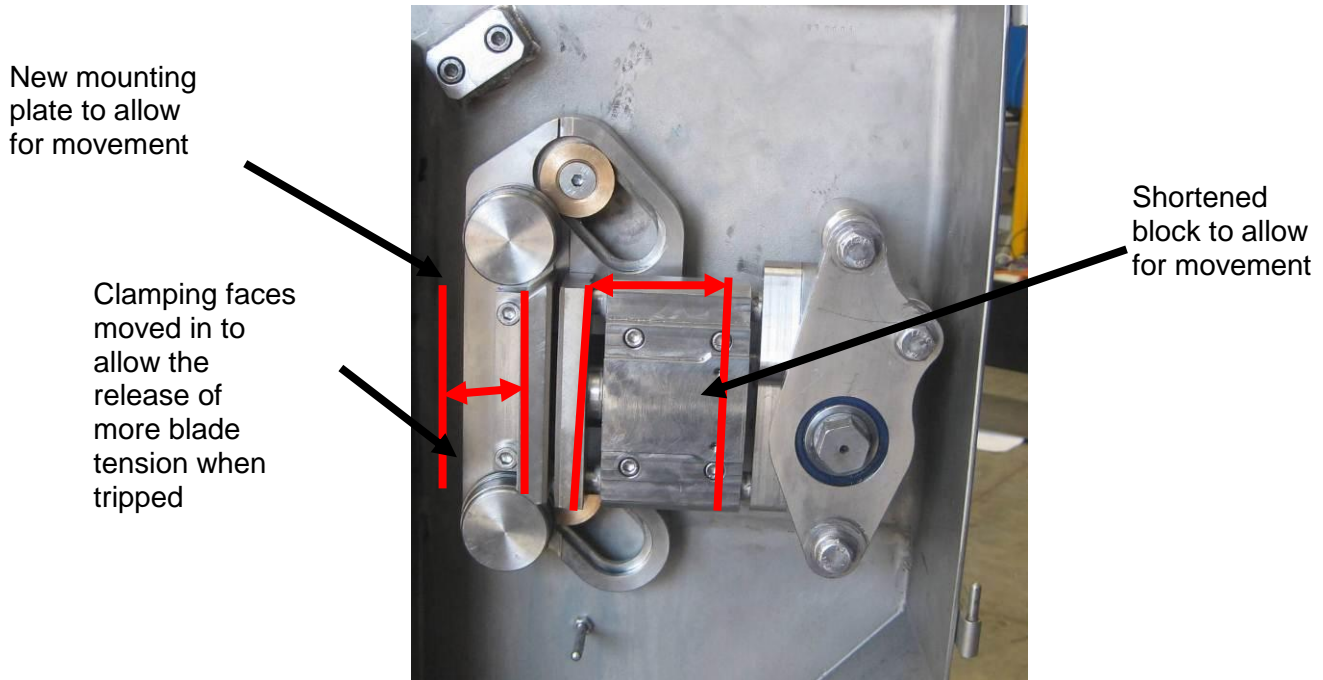
Fig.20 Changes to remove more tension in the blade

The design was modified so that there is minimum tension on the blade after tripping. The aim of this was to decrease the driving force on the blade from the bottom motor driven fly wheel when the mechanism was tripped. The clamping block was shortened to allow the clamping faces to be repositioned and a new sliding mounting plate was needed to allow for this a modified movement. This is shown in the image below.

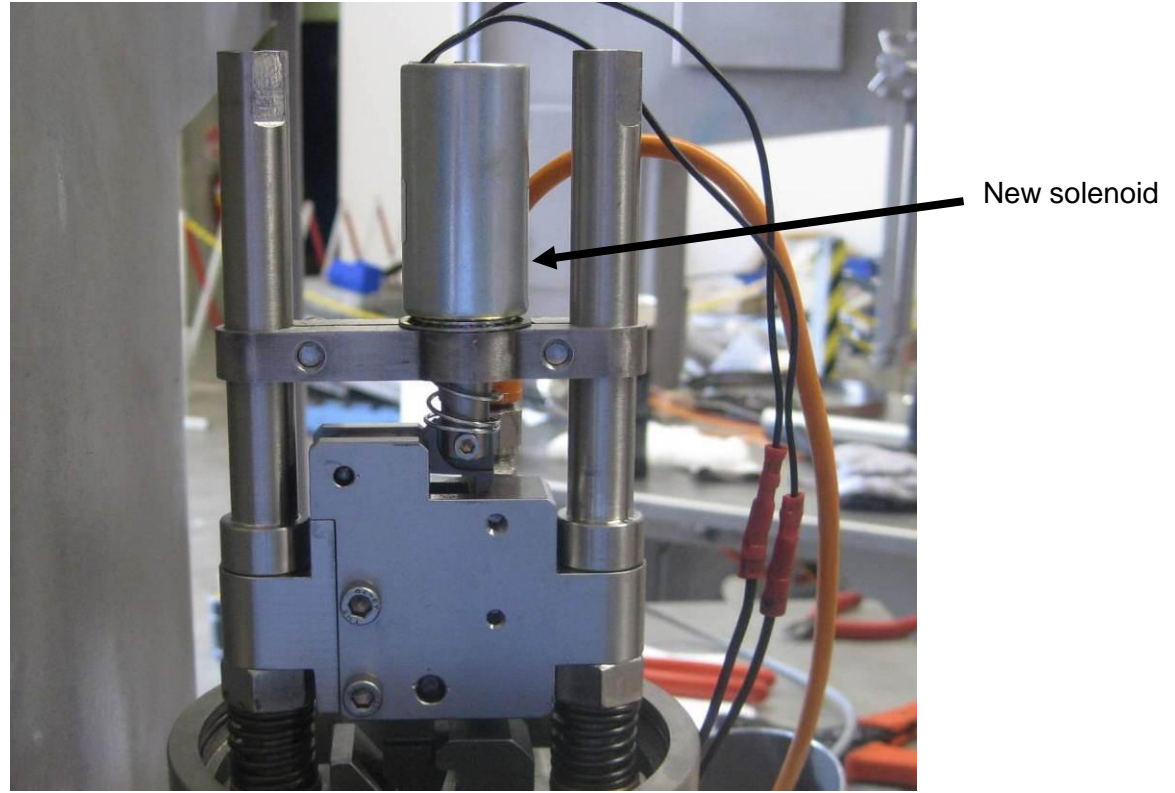
Fig.24 New Solenoid

The overall electrical design has been kept the same. The only change made is a new solenoid. The previous solenoid required modifications to adapt it to the tripping mechanism, this made it unsuitable for a production machine. The old solenoid required mounting to one side which resulted in misaligned forces that damaged the mounting bolt arrangement. A new solenoid has been sourced that requires no modification, improving reliability and serviceability.
