final report

Project code:	P.PSH.0237
Prepared by:	Ray Dennison
	FOOD FOUIPMENT

Evisceration pan table system

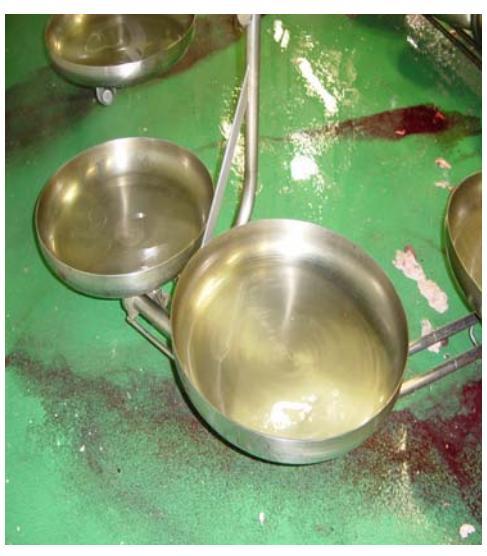
Photo 1

Empty pans approaching the evisceration area entering the guide rails and the pans 300mm from the finished floor level.

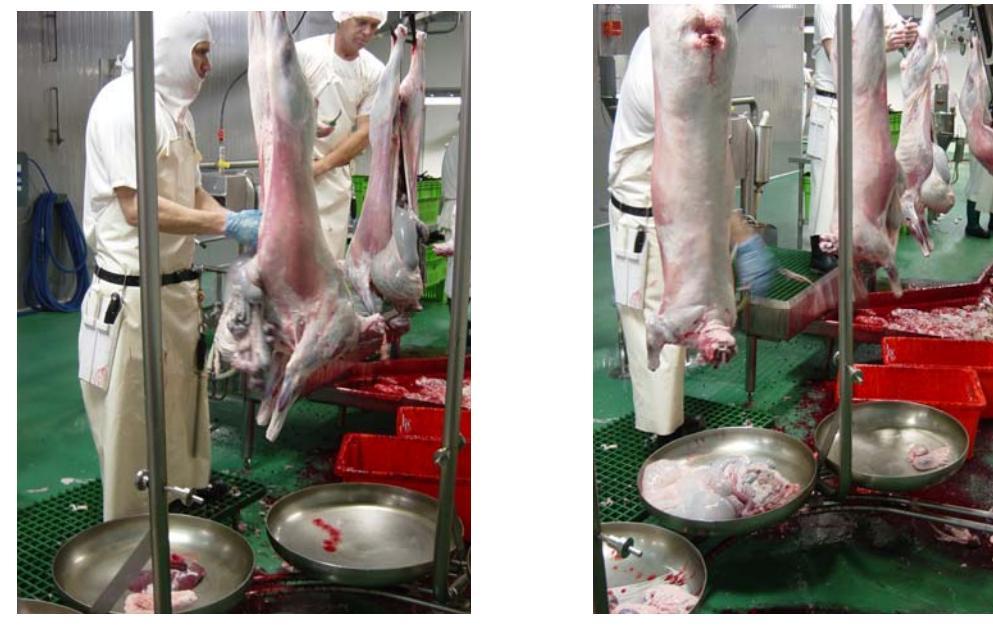
Photos 2 and 3

Evisceration procedure on the corner of the pan system and the carcases entering. The white offal pan and the carcases will be centred when the two conveyors are straight. The paunch and runners are lowered direct into the pan without operator turning.

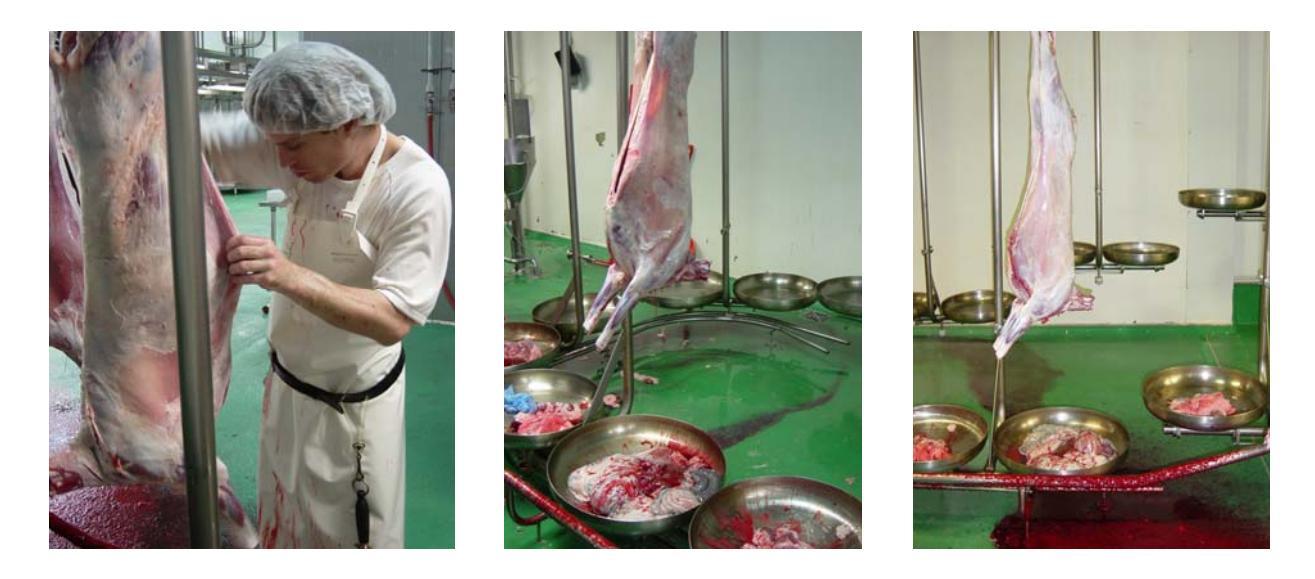
Photos 4, 5 and 6

Operator removing red offal carcases positioned central to white offal pan with red offal trailing.

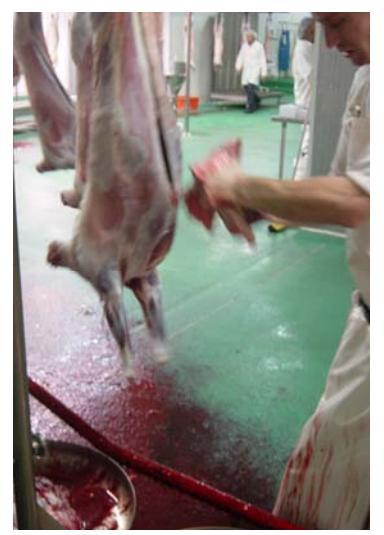
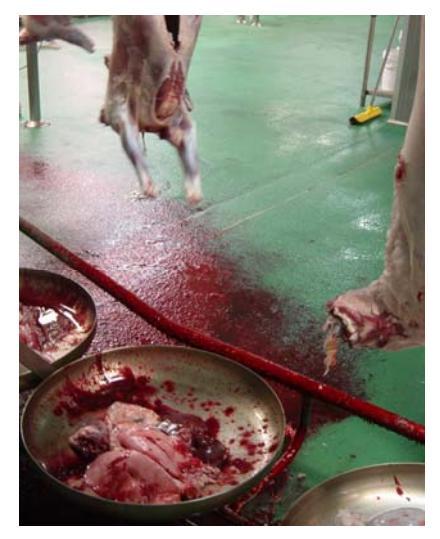
Photos 7 and 8

Carcase travelling away from the pan system at 45 degrees. If red offal operator becomes held up there is still time for him to remove the offal without too much manoeuvring.

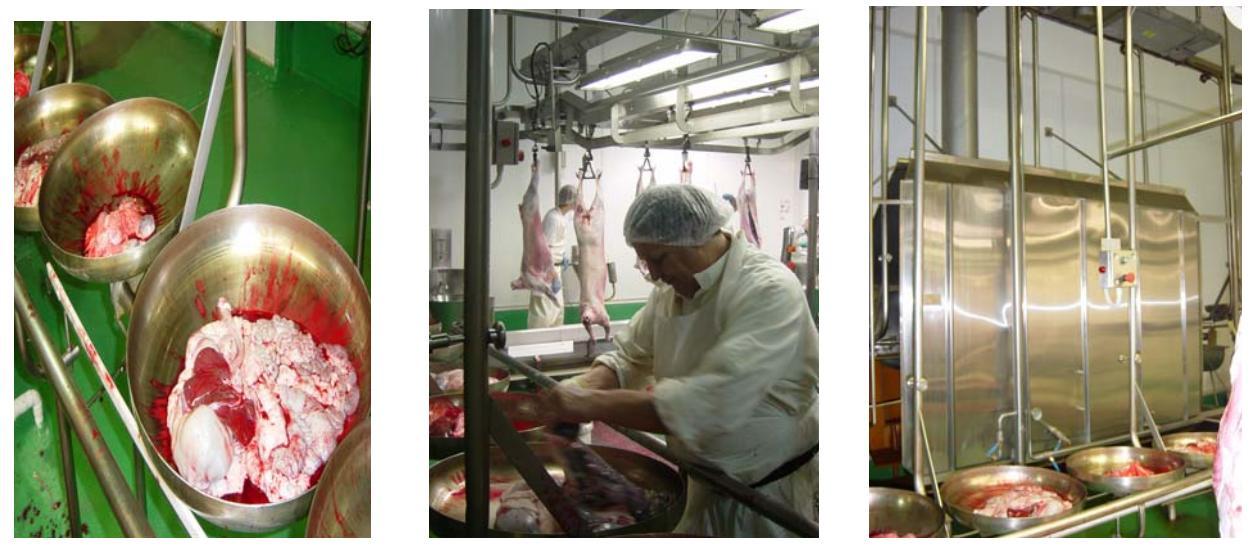
Photos 9,10 and 11

Pan incline up from 300mm from floor to 900mm for inspection. Guide rails provided for inspection to lean on as required. Photo 10 shows the sliding pin which when pulled forward will indicate to the system to be discharged to condemned. Photo 11 shows the wash cabinet on the return side.

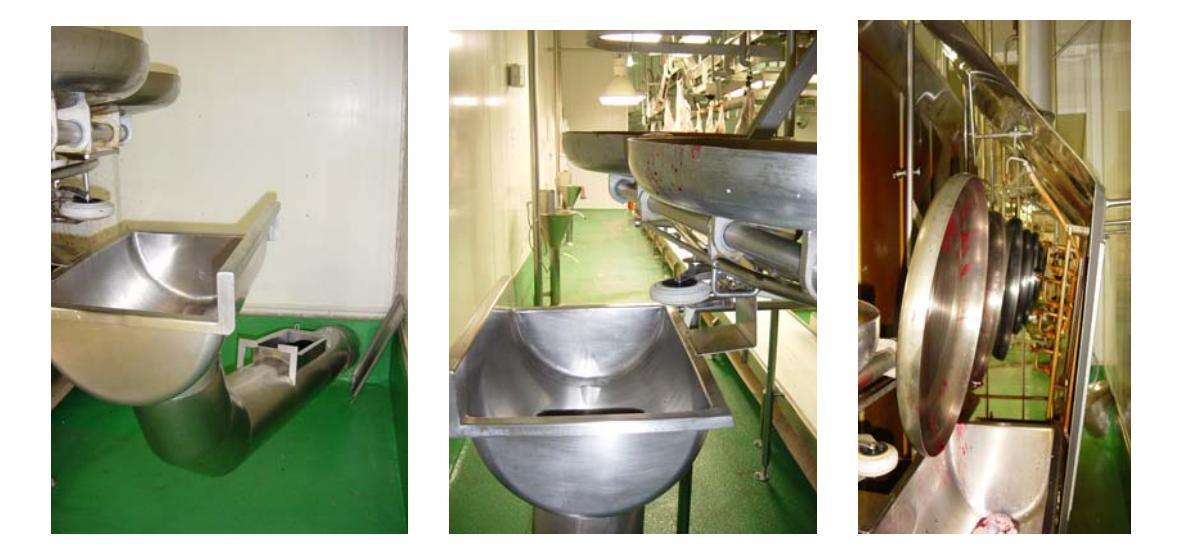
Photos 12, 13 and 14

Discharge hopper, red offal casing and condemned. Pans are tipped by a pneumatic system discharging into their correct hopper. All pans are tipped to the condemned regardless, to ensure they are in the vertical position for washing. If there is a malfunction the system is designed to allow the pans to pass through the wash without jamming.

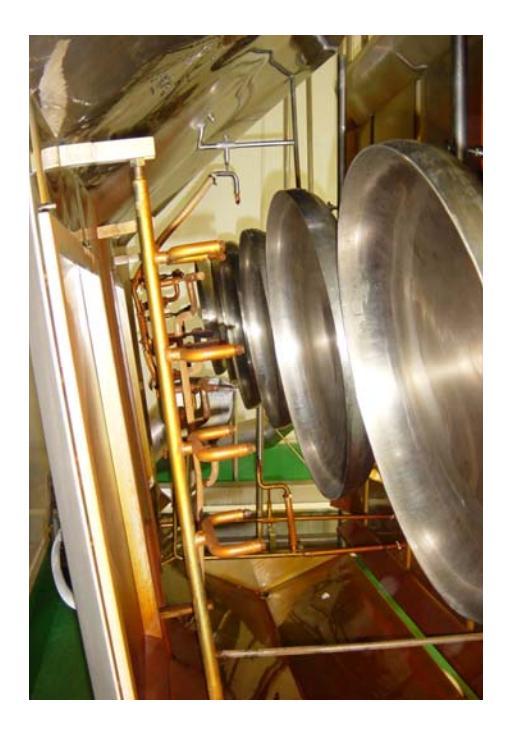
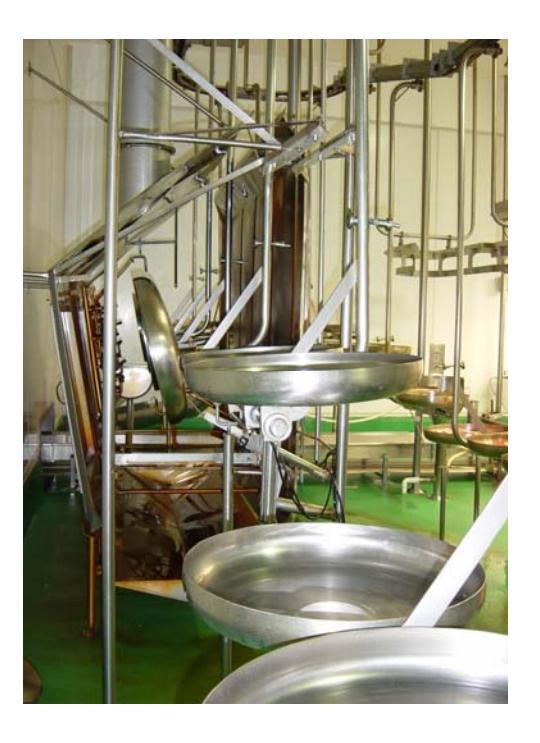
Photos 15 and 16

Wash cabinet showing pans in the vertical position for flushing and draining. Water collection trough mounted 300mm above floor level to assist in cleaning and collection of waste water. A 300mm diameter fan to vent and remove steam and mist.

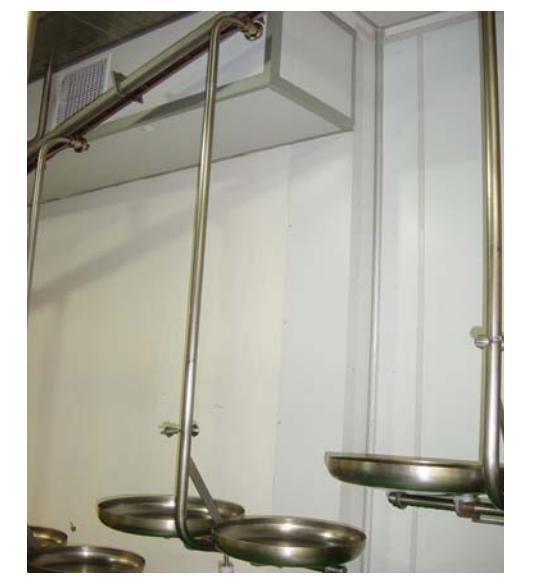
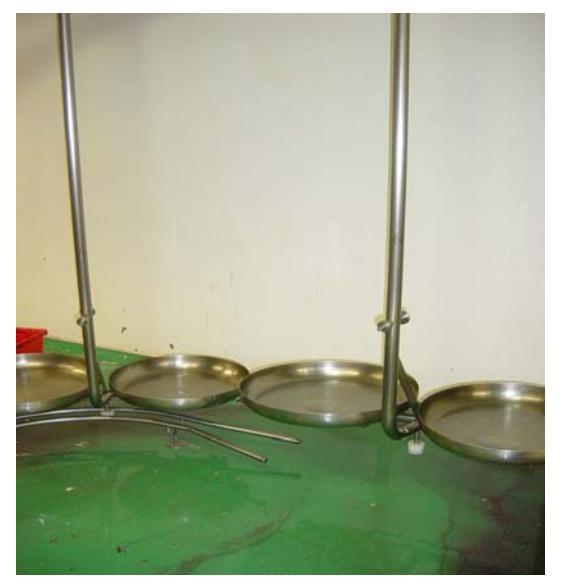
Pans decline from the wash cabinet level to the lower level evisceration area.

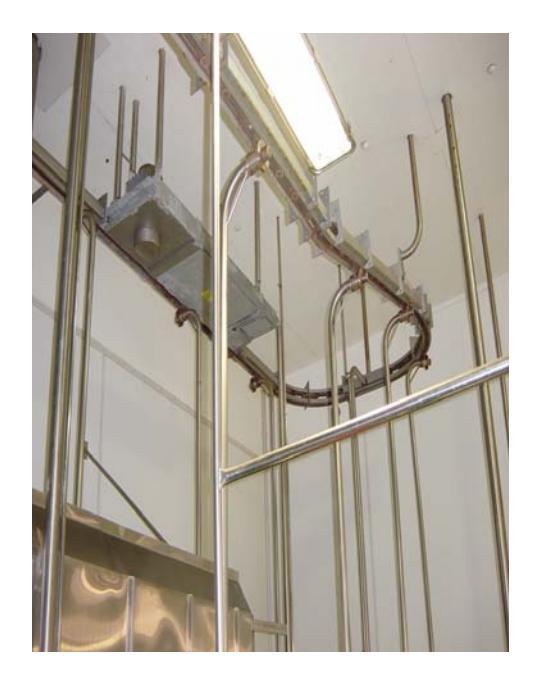
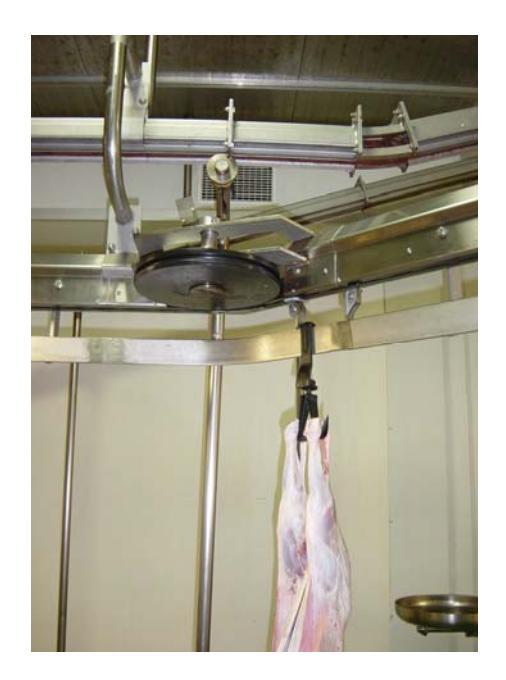
Photos 19, 20

Photo 19 being the caterpillar drive and stainless steel track suspended from structural steel above ceiling level. Photo 20 and 21 show the two conveyor configuration with the counter level pan support column.
