final report

Project code:	P.PIP.0065
Prepared by:	Norvic Food Processing Pty Limited
	DPI Victoria
Date published:	June 2011

Automated "Skin-on" goat meat processing

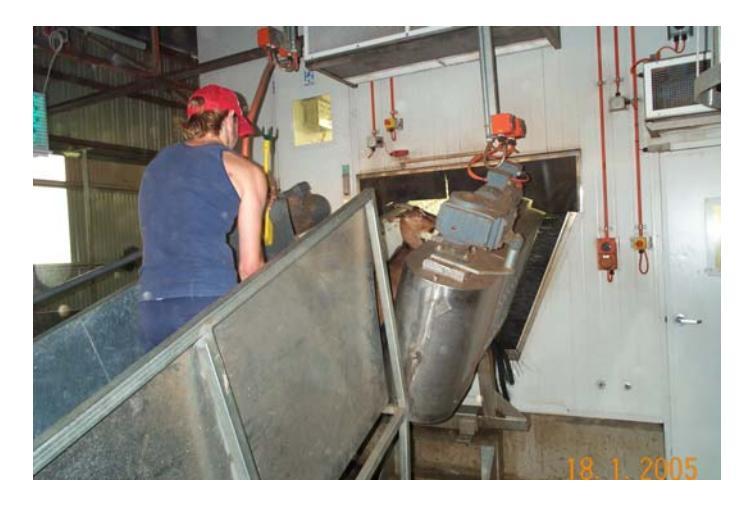
Figure 1 Restrainer Viewed from Outside SOG Room

After an assessment of site space limitations and projected production targets it was established that a purpose built goat restrainer would be required. The restrainer was developed specifically to handle goats in the 12 to 16 kg dressed weight ranges. An operator platform, access ramps and significant electrical works were also required for the restrainer

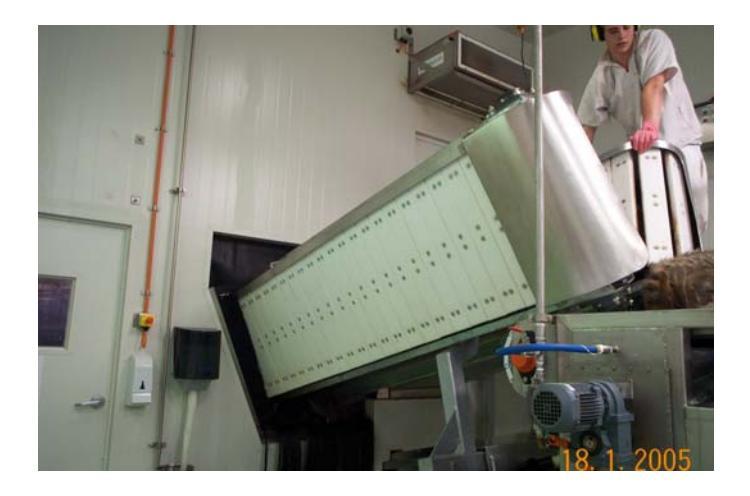
Figure 2 Restrainer Viewed from Inside SOG

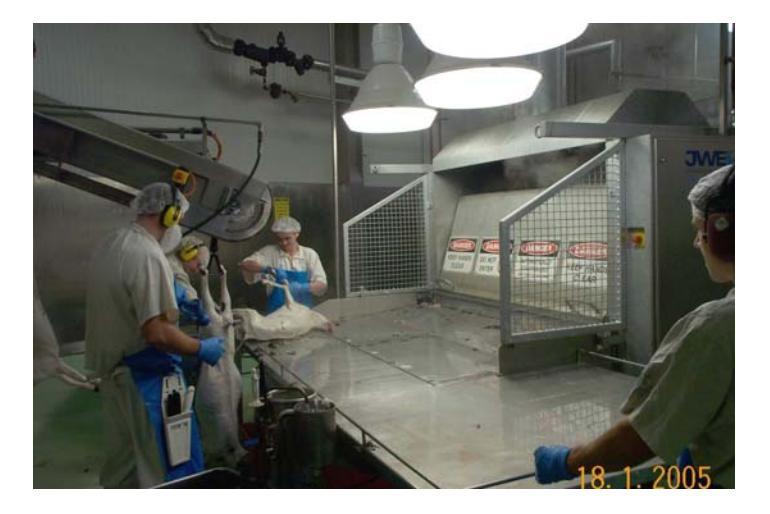
Figure 4 New Discharge Table with Extension

- All equipment were fitted with additional; stands to facilitate worker safety during operation and cleaning
- All equipment were fitted with mechanical guarding and/or locking devices to prevent the risk of injury to staff working in the vicinity of the machine.
- The discharge table was enlarged to eliminate the risk that workers may come into contact with the hydraulically operated discharge flap.
- The electrical control system was modified to provide safety interlocking for the overall system and provision of sufficient emergency stops to facilitate emergency shutdown of the system during operation.
- Training and where appropriate hazard signage was provided on all plant equipment to ensure staff were fully trained on the safe operating procedures that needed to be followed for all operational equipment.

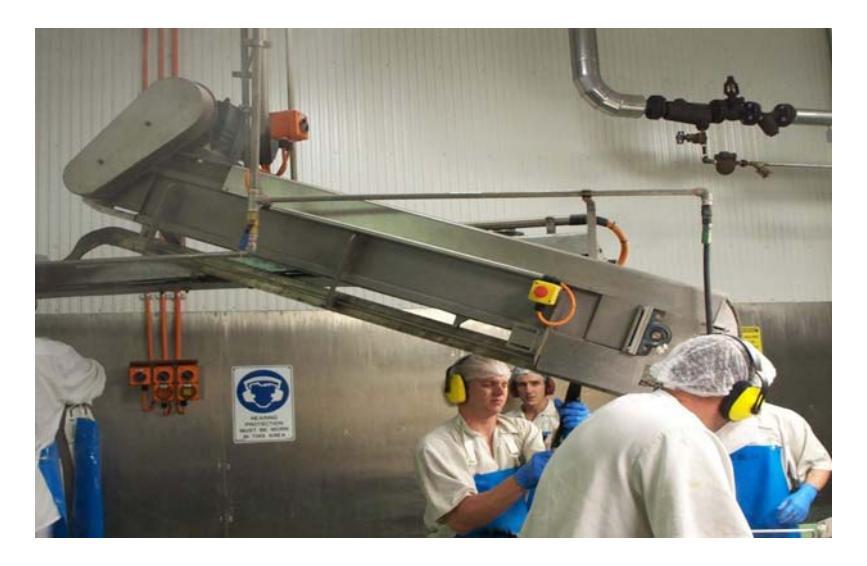
As the dehaired carcases are discharged from the dehairer a sliding gambrel is fitted to the hind hocks. The gambel then used to hook the carcase onto an ergonomically designed transfer chain conveyor that lifts the carcases onto an overhead rail that feeds carcases into the small stock processing area. The carcase transfer chain is central to the line of the dehairing machine enabling an operator to work on both sides.

Figure 5 Carcass Transfer Chain in Operation

The transfer chain incorporates variable speed drive to enable it to be synchronised with the existing small stock chain. The electrical control systems have been interfaced with the emergency stop systems to enable the complete system to be shutdown from any of the emergency stops strategically placed along the entire processing line.

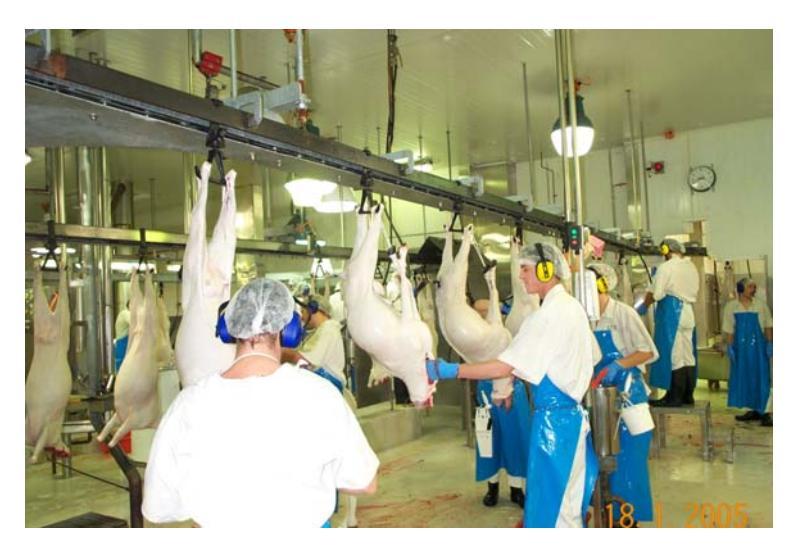
Figure 6 Dehaired Carcasses after Transfer to the Small Stock Processing Area

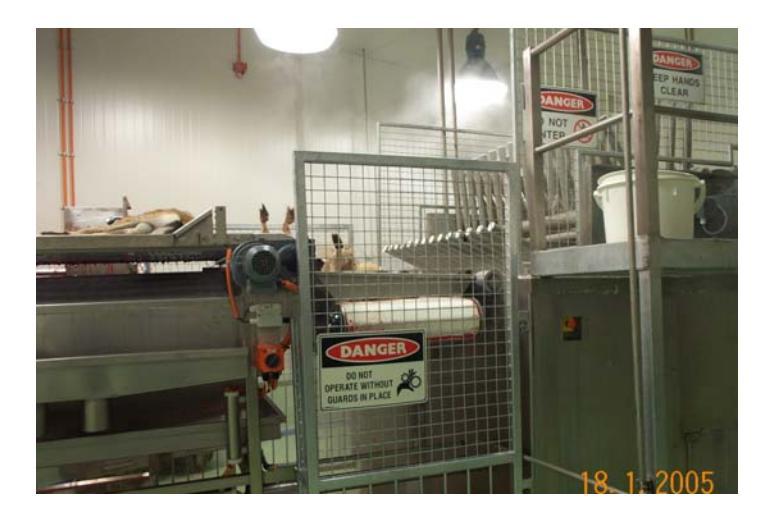
Figure 7 OH&S Guarding & Signage on Carcass Lifter Prior to Entry to Scald Tank

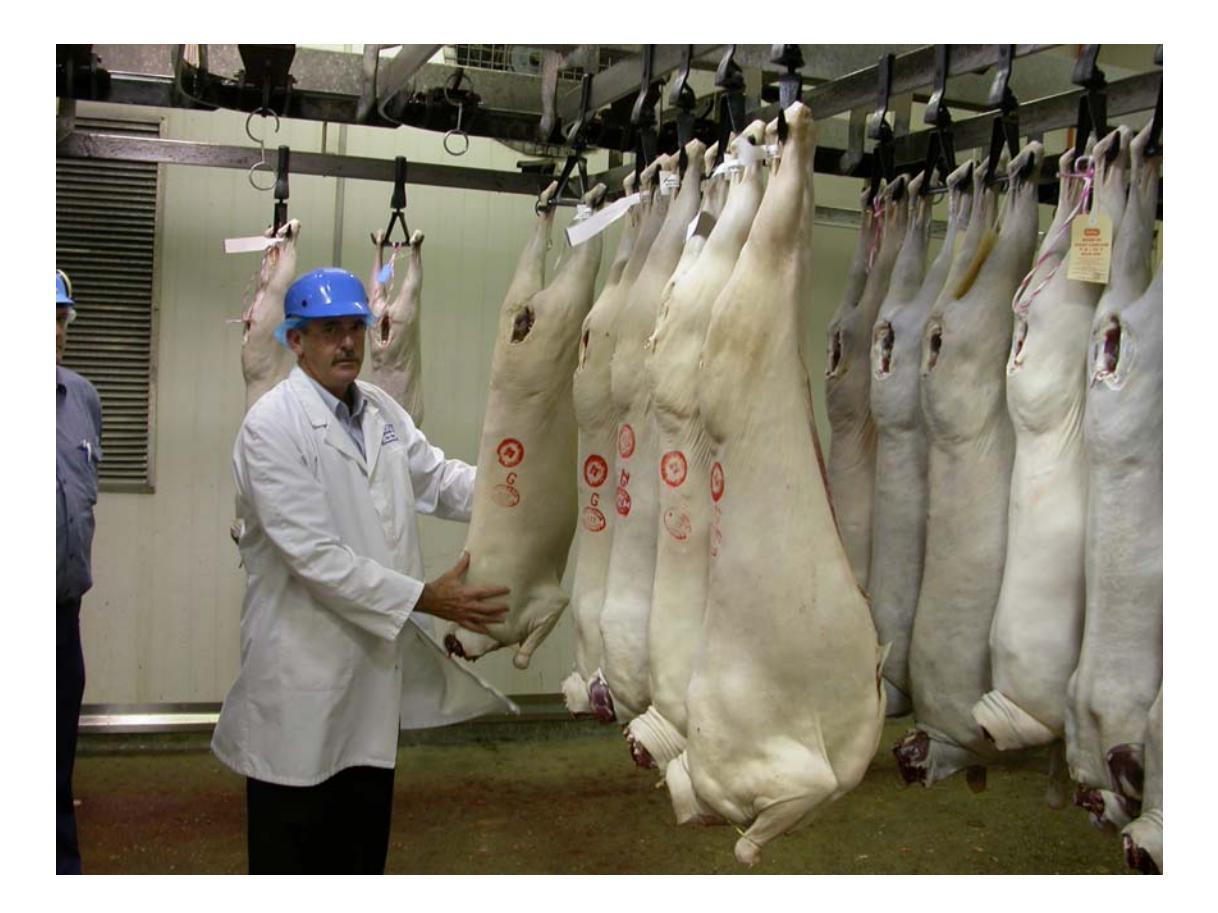
Figure 8 Quality of the skin on goat carcases processed through the new integrated system at Norvic Food processing Pty Ltd on 16th March 2005

The results obtained from the testing indicate that, for those days production were of high microbiological quality. The results obtained show:

- Salmonella was not detected on any the 49 carcases. The product easily meets AQIS requirements (as per AQIS Notice 2003/6) for Salmonella
- The product met AQIS performance criteria for E coli with 9 of the 49 samples meeting the Good category (1-10 E coli/ cm²) and the remaining 40 samples being in the Excellent category (not detected)
- TVC counts were in the Excellent range according to Meat Standards Committee guidelines of <1000
