## final report

Project code: A.ENV.0079

Prepared by: Teys Bros Pty Ltd

# Investigation of reuse of boning room effluent streams

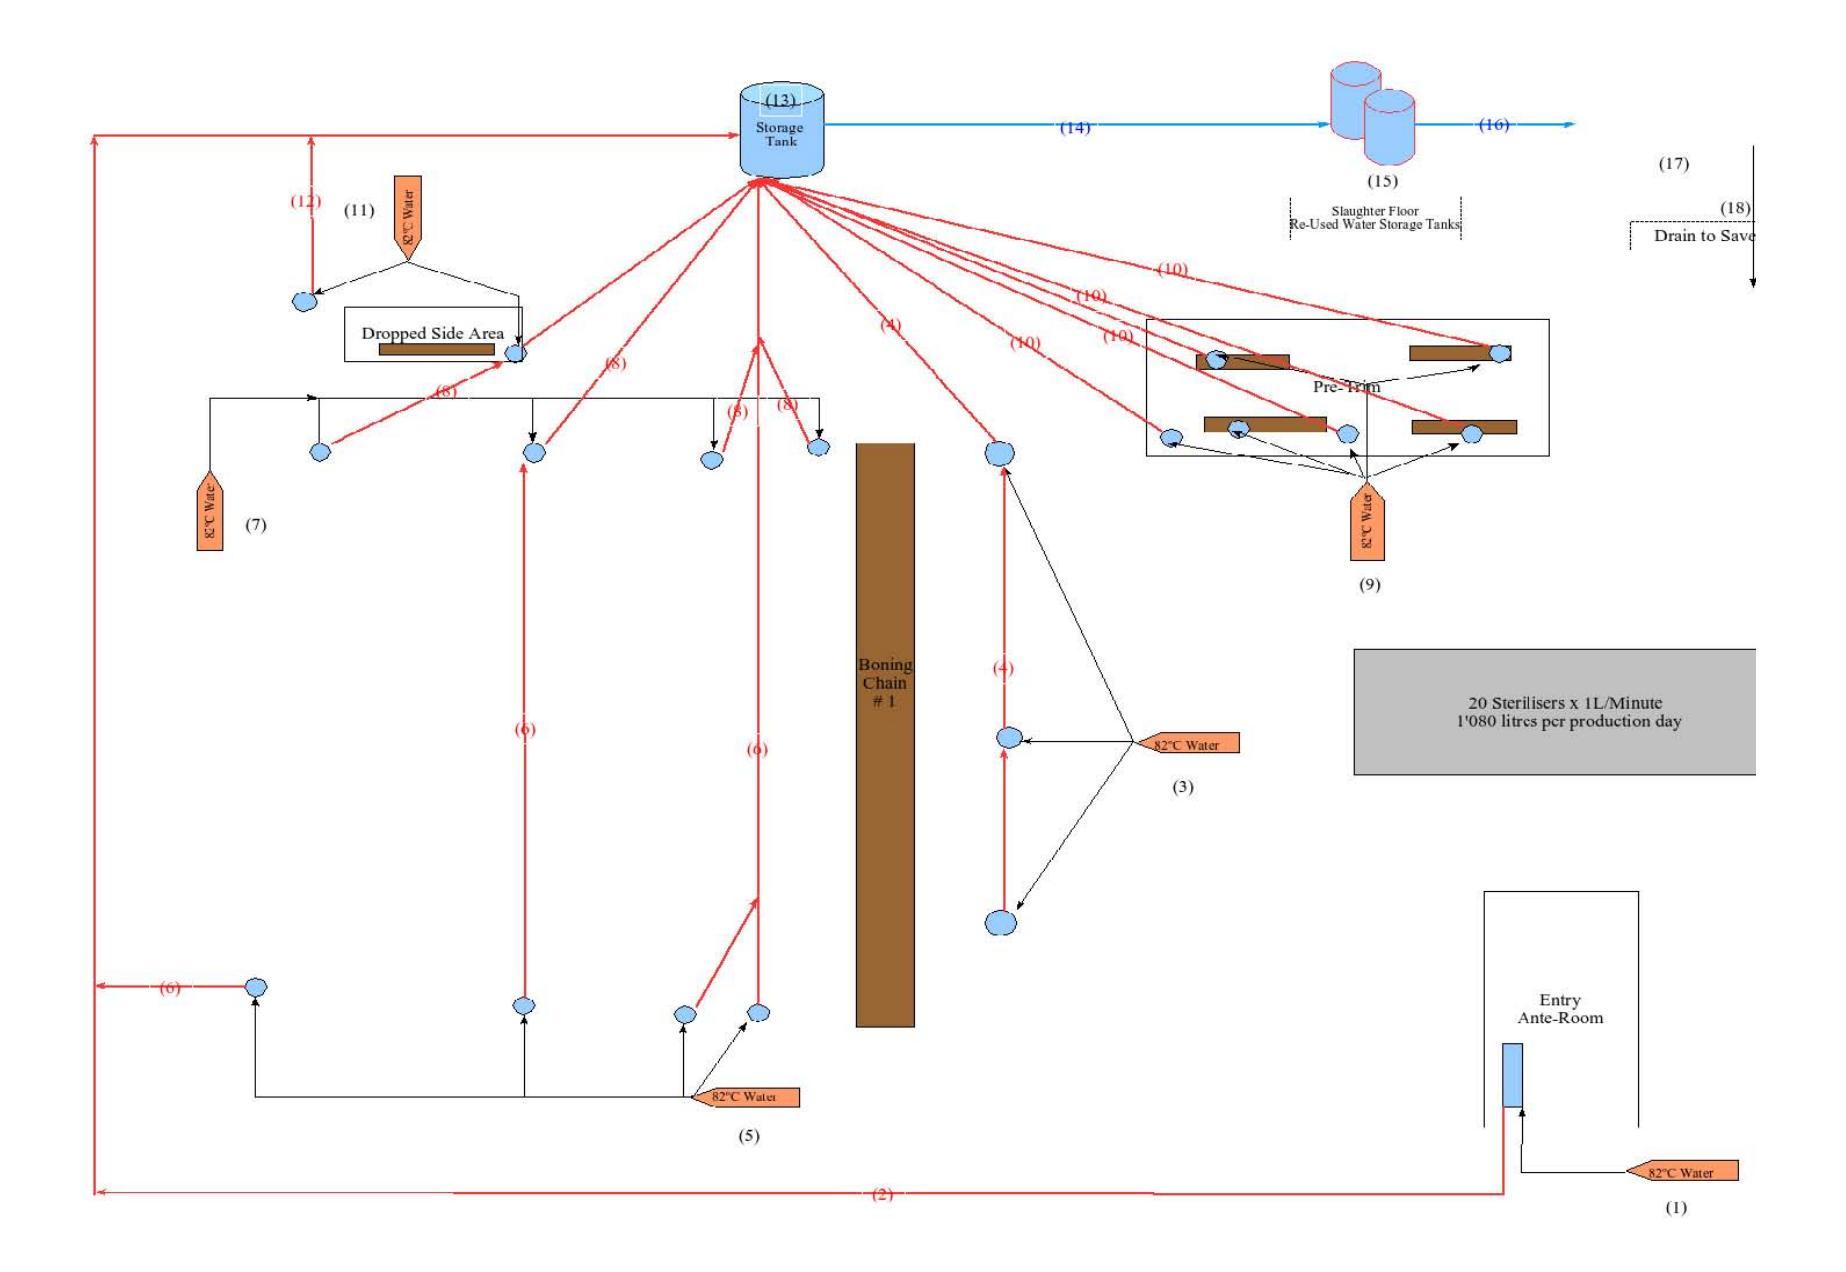
#### Location of sterilisers on boning room floor

The only stream which provided enough clean water to potentially be viable was the water from the boning room sterilisers.

20 sterilisers @ 1 litre per minute for 15 hours / day
